Phase 1 Inspection Report: National Dam Safety Program. Osage - Gasconade Basin. Little Prairie Dam, Phelps County, Missouri

LITTLE PRAIRIE DAM
PHELPS COUNTY, MISSOURI
MO 30090

PHASE I INSPECTION REPORT NATIONAL DAM SAFETY PROGRAM

Name of Dam: Little Prairie Dam
State Located: Missouri
County Located: Phelps County
Stream: Unnamed Tributary to Bourbeuse River
Date of Inspection: 24 August 1978

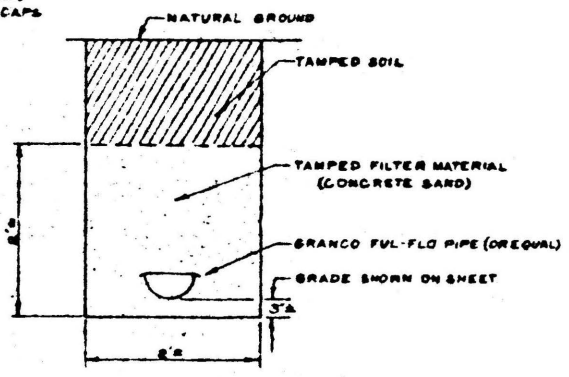
TYPICAL SECTION-TRENCH DRAIN

No foundation or embankment design reports were available from the Missouri Department of Conservation. Sheet 3 of Appendix A (from Plans for Construction) shows a plan view of a foundation trench drain. A typical section of this trench drain is shown on Sheet 8 of Appendix A. This foundation drainage system is shown located from about Station 7+00 to Station 11+50 at a distance of 60 ft downstream of the centerline of the dam. The bottom elevation of the trench drain ranges from 997 at Station 11+50 to 995 at its point of exit (Station 7+50). A shallow core trench apparently was constructed at the base of the dam from Station 4+00 to Station 17+00.
