**Phase 1 Inspection Report: National Dam Safety Program.
Missouri - Kansas City Basin. Binder Lake Dam, Cole County,
Missouri**

BINDER LAKE DAM
COLE COUNTY, MISSOURI
MISSOURI INVENTORY NO. 30051

PHASE I INSPECTION REPORT
NATIONAL DAM SAFETY PROGRAM

PREPARED BY
HOSKINS-WESTERN-SONDEREGGER, INC.
CONSULTING ENGINEERS
LINCOLN, NEBRASKA

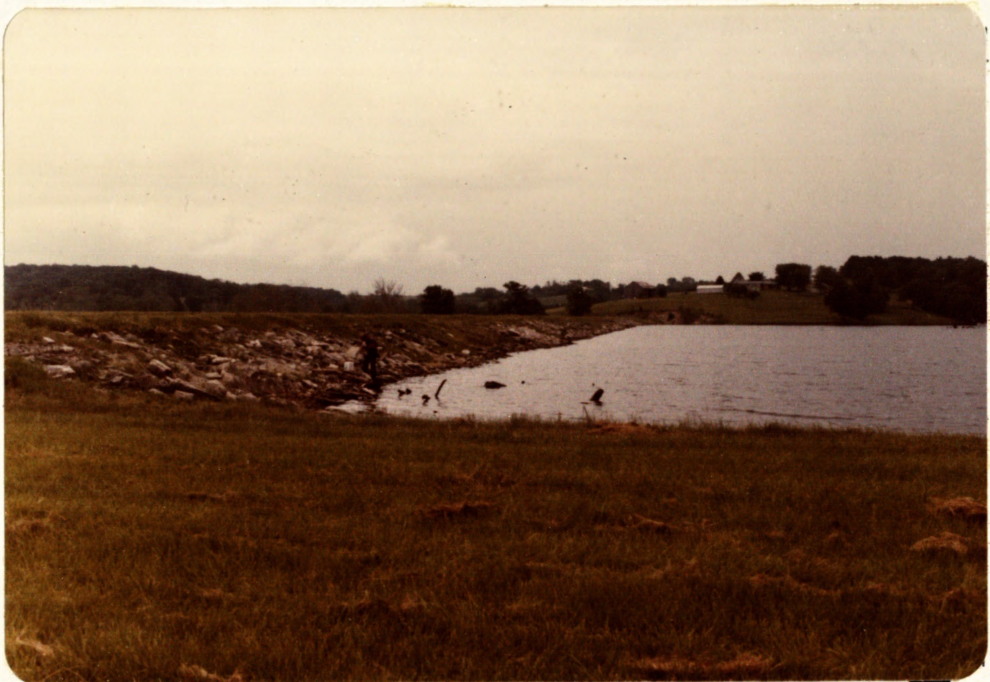
PHOTO NO. 5 - UPSTREAM FACE TAKEN FROM LEFT IN EMERGENCY SPILLWAY

- (2) The emergency spillway. The emergency spillway is well vegetated with adapted grasses and was recently mowed. It looks very good with no evidence of erosion or deterioration. The plans show the crest of the rock gabion structure as 1 foot above the spillway grade line. At the time of inspection the top of the gabion sill was essentially at the same elevation as the bottom of the spillway. This may indicate that the spillway bottom was plated with about 1 foot of topsoil for vegetation purposes. The rock gabion structure looks good with very little deterioration but it has not been used or tested to date.

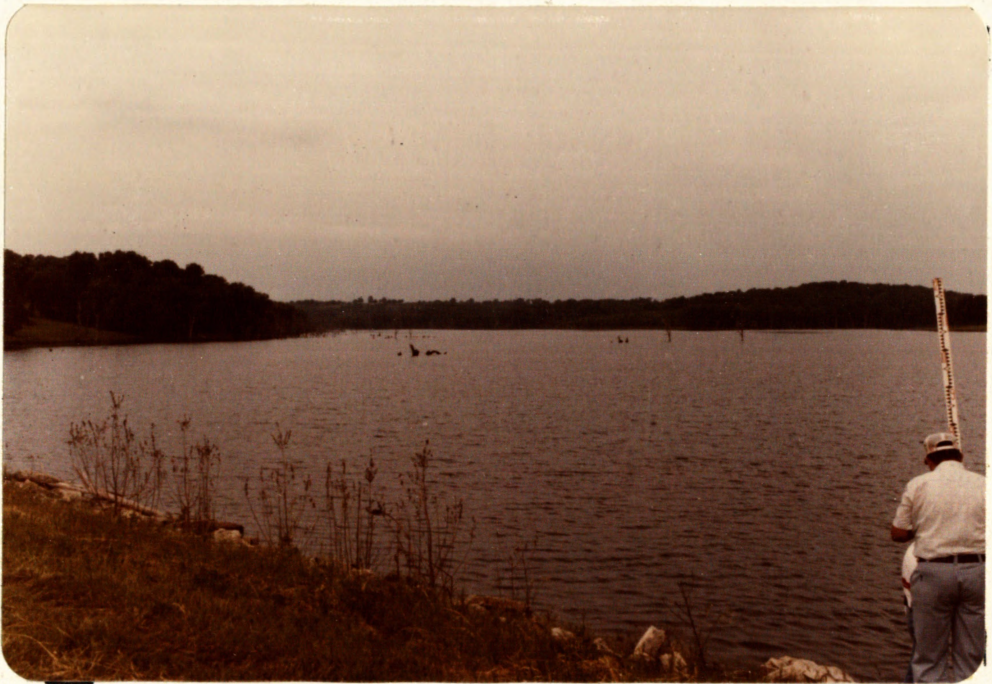
PHOTO NO. 9 - UPSTREAM ACROSS LAKE FROM CENTER OF DAM

- d. Reservoir Area. No slides or significant erosion were noted around the reservoir area. The reservoir was clear and beautiful.

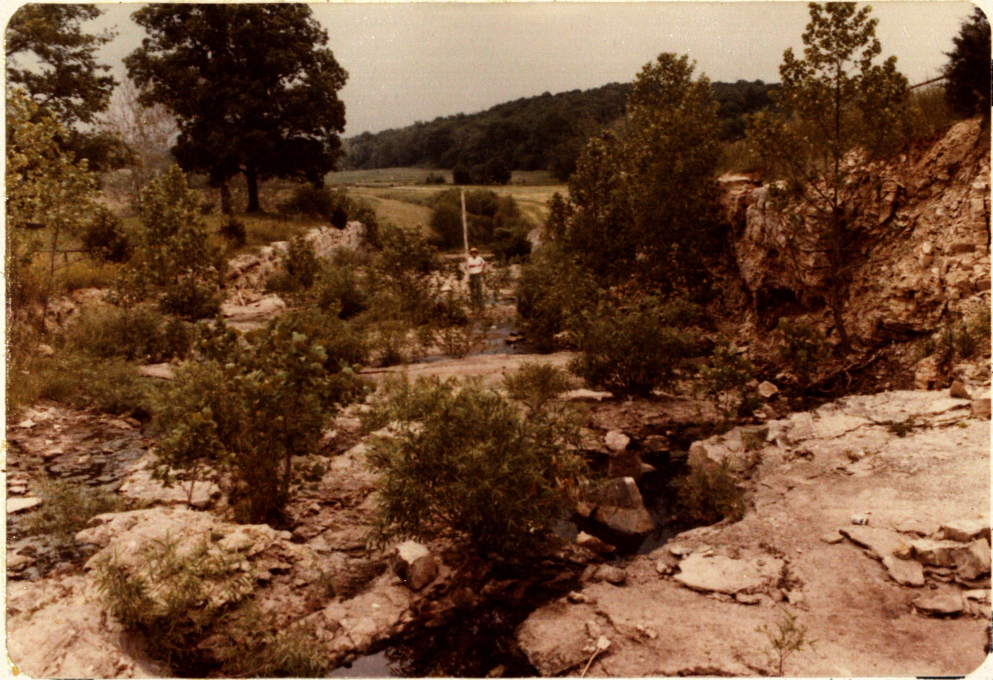
PHOTO NO. 12 - TAKEN FROM CONCRETE SILL LOOKING DOWNSTREAM
IN PRINCIPAL SPILLWAY

- (1) Principal spillway. Some erosion, spalling, and weathering of the limestone, with resulting undercutting, was observed at and under the downstream toe of the concrete weir control structure. (See photos 10, 11 and 13.) There is seepage outcropping along the downstream edge of the weir, predominately on both ends. All seepage is clear and the total effluent was estimated at $0.5 \pm$ gal./min. The exit channel is eroded bedrock with several small trees and shrubs growing in the cracks and erosion channels. The reservoir level was slightly below the crest of the weir.

- (1) The present maintenance program is generally adequate.
- (2) Erosion and deterioration of the bedrock foundation under the principal spillway weir should be repaired and controlled.
- (3) The condition of the upstream riprap should be evaluated regularly and rehabilitation measures provided, as needed.

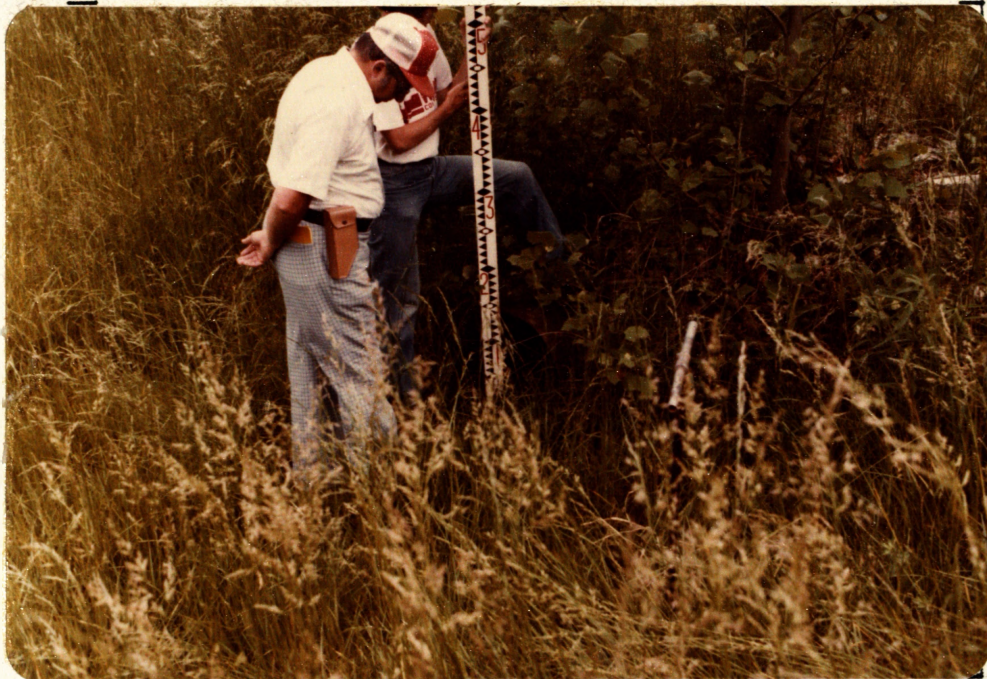
PHOTO NO. 14 - OUTLET END OF 18" CAST IRON DRAWDOWN PIPE

- (4) Downstream Slope. The downstream slope is densely vegetated with adapted grasses and was recently mowed. A few small trees are growing along the toe of the dam downstream from about station 5+00 to 9+00 (stationing according to plans). These trees may be feeding on discharge from the rock toe drain but no water or seepage was observed in the area. No cracks, rodent holes or deformations were observed on the slopes or at the toe. There was no indication of seepage on the slope or at the toe of the dam. No discharge was observed from the trench drain. The bottom of the outlet channel for the drawdown facility, which is some 5 feet below natural ground level, was moist but did not show free water. There was no sign of leakage from the valve on the drawdown pipe.

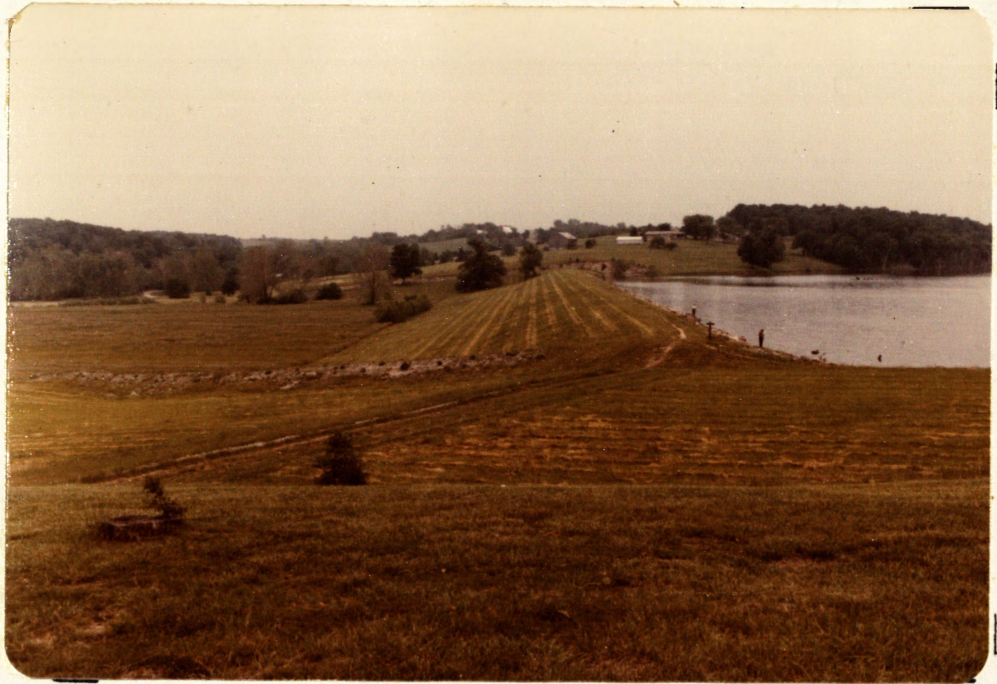
PHOTO NO. 16 - CREST AND DOWNSTREAM SLOPE FROM LEFT ABUTMENT

- (3) Crest. The crest is well vegetated with adapted grasses and was recently mowed. No cracks, rodent holes or deformations were noted along the crest.
