Lessons From Recent Collapses of Metal Buildings

David B. Peraza

By David B. Peraza, P.E.
Senior Associate, LZA Technology, New York, NY

This paper presents case studies of three roof collapses of metal buildings, discusses the most significant features of each case, and summarizes lessons learned that can be used to reduce future failures.

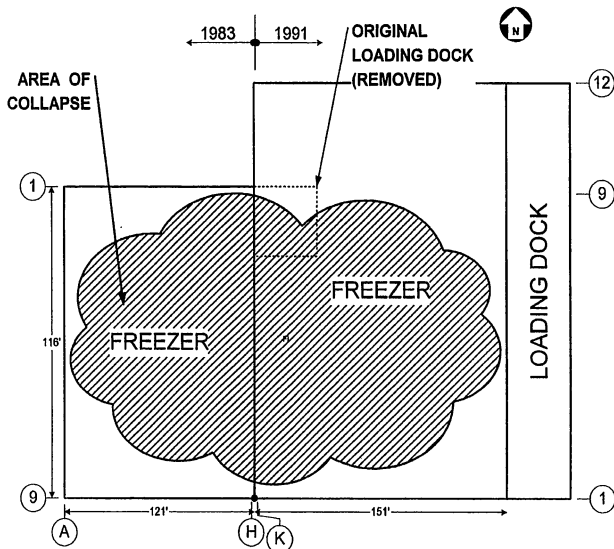
Figure 1: Roof Plan

On March 5, 1994, two attached freezer buildings collapsed under a snow load. The buildings were located near Harrisburg, PA. The buildings were owned by a food distributor and contained racks nearly 30 feet high for frozen food storage. These racks actually prevented the roof from falling to the ground. The claimed loss, primarily for food spoilage, was on the order of \$20 million dollars.

The buildings had been built in 1983 and in 1991, and their general arrangement is shown in Figure 1. For both buildings, the Owner had contracted with the same Design/Builder, who in turn subcontracted the design and fabrication to the same Metal Building Engineer/Manufacturer (Engineer).

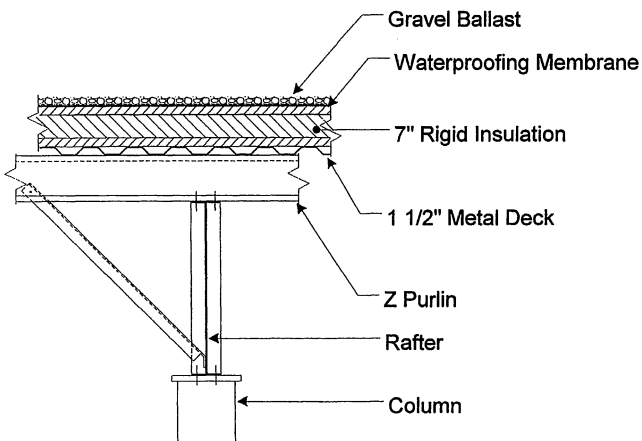
Figure 2: Typical Roof Construction

The 1983 Building measured approximately 121 feet by 155 feet in plan, and had a single slope roof. Its structure typically consisted of steel frames spaced at 19 feet and 20 feet, with one line of intermediate columns. The frames were composed of built-up plate girders, built-up columns, and intermediate round pipe columns. The secondary roof members consisted of 8-inch deep Z purlins spaced at 5 feet on center. Metal deck, 1 1/2" deep, was screwed to the purlins and supported seven inches of insulation and a ballasted roof membrane.

For the 1983 building, the purlins near the end rafters were found to be overstressed 20% to 41% in combined shear and bending. These overstresses occur at the end of the purlin overlaps at the first interior rafter. Similarly, for the 1991 building, the purlins near the end rafters were overstressed as much as 38% in combined shear and bending.

For the 1991 building, widespread instances of web crippling of the purlins was found in the interior bays. Overstresses ranged from 20% to 30% for design loadings, as compared to AISI 1986/89. A check for web crippling could not be found in the design calculations

- Design engineers must be familiar with current codes, and must be thoroughly familiar with the limitations of design software. In this particular case, checks for purlin web crippling and combined shear/bending could not be found in the calculations.

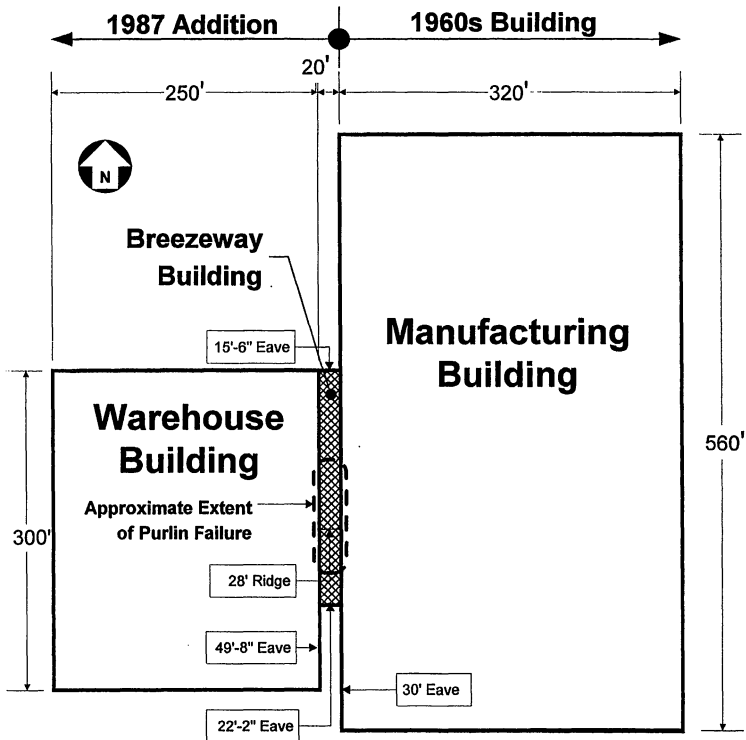
Figure 6: Roof Plan

the Breezeway me was substantially lower than that of the abutting buildings. Figure 6 shows the overall layout of the buildings.

Failure of a portion of the Breezeway roof occurred about a week after the January 1996 blizzard that blanketed the northeast United States. Sometime between the late evening hours of January 14 (Sunday), 1996, and the early morning hours of January 15, the roof purlins, particularly near the ridgeline of the roof, rolled and sagged excessively, although they did not actually collapse to the ground.

Anecdotal reports by employees indicated that there was 16' to 20' height of drifted snow on the Breezeway roof at the time of the failure.

In this case, it appears that the failure was caused by a drifted snow load that substantially exceeded the code-mandated values. This is based on the fact that the purlin design was adequate, plus the evidence that the snow loads present exceeded the code design values. Even if the strap bracing had not been installed, the purlins received sufficient incidental bracing from the standing seam roof to safely support the code-required loads. Evidence that the snow load exceeded the BOCA values is provided by meteorological data, published literature, and anecdotal observations by employees of the facility.

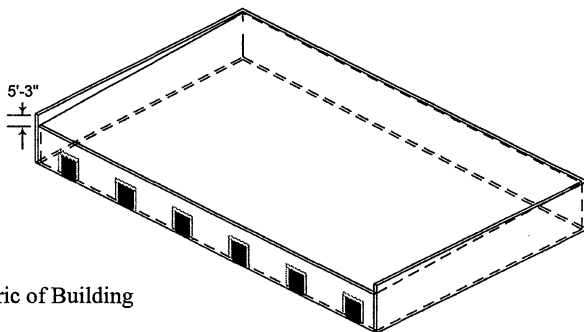
Figure 10: Isometric of Building

This building, which was used primarily for warehouse purposes, was located in Hamilton Township, New Jersey and was erected in early 1990. The building measured 110 by 180 feet. The eave height of this single slope building varied from 16' to 20'7", at a rate of 1/2" per foot. A masonry perimeter infill wall occurred on all sides, with a masonry parapet on three sides and a gutter on the low side. The parapet was about 8" high along the high side of the roof, and about 5'3" at the low side of the roof.

Frames were spaced at 29'-10" intervals. The frames had one line of intermediate columns, resulting in rafter spans of 55'.

Roof purlins, which were spaced at 5'-3", consisted of 8" Z-shapes with 3 1/2" flanges, made of 12 gage material in the end spans and 14 gage elsewhere. Purlin laps of nearly 5 feet were called for over the rafter frames. Purlins were attached to rafters via fin plates welded to the rafters. Roof decking was a 24 gage standing seam roof system fastened to the purlins using one-piece clips. Erection drawings called for a line of strap bracing at midspan of the purlins, for both top and bottom flanges.

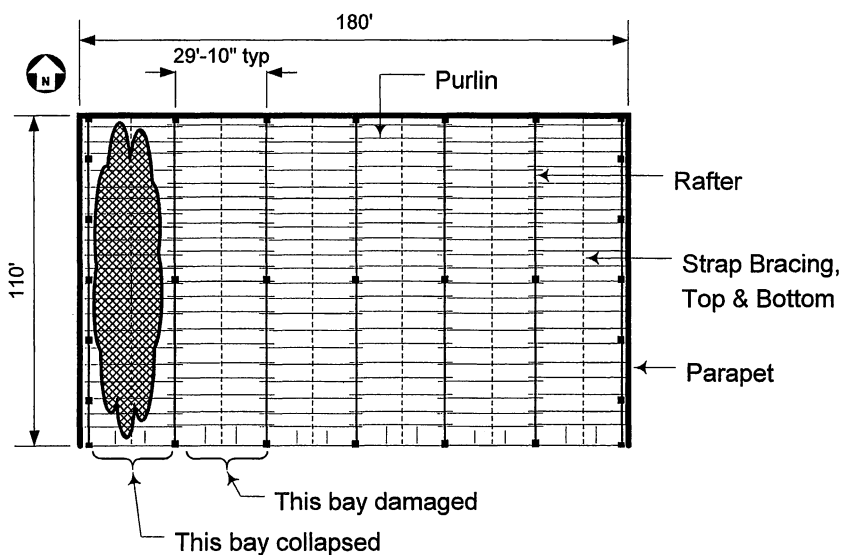
Figure 11: Roof Plan

A partial collapse of the roof occurred in the early morning hours of March 14, 1993 under snow conditions. LZA Technology was retained some years after the collapse by attorneys for the builder.

A representative from the engineer/manufacturer inspected the building several days after the collapse and concluded that the cause of the collapse was excessive build-up of ice and snow behind the parapets. No details of observed depths were provided.
