# Liquefaction and Ground Failure During the 1998 Adana (Turkey) Earthquake and Lab Model Simulations

## LIQUEFACTION AND GROUND FAILURES DURING THE 1998 ADANA (TURKEY) EARTHQUAKE AND LAB MODEL SIMULATIONS

Paper No. 4.47

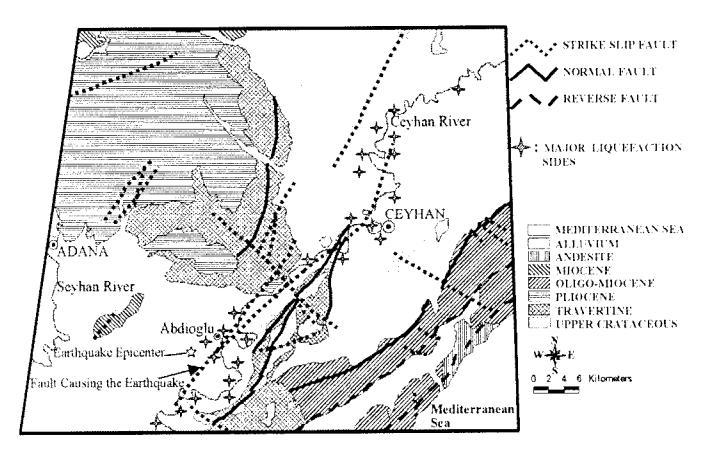
The earthquake epicenter was located on thick Quaternary alluvial soils covering most of the area where the earthquake was strongly felt (Fig. 1). In the areas along the Ceyhan River, where widespread liquefaction was observed, the ground was typically formed by young alluvial soils of mainly silty clay, overlying silty fine sands with occasional gravel. According to the Turkish Geological Survey, the thickness of the sediments in this area varies from 50 to 250 m with shear wave velocities typically ranging from 100 to 300 m/s.

Fig. 1 Main geological and tectonic elements of the earthquake region (modified after ERD 1998) along with the major liquefaction sites observed after 1998 Adana earthquake.

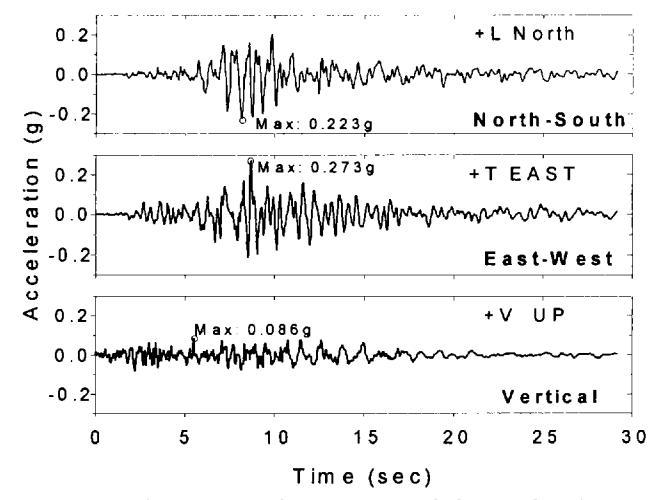
Based on regional seismogram data, Turkish Earthquake Research Department-ERD estimated the earthquake epicenter at the outskirts of Abdioglu Village (see Fig. 1) and the focal depth as 23 kms. The earthquake was measured 5.9 on the Richter Scale (ML) and had a Surface Wave Magnitude (Ms) of 6.3 (ERD 1998). From the observed damage, an intensity of VIII on the Modified Mercalli Intensity (MMI) scale can be assigned to the affected areas in the vicinity of the epicenter. No foreshocks were detected before the earthquake. However, hundreds of aftershocks were measured but none was strong enough to cause further damage or liquefaction. The ground motion-acceleration record (digital data provided by ERD) nearest to the epicenter obtained at Ceyhan Station (32-km away from the epicenter and about 10-km from the fault line) is shown in Fig. 2. This station was founded on a flat ground of young alluvial soils; 1-1.5 m clayey silt with high organic content, 5-6 m soft silty clays, underlain by silty loose sand layers. In general, similar soil conditions prevail at most areas where earthquake was effective. At this location, the duration of the strong ground motion was about 25 seconds with maximum accelerations of 0.223g in N-S, 0.273g in E-W, and 0.086g in the vertical directions. Some important ground motion parameters for the Ceyhan strong motion is given in Table 1.

Fig. 2 Acceleration time histories recorded at Ceyhan Station.

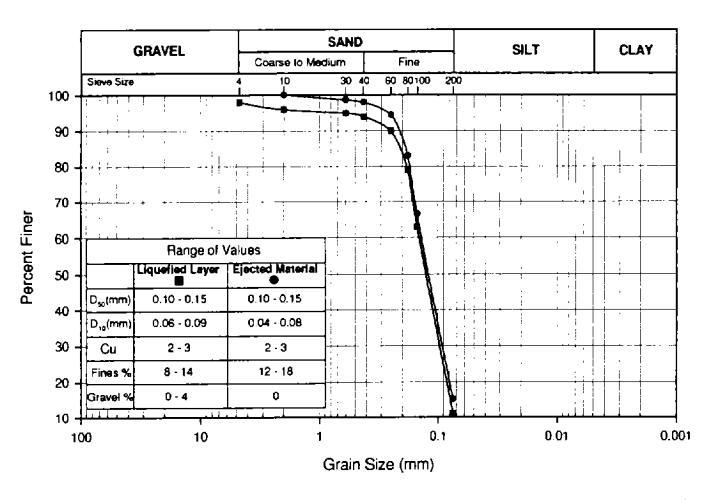
Most comprehensive field reconnaissance for surface and subsurface information was made in the areas around Abdioglu Village, where some of the most spectacular liquefaction effects were observed. Subsurface soil investigations included mainly trench studies and some laboratory testing. In determining soil information, maximum use of exposures such as riverbanks and fault/cuts caused by large lateral spread of thick blocks of soil was made. Such features provided a natural trench to study the nature and the thickness of soil strata in some cases as deep as 6 m. Torvane and proving ring penetrometer tests on the walls of the trenches were used (for preliminary strength classifications) to estimate shear strength of cohesive soil and density of the cohesionless soil layers respectively. Due to the rural nature of the zone affected by ground failures, pre-earthquake boring logs are very rare. One standard penetration test (SPT) profile was found dating back to about four years before the earthquake. The boring was done at a location less than a km away from Abdioglu about 100 m from the river. Based on this pre-earthquake SPT boring and the post-earthquake trench data Fig. 3 presents a typical soil profile near Abdioglu. The spatial variation of soil conditions around Abdioglu was practically insignificant. Furthermore, cursory field investigations revealed that the soil conditions at most of the sites liquefied during this earthquake bear close similarity to the ones around Abdioglu. Typical grain size distribution curves for the underlying loose sand layer and ejected sand boil material are shown in Fig. 4. As seen, the liquefied layer was composed of poorly graded fine sand with about 10% fines, a soil type that has been categorized as highly susceptible to liquefaction (Iwasaki 1986). The ejected material and the soil in the liquefied silty sand layer were almost identical with the exception that the ejected material had typically 3-5% more fines and did not contain any gravel. This was obviously expected as the upward flow of water in sand boil channels would usually erode and carry some material from the overlying clay layer to the surface. However, this channel flow is usually not strong enough to carry gravel size particles to the surface.

Fig. 4 Grain size distribution of liquefied layer and ejected material.

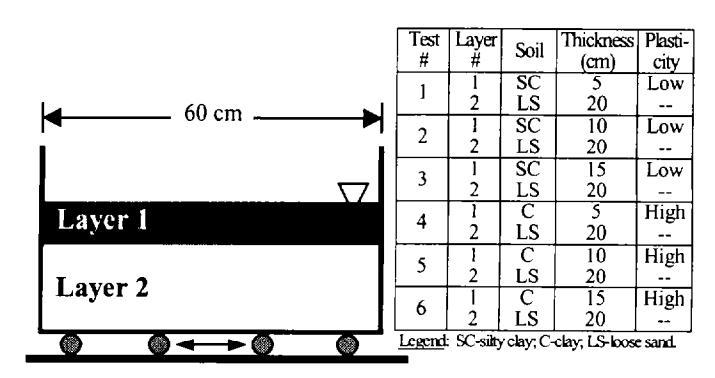
A series of qualitative small-scale 1-g tests were performed with the primary aim of exploring some of the basic post-liquefaction mechanisms involved in soil formations resembling to that of observed in the 1998 Adana-Ceyhan earthquake area (Fig. 3). A transparent rectangular box (a commercial fish tank of 60 cm x 30 cm x 45 cm) was employed. Dynamic excitation was imparted by rolling the box (supported on cylindrical steel tubes of 2.5 cm in diameter) on a roughened flat surface. Model preparation procedures explained previously by Adalier (1992) were employed generally. Based on previous experience (Adalier 1992), the imparted horizontal motion is estimated to be 0.5-0.7 Hz at 0.2-0.3g. Figure 8 shows the performed model tests conditions. Due to the limitation of space, only the main conclusions-observations from this on-going study will be presented herein, as follows:

Fig. 8 Setup of the performed model tests.
