A Field Study and Dynamic Finite Element Analysis of Railway Retaining Structures Damaged by the Hyogoken-Nambu Earthquake (1995)

A FIELD STUDY AND DYNAMIC FINITE ELEMENT ANALYSIS OF RAILWAY RETAINING STRUCTURES DAMAGED BY THE HYOGOKEN-NAMBU EARTHQUAKE (1995)

ABSTRACT

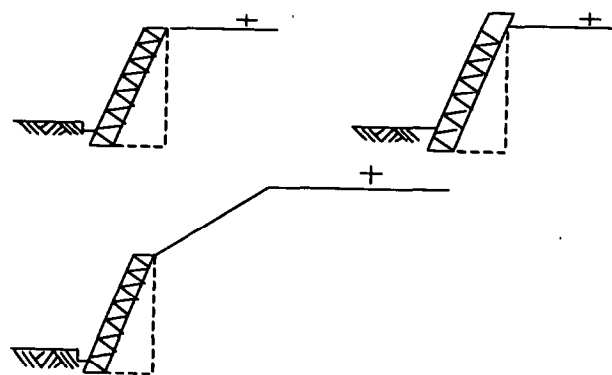
Fig.5. Three structures compared: stone masonry wall (above left), stone masonry wall with protruded crown (above right), and stone masonry wall with slope (below)

In a smaller limited section, all stone masonry retaining structures including non-damaged ones were analyzed, and the damage ratio was calculated. The retaining structures in this section were composed from stone masonry wall, stone masonry wall with protruded crown, and stone masonry wall with slope as shown in Fig.5. Figure 6 shows that the damage ratio of stone masonry wall with slope is twice greater than that without slope. The ratio of collapse in stone masonry wall with protruded crown is nearly twice greater than stone masonry wall. But even if tilted structures are included to the collapsed, the damage ratio with protruded crown does not change so much. From this figure, it is suggested that in the

applied aseismic design of retaining walls with slope, seismic active earth pressure can be estimated to be too small. Figure 7 shows the assumed slope for calculating seismic earth pressure in the applied seismic design. The shaded triangular soil mass over the assumed slope is considered to slide during earthquake, and neglected in the calculation of seismic earth pressure. This underestimation of seismic earth pressure may contribute to the large ratio of collapse. Moreover, some other factors such as slope protection works might accelerate the damage.

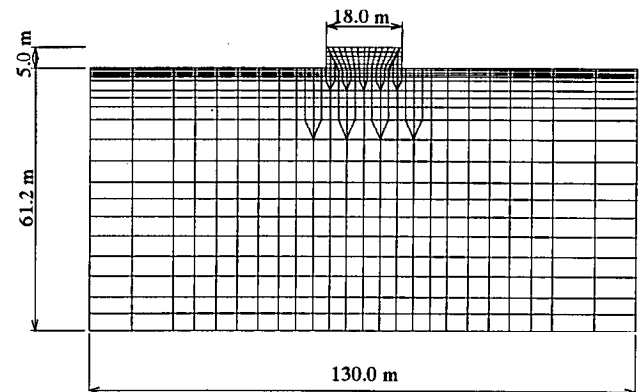
Fig. 10. Finite element model (gravity-type wall)

The two-dimensional finite element model has depth of 61.2 meters and extends 56 meters from the wall location to both boundaries as shown in Fig. 10. The lower boundary faces bedrock. Non-linearity of ground stiffness, de-lamination or sliding at the contact face between backfill and wall is considered in the calculation. Soil properties were obtained at the damaged site of the gravity-type wall. As the aim of the analyses is to find some difference in seismic response among these three retaining structures, the same soil properties are used for analyses. The shear wave velocity is 150 meters per second in the backfill, and 100-540 meters per second in bearing layer increasing from surface to bedrock. Backfill soil and the top five-meters layer of the ground follow the elastoplastic Mohr-Coulomb's criterion. The angle of internal friction for the cohesionless backfill and the top layer are 42.0 and 35.8 degrees respectively. The soils below this layer and concrete walls are modeled as linear materials. Geo-textile material is modeled as non-symmetrical bi-linear spring that resists tension force only.

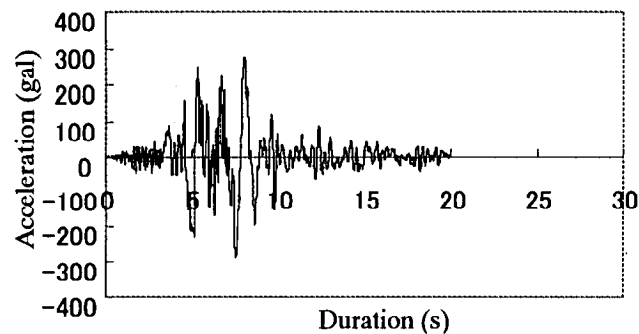
Fig.11. Waveform in acceleration

In order to obtain an input waveform, a pre-calculation was performed. The waveform of earthquake ground motion detected at the location of Kobe University on bedrock surface during the 1995 Hyogoken-Nambu earthquake was applied on the bottom viscous boundary with half space, and a quasi-linear analysis was conducted. The resulting waveform at the upper side of the boundary is used for the present finite element analysis. Figure 11 is the waveform thus obtained.

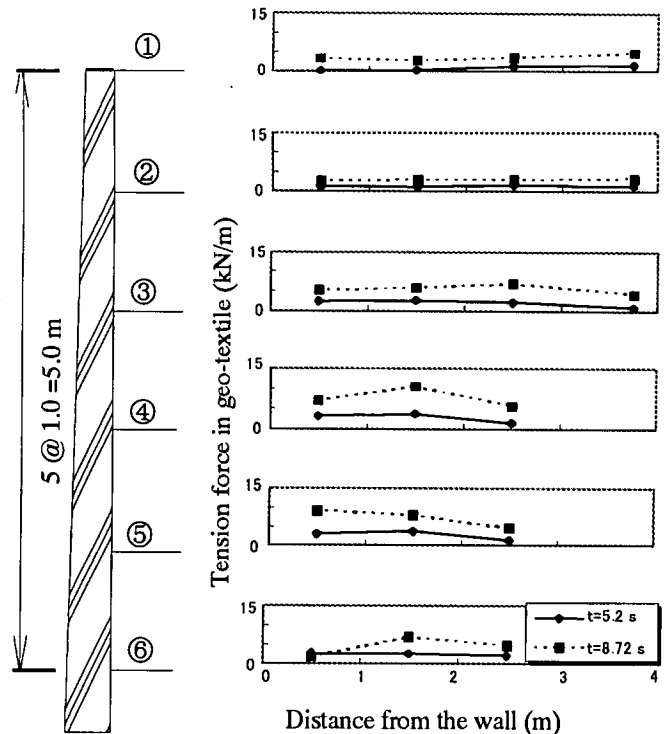
Fig.17. Distribution of tension force in the geo-textile

whether the wall is moving right or left. Therefore, the tension force is not directly caused by the horizontal movement of the wall, but by the settlement of backfill. This tension force suppresses sliding of the wall. Figure 17 shows the distribution of tension force when the whole structure is moving from the left to the right.
