## Sinkholes in Earth Dam Kota Barrage [India]

## SINKHOLES IN EARTH DAM KOTA BARRAGE [INDIA]

**Paper No. 3.16**

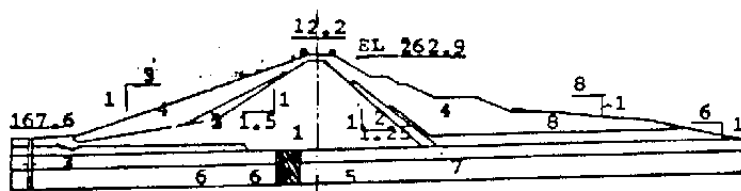
Fig. 1 General Layout Plan Kota Barrage.

embankment with impervious core in centre, semi-pervious transition and shells of rockfill on either side as shown in Fig.2. The dam is intervened by two old fort walls called Lower Fort Wall and Upper Fort Wall which have divided the embankment in three distinct reaches (Fig 1). The Lower Fort Wall with about 6.0m base width at EL 219.9m and 43m top width at EL 241.2m intercepts the dam obliquely at Ch 182.9m whereas the Upper Fort Wall with its top at EL 260.6m in upstream and 258.9m in downstream intervenes the dam nearly at right angles to the dam axis at Ch.243.8m. At the junction of these walls, the core was laid after dismantling the walls for a short strip to accommodate the core.

In the year 1990, five boreholes were drilled in the right abutment in the Garh Complex to know about the geological conditions of the region. The investigations revealed that the depth of the overburden in the region varied from 4m to 9m and the overburden materials comprised of low density silty soil mixed with pieces of stones bricks, etc. These drillings showed a very good to excellent core recovery (90% to 100%) of fresh, hard and massive sand stone, but bed rock was found highly fractured. Tracer studies carried out in these bore holes indicated that the seepage exit at EL. 254.2m, was hydraulically connected to the reservoir (Fig. 1).
