Geotechnical Aspect of Damage In Adapazari City During the 1999 Kocaeli, Turkey, Earthquake

GEOTECHNICAL ASPECT OF DAMAGE IN ADAPAZARI CITY DURING THE 1999 KOCAELI, TURKEY, EARTHQUAKE

This report summarizes detailed investigation on the structural damage and its geotechnical condition in the Adapazarı City, Turkey, during the 1999 Kocaeli earthquake by the reconnaissance team of the Japanese Geotechnical Society. Damages to individual buildings were investigated along several streets in the downtown area. A little rough investigation was made almost all downtown area, in which damages were classified by its cause, i.e., inertia force or soil liquefaction. These investigations as well as hearing investigation and areal investigation by means of helicopters made clear the area where there was an island a few hundred years ago by which the name of Adapazarı, i.e., ada (island) + pazary (market), came from. In addition, the damage in the Adapazarı City is shown to be strongly affected by the ground condition because damage caused by liquefaction was observed only outside the old island and areas where significant structural damage was observed were concentrated near the boundary betw

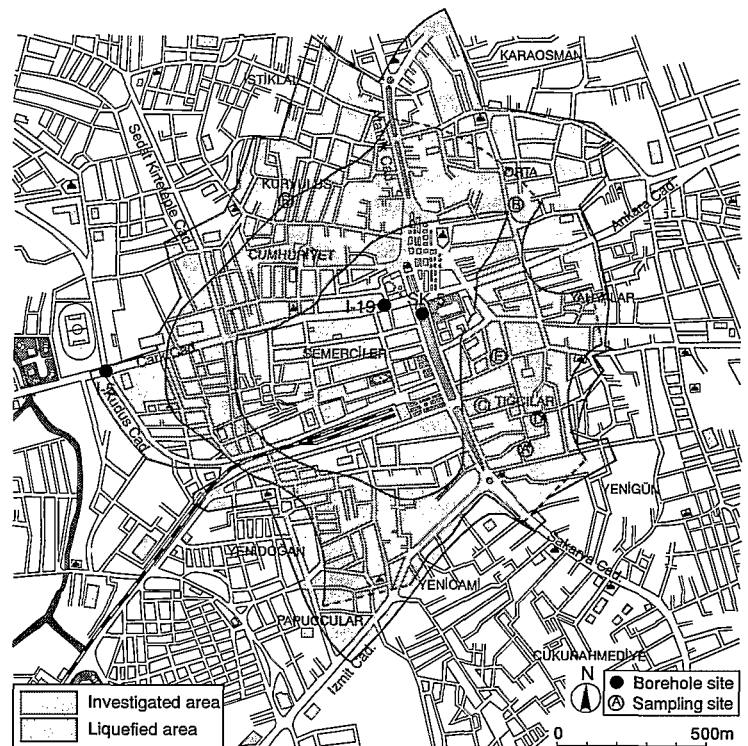
Figure 4 shows the map in the downtown of the Adapazarı City, in which various informations obtained by the reconnaissance are overdrawn. The dark gray shading indicates the liquefied area, which will be discussed later. Several borehole data are obtained out of this area, some of which is shown in Fig. 5. The I-5 point is located west of the map along the Çark Cadesi in

Fig. 4. Map of Downtown Adapazarı: Investigated area, site of borehole investigation, sand sampling, and liquefied area are shown

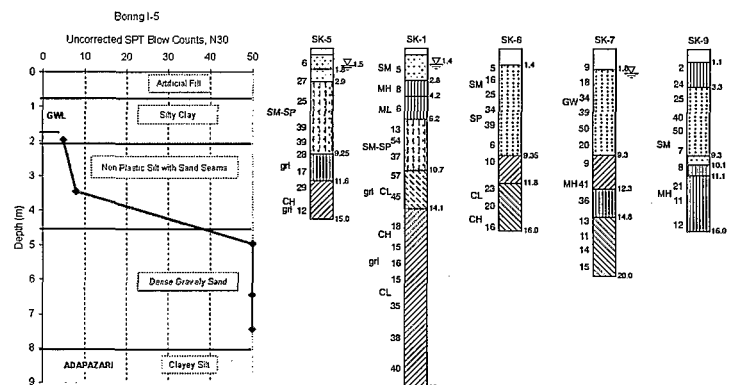
Fig. 5. Drilling log

Fig. 4 (Erken, 1999). Water table is about 1.8 m below the ground surface. There exist fill with 1 m thickness and silty clay layer with 1 m thickness. Non-plastic silt with 2 m thick that includes lens shaped sand exists beneath them. Then there exists dense gravely sand with more than 50 SPT-*N* value. The right hand drilling logs in Fig. 5 are obtained close to the station (the name SK-5 is used to indicate the location in Fig. 4) (Onalp, 1999). Although they are located close by, the data fairly scatters. The surface layers are made of silt and sand, but SPT-*N* values are considerably large, which may be the reason why liquefaction did not occur at this site.

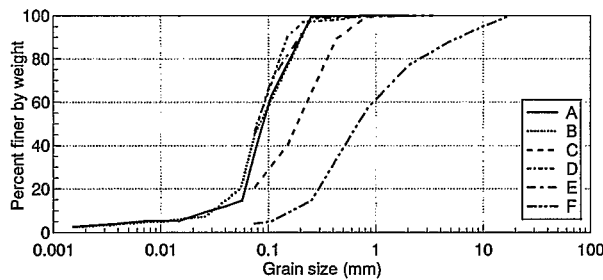
Since data in the liquefied area was not obtained, sand samples were taken at the liquefied area. Fig. 6 shows grain size distribution of the samples. Sites where samples were taken are shown in Fig. 4 as notation A to F with circle. Among these samples, A to E are samples taken from sand boils, therefore

Fig. 6. Percent finer by weight

liquefied material. The sample at point F is excavated sand at the water supply construction site, therefore may not be related to liquefaction. Grain size distributions are nearly identical in the liquefied site except B. The average grain size D_{50} is fairly small to be a little less than 0.1mm; the sand is classified to be fine sand close to silt. The grain sizes are concentrated around D_{50} , therefore it is easy to liquefy. The D_{50} at B is about 0.2 mm which is about two times larger than the other sand, but it is also easily liquefiable sand.

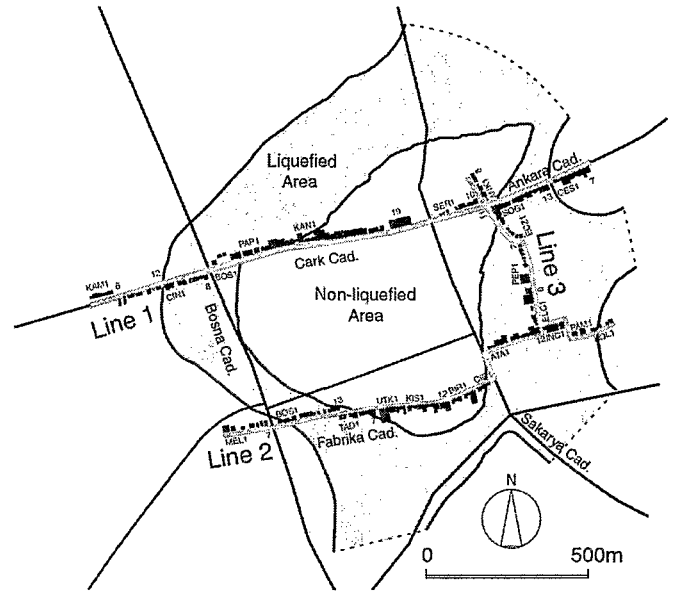
Fig. 11. Map showing lines for detailed investigation such as Cark, Fabrika and Izmit Cadesi. These areas can also be said to be located adjacent to the liquefied area. Irregular ground configuration between liquefied and non-liquefied sites may be the reason of the localization of severe inertia type damage.

Investigation of all buildings was conducted along three lines shown in Fig. 11. Structural dimensions such as size of plan and number of stories, settlement, tilt and damage level were measured and evaluated. 192 building were investigated in total. Elevations of investigated buildings are schematically drawn in Fig. 11. Since one side of the road was generally investigated, the buildings are drawn on the side where original building exists.

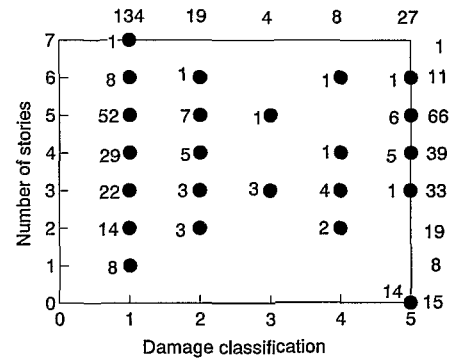
Figure 17 shows the relationship between the damage level and number of stories. Numbers beside each solid circle is a sum total of data that belongs to each dot, and numbers on the top and in the right of the figure are sum total of each classification. Here, number of stories of zero indicates that it is not known because it completely collapsed. In total, 14 buildings are included in this classification. It is, however, sure that number of stories of these building is not small such as 1 or 2; they are probably 4 or more. Two features can easily be obtained from this figure. The first one is that number of buildings with middle damage level is smaller than that with small and large damage levels. It is natural that it is smaller than that with small damage, but not natural that it is smaller than that with large damage. This probably comes from the brittle structural members of the building. The building directly goes to complete failure in brittle structures when earthquake load exceeds the structural load carrying capacity. The second feature is that severely damaged structure is concentrated in 3 to 5 storied buildings.

Fig. 17. Relation between number of stories and damage classification

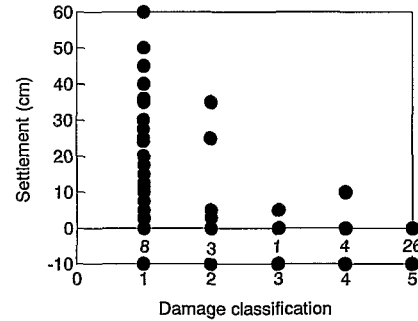
Figure 18 shows the relationships between damage level and settlement of the buildings. Here, settlement of -10 cm indicates the buildings whose actual settlement was not observed partly because the structure is completely collapsed and partly because evaluation was difficult. Number of this classification is written in the figure. There is clear tendency of the settlement. Large amount of settlement can occur only when damage level is small. In other words, buildings that settled did not suffer severe structural damage. It is noted that some damage in damage level 2 to 4 was caused even by soil liquefaction. Tilt of buildings sometimes stops by hitting the neighboring building, in which case structural members in both building sometimes damaged. Moreover, tilt of building itself sometimes becomes the cause of the structural damage. Considering these situations, it can be concluded that building damaged by soil liquefaction did not suffer large inertia force. The separation between liquefied and non-liquefied area shown in Figs. 4 and 11 is justified by this figure.

Fig. 18. Relation between settlement and damage classification.

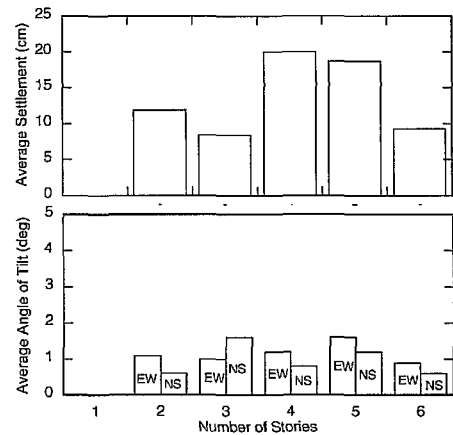
Figure 19 shows the relationships between average tilt and average settlement versus number of stories in the liquefied area. Average settlement is about 10 cm for 2 and 3 storied buildings. It increases to 20 cm for 4 and 5 storied buildings. These values are fairly smaller than past experience such as Niigata City during the 1964 Niigata earthquake, Japan, and Dagupan City during the 1990 Luzon Earthquake, Philippines.

Fig. 19. Effects of number of stories on settlement and tilt of buildings in liquefied area

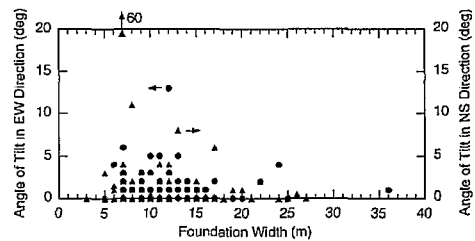
Figure 20 shows the relationship between foundation width and angle of tilt. Although data scatters, the tendency that tilt becomes larger as foundation width becomes smaller is clearly observed.

Fig. 20. Relation between angle of tilt and foundation width of buildings in liquefied area
