Change of Waterline and Water Depth at Izmit Bay Due to 1999 Kocaeli Earthquake in Turkey

CHANGE OF WATERLINE AND WATER DEPTH AT IZMIT BAY DUE TO 1999 KOCAELI EARTHQUAKE IN TURKEY

ABSTRACT

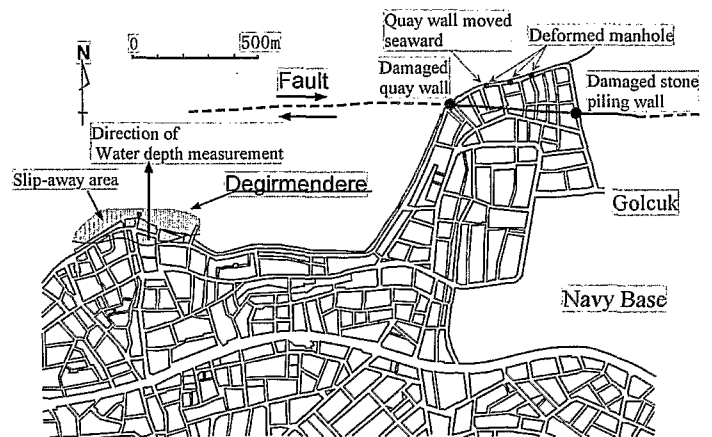
Fig. 2. Location of the damaged and slip away area in Degirmendere

Locations of fault line and land submergence in the city of Degirmendere that is located west of Gölcük City are shown in Figure 2. The fault was observed on ground in the east of downtown Gölcük, whose traveling direction is also roughly shown in Figure 2. Two typical damages to waterfront area were observed. The stone-piling wall was just located on and was damaged with a horizontal relative displacement in 1.5m of west-east direction and 4.3m of north-south direction. Quay wall along the coast was moved seaward, and damaged due to ground gaps by the fault.
