## Damage to Water Supply System and Surface Rupture Due to Fault Movement during the 1999 Ji-Ji Earthquake in Taiwan

# DAMAGE TO WATER SUPPLY SYSTEM AND SURFACE RUPTURE DUE TO FAULT MOVEMENT DURING THE 1999 JI-JI EARTHQUAKE IN TAIWAN

## ABSTRACT

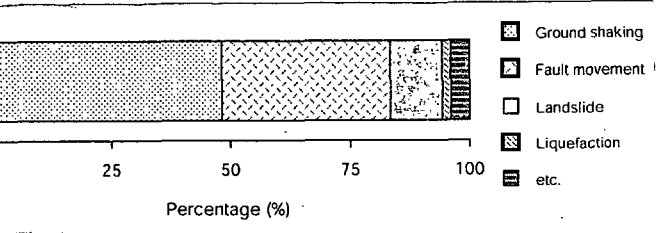
*Fig. 6* Number of cases of damage in relation to causes of failure
