China Earthquake Reconnaissance Report: Performance of Transportation Structures during the May 12, 2008, M7.9 Wenchuan Earthquake

PUBLICATION NO. FHWA-HRT-11-029

OCTOBER 2011

U.S. Department of Transportation
Federal Highway Administration

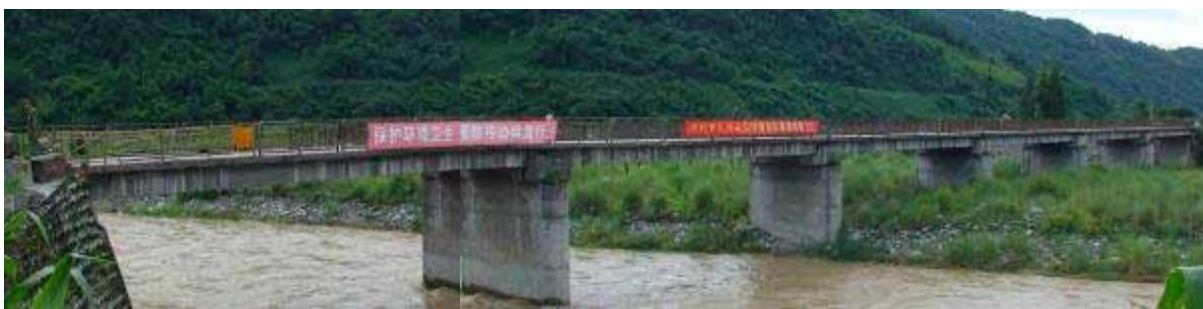
Figure 9. Photo. Overview of Zhima Bridge.

Zhima Bridge is a six-span, T-girder river crossing structure on pier walls, with a span arrangement of 19.7 to 56.7 ft (6 to 17.3 m), shown in figure 9. It is mainly used by pedestrians and motorcycles. The approach on the highway side settled about 1.64 ft (0.5 m). No shear key or other structural damage was observed. Some guardrails may have been displaced prior to the earthquake. Military personnel were welding steel railings, as shown in figure 10, when the reconnaissance team arrived at the bridge site.

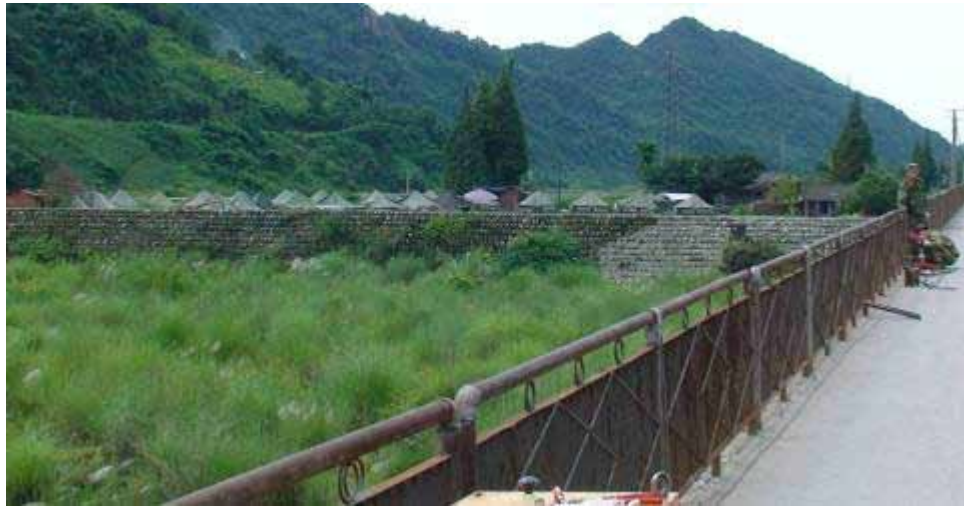
Figure 12. Photo. Tent Area Near the Bridge.

As shown in figure 11, many buildings around the bridge suffered significant damage. There is a village on the other side of the bridge. Near the village were many tents that were most likely provided as shelters for people, as shown in figure 12.

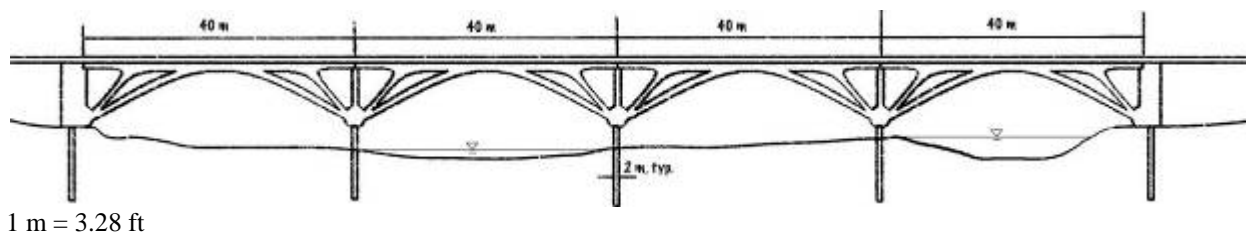
Figure 15. Illustration. Schematic Elevation View of Xiaoyudong Bridge.

Xiaoyudong (little fish hole) Bridge is a four-span RC arch structure with long approaches supported on two abutments and three intermediate bents, as shown in figure 15 and figure 16. Each bent consists of one cap beam and two rectangular columns and is supported on two drilled shaft foundations of 6.56 ft (2 m) in diameter. Built in 1999, the bridge is oriented east-west. Each span is 131.2 ft (40 m) long and is an arch strengthened with two struts. The arch and strut are both supported on the pile cap of drilled shafts. The bridge deck is integrally cast with the top of the strut and arch but is seated at the bent caps and abutments. Expansion joints exist at each abutment and bent.

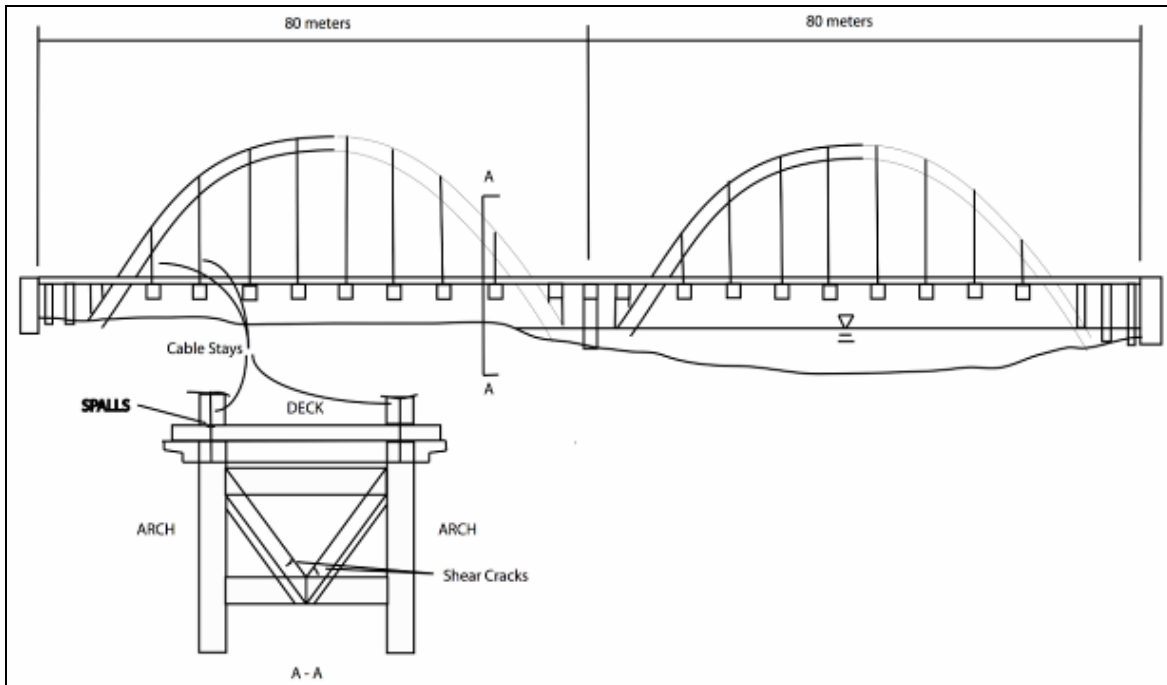
Figure 24. Illustration. Schematic of Anzhou Bridge

Anzhou Bridge, built in 1996, is a two-arch structure along Highway S105. Each arch is 262.4 ft (80 m) long, as shown in figure 24. A slab superstructure is hung from the two RC vertical arches using a number of cable suspenders, as shown in figure 25. Surprisingly, there is no cross bracing between the arches above the deck, which may explain why the cross bracing below the deck had cracks, as shown in figure 26. The cross bracing members are designed to restrain the arches from transverse movement. The concrete deck spalled around the cable suspenders, around the arches, and at the expansion joints, as shown in figure 27. The spalls and cracks suggest that the slab superstructure was shaken transversely and longitudinally during the earthquake.

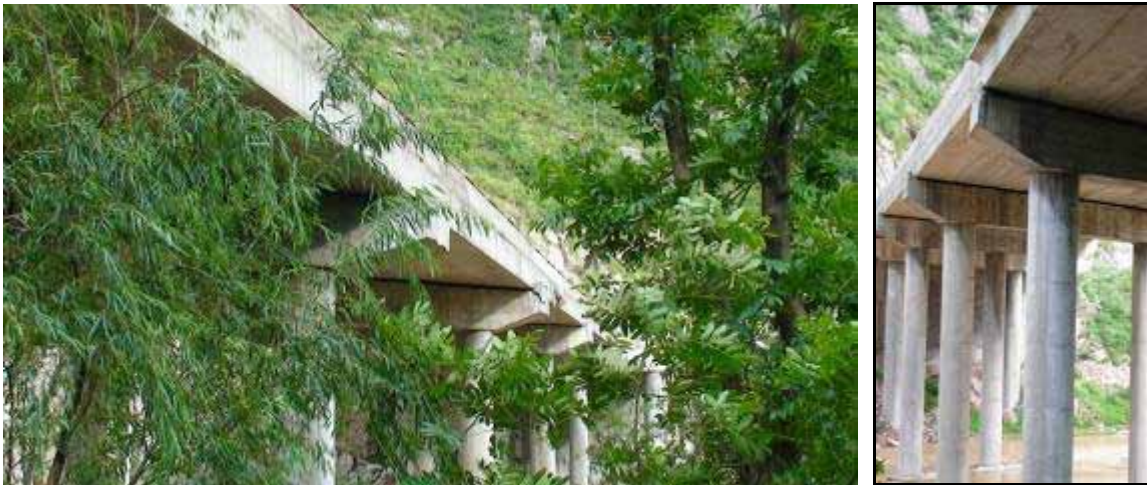
Figure 30. Photo. Overview of Baimayan Bridge.

Baimayan Bridge is a six-span skewed slab bridge with a 68.88-ft (21-m) span length and carries north-south traffic along Highway S105. It was constructed in 2003. As shown in figure 30, the bridge is supported on three-column bents. During the earthquake, the bridge suffered minor damage. Concrete spalling was observed at the embankments, and shear keys were damaged, as shown in figure 31. Both indicated that the bridge was shaken during the earthquake. The expansion joints were offset by approximately 2.73 inches (70 mm) in the traffic direction and 1.56 inches (40 mm) in the transverse direction (see figure 32). The level of shaking at the bridge site is notable. In a nearby town, buildings were severely damaged, as shown in figure 33.

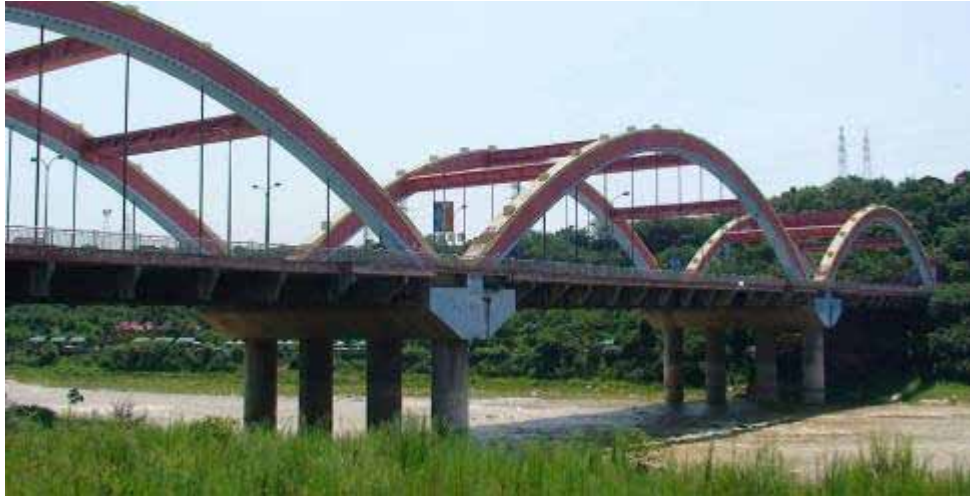
Figure 34. Photo. Overview of Baiyun Bridge.

Baiyun Bridge was built in 2001 and spans the Anchuang River in the northwest-southeast direction. It is a three-span simply supported tied-arch structure, as shown in figure 34. As illustrated in figure 35, the three spans of the bridge are 223, 262.4, and 223 ft (68, 80, and 68 m). The height-to-span ratio is approximately 1:5. The arches are supported on four-column bents and seat-type abutments. To protect ties from corrosion, the tendon duct of each tie was filled with oil. Both the tie and the oil duct were embedded in the RC bridge deck. After the earthquake, oil in the tendon ducts began to leak, as shown in figure 36, suggesting that the ducts developed cracks during the earthquake or that the anchorages were damaged. In addition, concrete spalling and cracking were observed on the bridge deck around the arches and cables, as shown in figure 37.

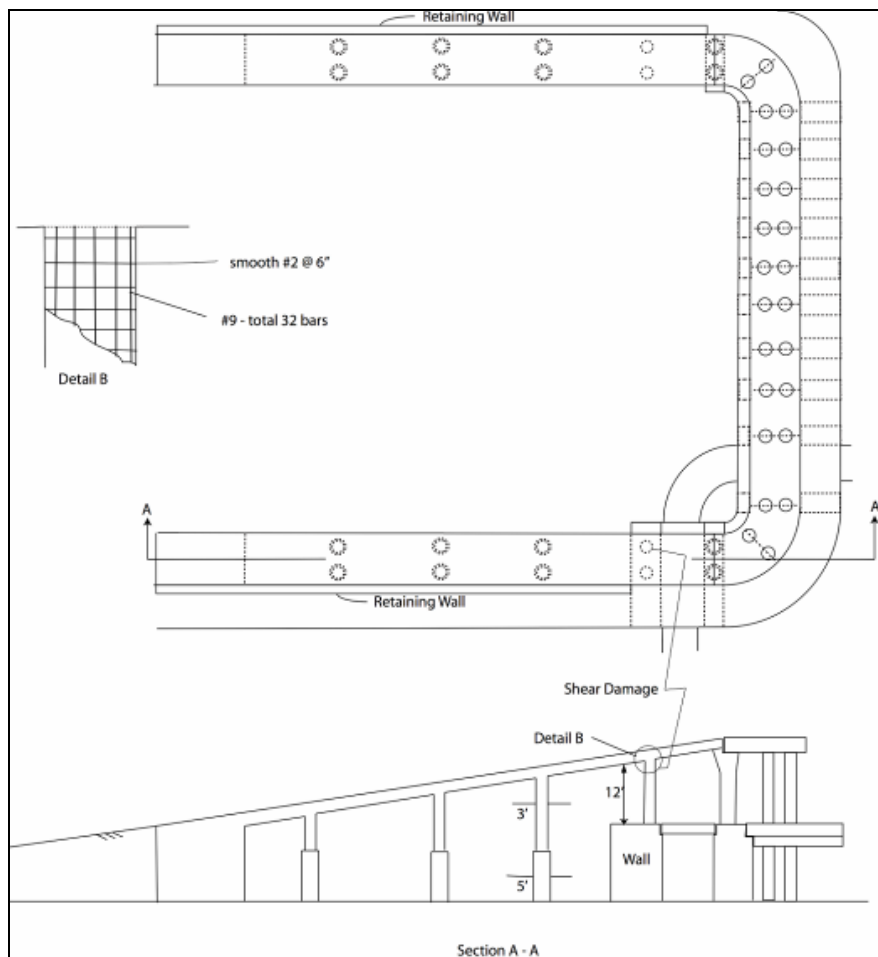
Figure 40. Illustration. Schematic of the Mianyang Airport Viaduct.

Mianyang Airport Viaduct is a U-shaped structure illustrated in figure 40. Built in 2001, the middle of the structure is a double deck system serving airport passengers. Two approaches (northwest and southeast) are connected to the upper level of the airport. They are supported on two-column bents, as shown in figure 41.

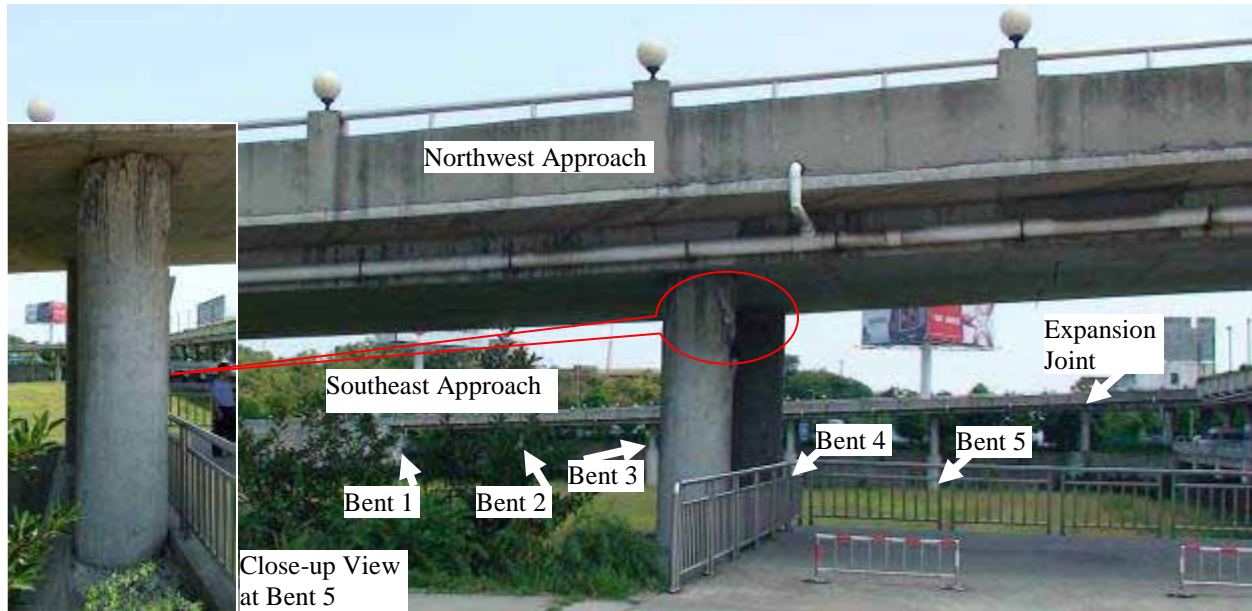
Figure 41. Photo. Overview of the Viaduct Structure.

The southeast approach consists of a five-span structure supported on columns of varying heights. The five-span structure is continuous, with expansion joints at both ends. The diameter of the upper portion of the columns (approximately 3.28 ft (1.0 m)) is smaller than that of the lower portion (approximately 4.92 ft (1.5 m)). The columns have a smooth #5 (metric) spiral spaced at 5.85 inches (150 mm) and 32 #29 (metric) bars for longitudinal reinforcement. The northwest approach also has five spans. The spans are similar to those on the southeast approach except that the lower portions of the tallest circular columns at bent 5 are connected by a concrete wall, as shown in figure 41. The concrete wall makes bent 5 much stiffer than its adjacent bents.

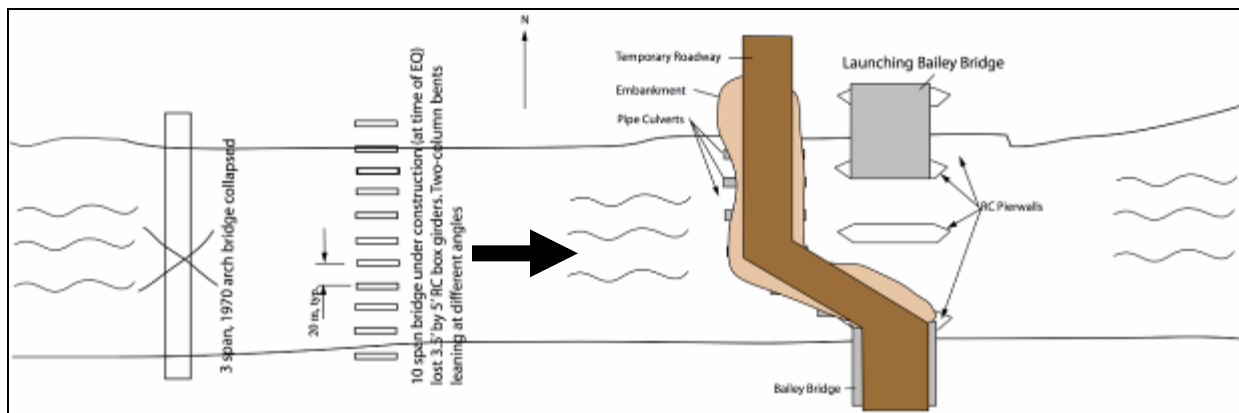
Figure 45. Illustration. Three Bridges at Nanba Town.

Three bridges cross a river near Nanba Town, as shown in figure 45. The west structure was a concrete and masonry three-span arch bridge built in the 1970s. The old arch bridge completely collapsed during the earthquake, as shown in figure 46. Immediately downstream of the arch bridge was a 10-span river crossing (on a 10-degree skew) that was under construction during the earthquake, as shown in figure 47. Each 19.68-ft (6-m)-long span was simply supported on two-column bents and seat-type abutments with 21.84-inch (560-mm) seats. As shown in figure 48, each span consisted of eight precast box girders with a cross section of 41.61 inches (1,067 mm) by 59.28 inches (1,520 mm). Each girder was supported on two 7.8-inch (200-mm) round elastomeric bearings at each end. The girders were in place, but the concrete deck had not yet been poured at the time of the earthquake, as seen in figure 48.

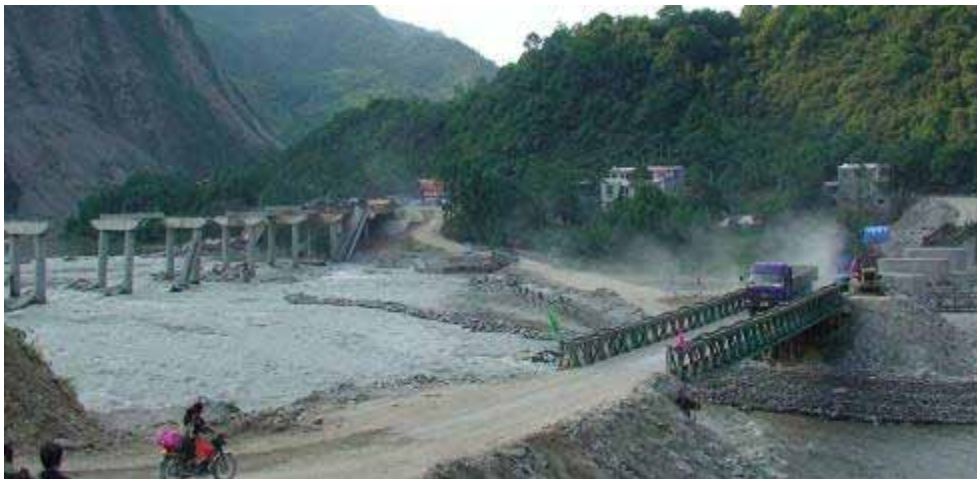
Figure 49. Photo. Overview of Temporary Bridge Construction.

On the east side of the old and new bridges was a temporary structure that was being constructed by launching Bailey bridges onto new RC pier walls. As shown in figure 49, vehicles were crossing the river on fill material laid over culverts during construction. Figure 50 shows the completed Bailey bridge.

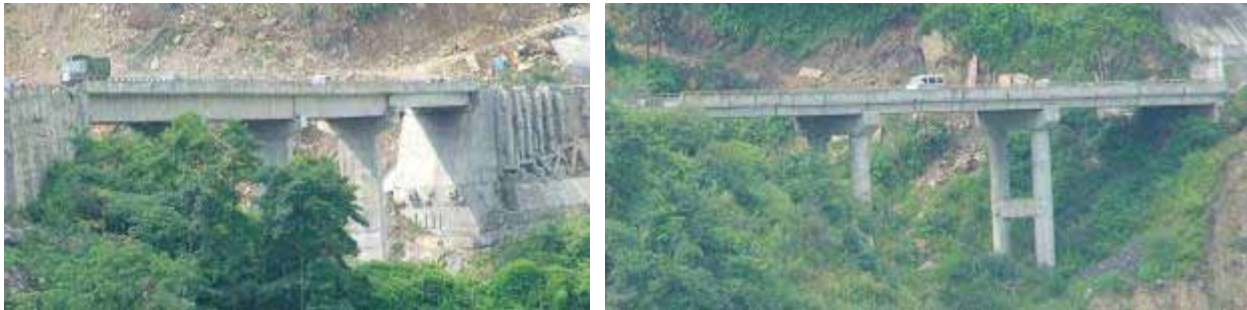
Figure 60. Photo. Bridges in the Vicinity of Miaozhiping Bridge.

There are several RC girder bridges in the vicinity of Miaozhiping Bridge, as shown in figure 60. These bridges appeared to suffer little damage. No weight limits were posted on these bridges.

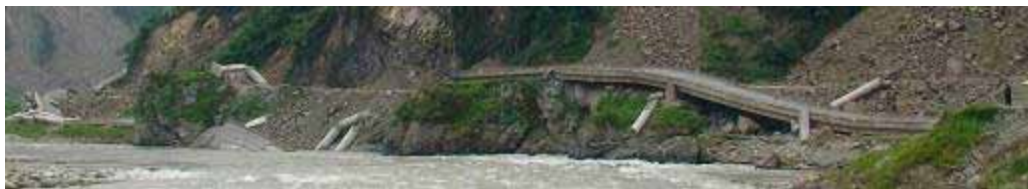
Figure 71. Photo. After Demolition of Baihua Bridge.

The curved part of the bridge was probably subjected to higher deformation and stress during the earthquake, resulting in collapse. Due to the tall columns, the earthquake caused tilting that pushed the superstructure almost off its support at several locations in the straight part of the bridge. A detour was graded along the side of the damaged bridge. Considering the high risk of further collapse during an aftershock, the bridge was demolished with dynamite, as shown in figure 70 and figure 71.

Similar to Xiaoyudong Bridge, this bridge could have been damaged by surface faulting, though the reconnaissance team did not find a clear surface fault feature near the bridge site. Considering the complex vibration system of the irregular structure with varying column heights and a lack of continuity between the substructure and superstructure, severe shaking alone could have resulted
