Damage of a Broadcasting Station Due to Shrinkage of Soil

SYNOPSIS This paper discusses the causes of damage of a broadcasting transmission station suffered from settlement cracks. The station buildings were low-rise reinforced concrete structures with isolated footings founded on alluvial deposit. Investigations revealed that the main causes of the observed nonuniform settlement were the existence of silt pockets below some footings, and the shrinkage of clayey soils due to dryness of the subsoil after ceasing the cultivation of land and using it as construction site. Rehabilitation scheme included structural repair of the cracked columns, beams and walls, and injection grouting of the foundation soil beneath the settled columns.

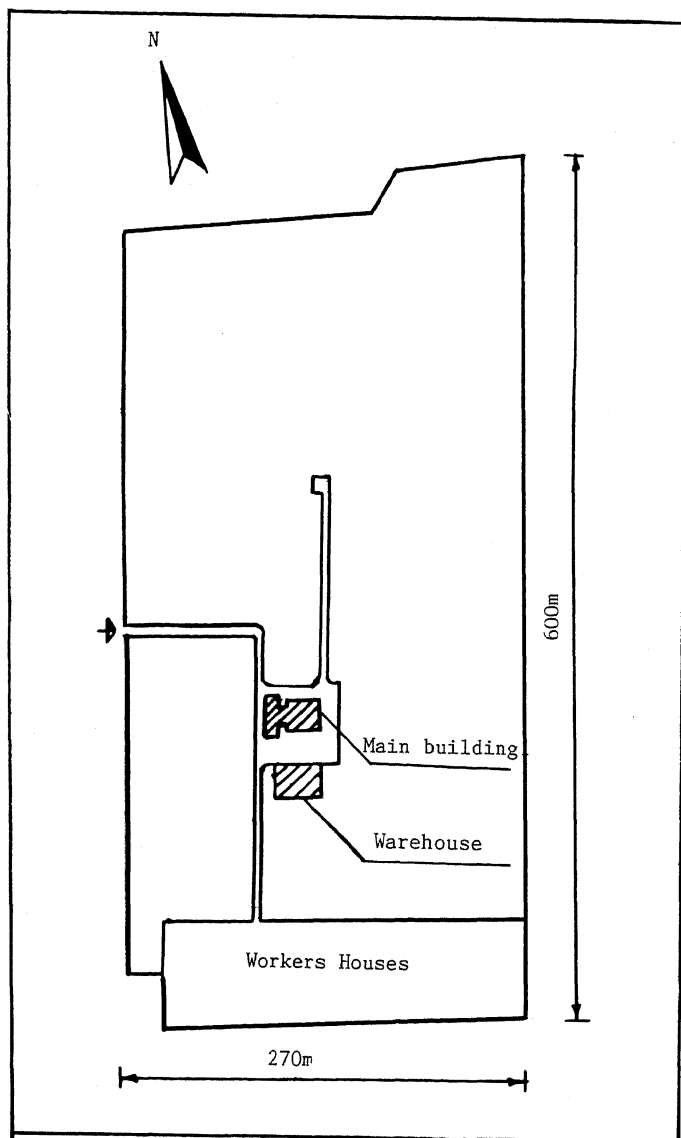
Fig. 1. General Layout of the Site

The authors were assigned to investigate the buildings of a broadcasting transmission station suffered from settlement damage. The station was located in a small town at the middle of the Nile delta, about 100 km north of Cairo. It consisted of two low-rise buildings founded on spread footings. The main building was two-storey, reinforced concrete skeleton type structure with brick walls. Its length was 40 m and its breadth was 20 m in two thirds of the building and 30 m in the rest of it. The second building was a warehouse with dimensions of 33 m x 21 m. The foundation level was at 1.50 m below the ground surface the station buildings were constructed at the center of a large site, 600 m by 270 m, surrounded by cultivated land. This site was also a green field before the construction of the station. However, it has not been cultivated since the erection of the buildings. A navigation canal existed at about 100 m west of the site. A longitudinal depression, 20 m to 50 m wide and 3 m deep, was crossing the site and passing east of the buildings. It was used in the past as a drain. A general layout of the site is shown in Fig. 1.

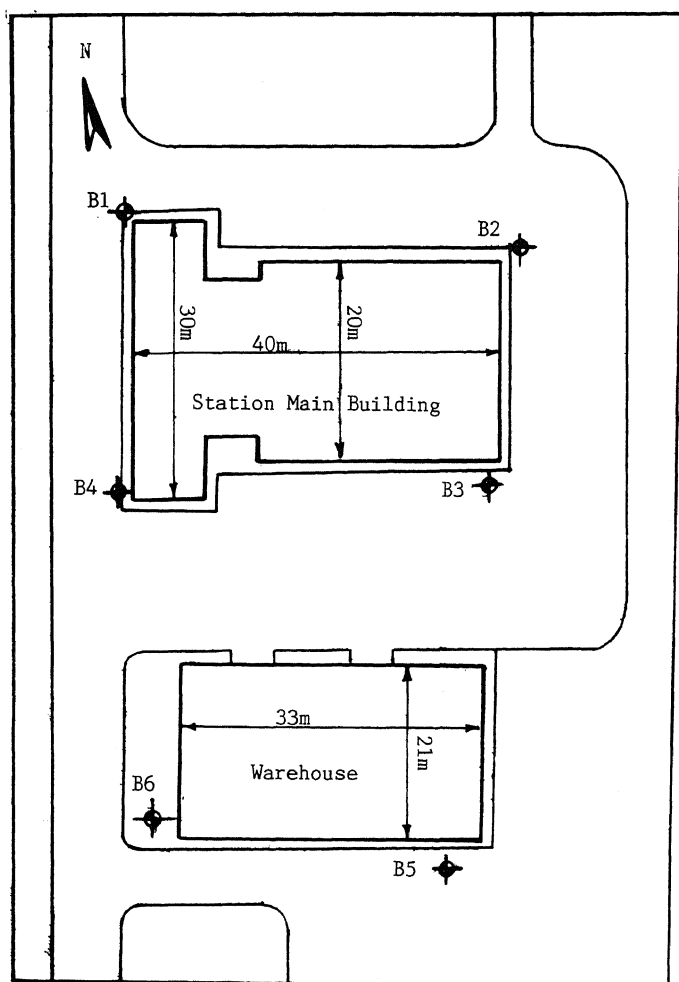
Fig. 6. Location of Borings

Investigation were conducted to study the subsurface conditions. Seven borings with depth of 20 m were executed. Six of them were adjacent to the buildings as shown in Figure 6 and the seventh was located on the boundary of the site close to the main gate to reflect the normal conditions in the area outside the construction site. The ground water table appeared firstly at - 11.30 m, then rose up to about - 3.70 m in all borings, except in the far boring where it was encountered at - 3.50 m and stabilized at -3.00 m.

of blows per 30 cm recorded in the Standard Penetration test ranged from 10 to 27 in the clayey layers, and was between 10 and 75 in the sand strata. A layer of silt, about 1.0 m thick, appeared right below the foundation level in borings 1,2, and 3.
