Failure of Buildings Founded on Fills

Failure of Buildings Founded On Fills

CASE-1: FAILURE OF A DOUBLE STOREY BLOCK OF FLATS

CASE II: FAILURE OF SEVERAL FOUR STOREY BLOCKS OF HOUSES

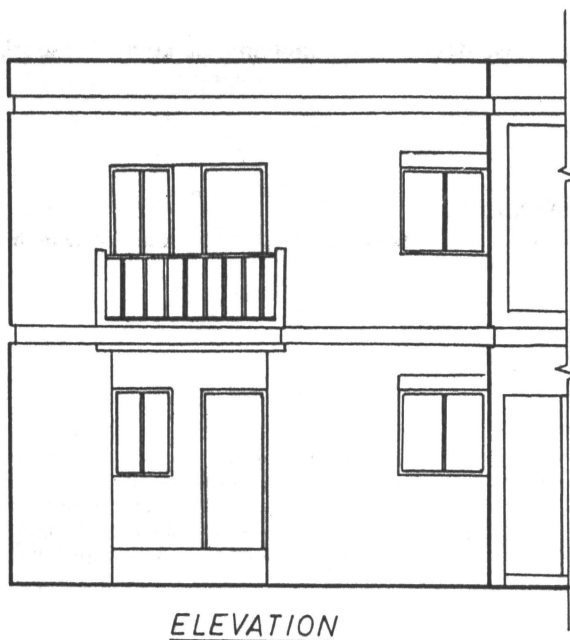
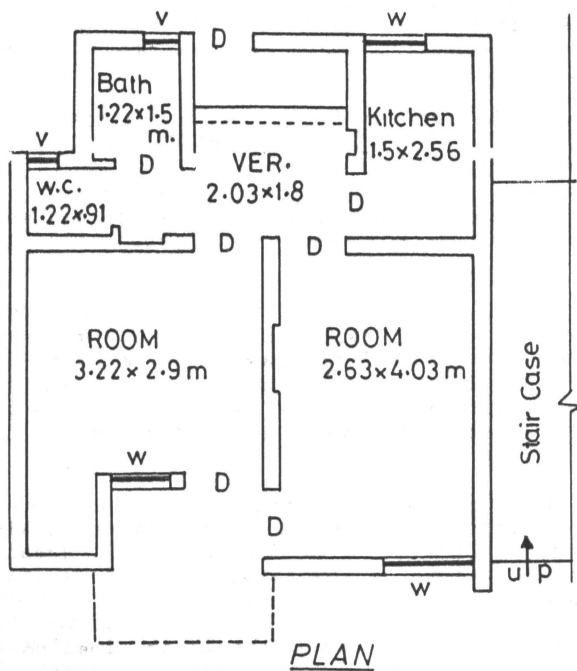
Fig.1. Case I: Plan & Elevation of the Building.

About seven hundred houses were constructed for people of low income group in an area south-east of Delhi. These are generally two storey blocks with two flats on each floor. (Fig.1) Two years

after their construction several blocks suffered cracks especially in the load bearing walls. In one particular block, cracking progressed rapidly and cracks as wide as 8.0 mm, appeared on the external as well as internal partition walls. Extensive damage has since occurred. (Fig.2).

Foundations of the failed blocks are located at 1.5 m depth whereas soil is loose and very weak upto a depth of at least 7.0 m at this location. Comparison with the original contour map of this location revealed that some of the blocks are standing on a filling. Uneven features with many depressions and a deep ravine existed at this site before the filling and levelling operations were carried out.

Several remedial measures were considered eg soil stabilisation, jacking up the walls, or providing piles. (C.B.R.I: 1980 Bureau of Indian Standards, 1985; Chand, 1979) But in each case the estimate of cost of providing the remedy was prohibitive. There is, therefore, no alternative but to demolish such blocks.
