Foundation Strengthening and Protective Measures for Sri Sangameshwar Temple at Kudal Sangam, Karnataka

Devendra Sharma
Central Building Research Institute, Roorkee, India

SYNOPSIS : Sri Sangameshwara temple situated at the confluence of two rivers developed noticeable tilt. Also the temple site be inundated by the back waters of the dam during floods. An elaborate plan of dismantling the temple and reconstructing it by the same stone pieces and statuary could be carried through partially only and the sanctum sanctorum portion housing the 'Lingam' had to be retained. Now the entire temple is to be reconstructed as and where it was. The temple was founded on a boulder platform with heterogeneous river deposits below it. Honouring the constraints of uninterrupted daily worship rituals in the temple and the underside of the pedestal supporting 'Lingam' not to be disturbed, strengthening by providing a double row of piles around the existing structure and a protective wall around the site were recommended. The choice and design aspects of these measures are discussed.

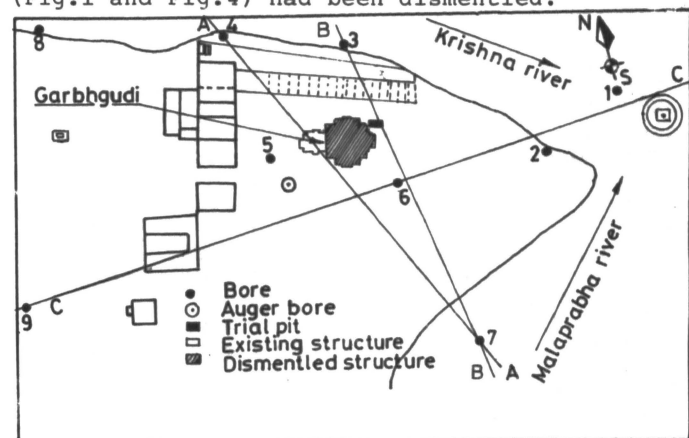
FIG.1 Sri Sangameshwara temple - key plan

endanger the temple site, has an area of 6400 sq.km. The area around the confluence is generally 'black cotton soil', expansive clays, covered country. The basement rock as revealed by mine boreholes at the site (Fig.1) was granite and its variants. The ground levels varied from 482m to 492m and hard rock encountered from 470m to 480m and an overburden of 1.5m to 21.0m thick (Report, 1987). the present floor level at the temple is around 493m. The likely depth of the basement rock indicated by sections AA, BB and CC through the boreholes (Fig.1) is at an elevation from 475m to 470m. These boreholes showed no general sequence of deposit layers which varied from soil to boulders and mixed heterogeneous

materials. The temple seems to be located over a depression in the basement rock and the borehole B6 (Fig.1) showed the lowest bedrock level at 470.31. Both the site and the bedrock below had an overall general slope towards the north and northeast. The closer proximity of the river on the north side and general ground to north are important to note. The same slope would have existed prior to the temple construction. According to the classical Hindu temple architecture slope of the site is an important consideration for the choice of the site (Sharma, 1988) and a site sloping towards, north, north east or east is considered auspicious (Mansar, 1951; Namboodriped, 1987, Kulkarni, 1985). Specially northward slope is more important for Shaivite temples. Several Indian classics on architecture support this practice.

The borehole made by augering and a pit dug at the site (Fig.1) showed strata as given in Fig.5. There is a trend of increasing finer fractions, higher liquid limits and swelling with depth. The lower strata soils in borehole and the soil in the interspaces of the boulders below the temple are of compressibility increasing with depth.

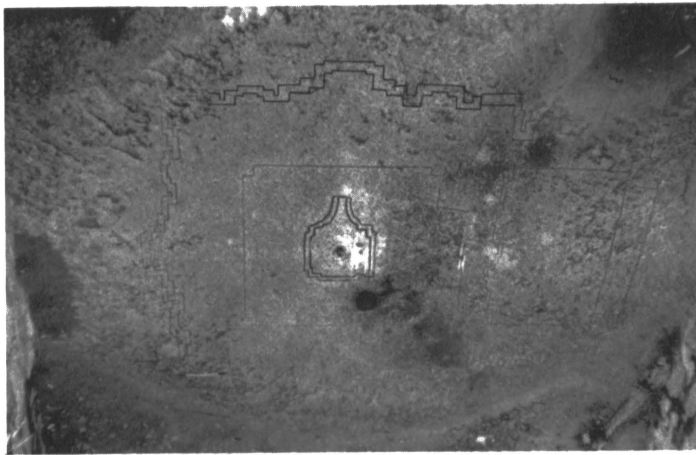
FIG.6 Original plan carved on rock

The temple is several centuries old and no documented details except an original temple plan carved on a rock outcrop (Fig.6) at a place few kilometers away from the temple could be available. This plan is at the temple plinth level and if it is the complete layout, the original temple had only a smaller structure leading to the entrance of the sanctum sanctorum. Now dismantled front portion within a square of about 16m sides (Fig.4) must be a later addition. A part of the originally constructed front is still retained (Fig.2). The sanctum sanctorum structure at its base is within 7.5m x 7.5m (Fig.4) and with a total height of 16m upto temple top above the present floor level. The granite stone masonry with exquisite carvings Fig.7 has a wall thickness of about 1m and is 5.6m high. The remaining tapering top structure is plastered brick work with moulding (Fig.2 and Fig.3). The estimated weight of the superstructure is 1130t. The masonry on outside showed signs of weathering, obliteration of stone carvings, opening of joints and dislocation of stones (Fig.7). The brick top was also reported to have cracks in the past and repaired.
