Interaction with Nearly Environment and Old Structure for a Deep Excavation. Case History in Bucharest

INTERACTION WITH NEARLY ENVIRONMENT AND OLD STRUCTURE FOR A DEEP EXCAVATION. CASE HISTORY IN BUCHAREST

The paper presents the influence of a deep excavation performed in Bucharest on the adjacent ground and on some old buildings around it; the damages and effects appeared during the excavation and the remedial measures are presented in detail, too. The excavation was designed to be 16.15 meters deep, sustained by a slurry wall enclosure of 60 cm thickness and pre-stressed anchors, and steel struts. Due to an accident that occurred to the trench walls, a thorough monitoring by instrumentation started. The results of this monitoring are shown.

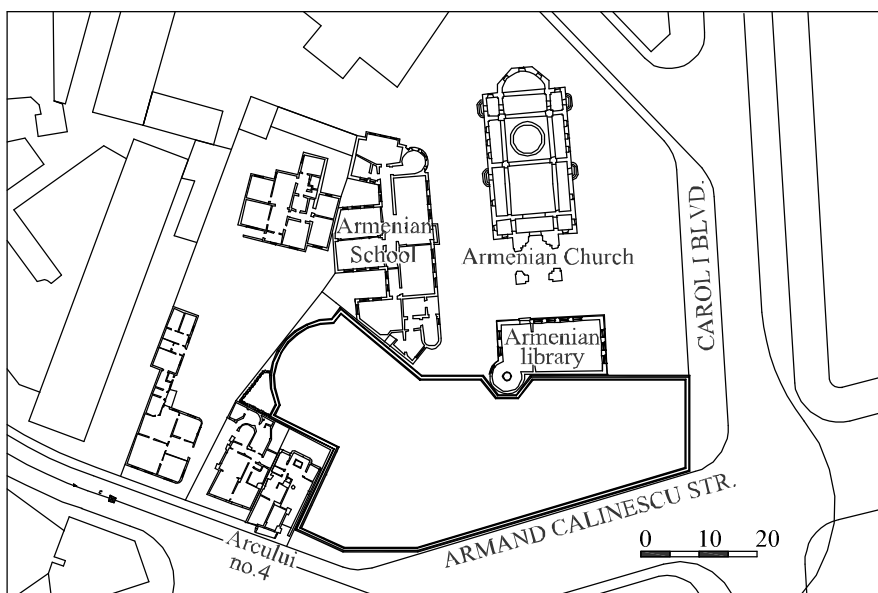
Fig. 2. Deep excavation contour and neighbourhood

The site location (Fig. 1) were will be the Millenium Bussiness Center (MBC) is situated in the proximity of old buildings (Armenian Church, Armenian School, Armenian Library, Arcului 4 block of flats) and heavy traffic streets (Carol I Blvd, Armand Calinescu Street.) as is shown in the Fig. 2.
