Investigation of Structural Damage in a Corrosive Environment: A Case Study

Joanna L. Meldrum
Exponent Failure Analysis Associates, Inc., Menlo Park, CA

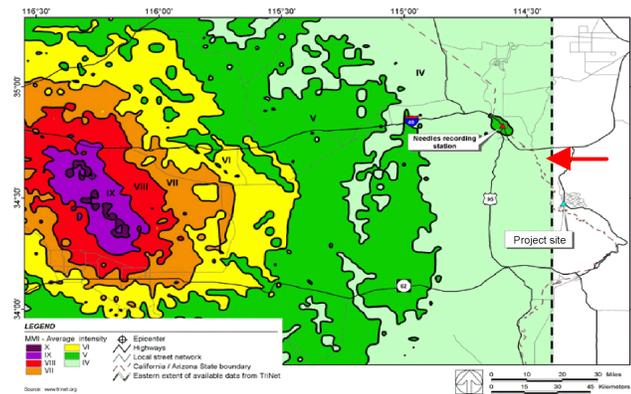
Fig. 8. Intensity distribution for the October 16, 1999 Hector Mine Earthquake (based on TriNet data). The arrow points to the eastern extent of the TriNet data.

As seen in Fig. 8, based on the TriNet data, the ground shaking intensity at the project site is estimated to be less than V (more likely IV, but conservatively using V). At Intensity V the shaking is described as *moderate* from a human perception standpoint and *very light* from a potential structural damage standpoint. TriNet also compiles a “felt intensity,” which is an intensity measure based on observations made by residents of different areas during the ground shaking. Based on 58 independent descriptions of the ground shaking for the zip code in which the project site is located, TriNet reported the ground shaking “felt intensity” to be IV. At Intensity IV shaking is described as *light* from a human perception standpoint and no structural damage is expected.

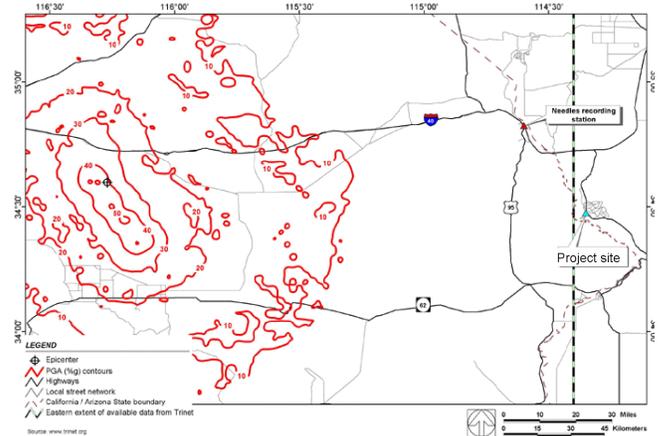
peak ground acceleration of 0.071g was recorded at the Needles station (Fig. 9). Again, the peak ground acceleration value suggests a low possibility of any structural damage.

Fig. 9. Peak acceleration map for the October 16, 1999 Hector Mine Earthquake (based on TriNet data).

The spectral acceleration at a period of 0.3 seconds, at Needles, as reported by TriNet, was 0.138g. Using standard attenuation relationships, the epicenter-to-site distance, and the ground motion parameters reported for Needles, the peak ground acceleration at the project site was conservatively determined to be 0.066g, with a spectral acceleration of 0.12g at a period of 0.3 seconds. These estimated values are consistent with (slightly higher than) the values reported by TriNet, which indicate a peak ground acceleration of 0.053g and spectral acceleration of 0.102g at the TriNet grid point located closest to the project site (the TriNet information geographically stops short of the project site).

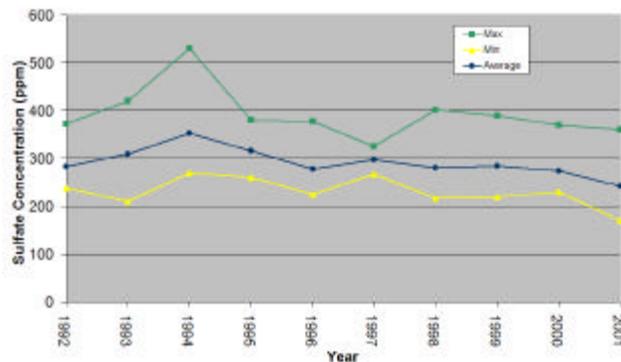
Fig. 10. Sulfate content data from the City Water Department.

Sulfate is classified under the secondary maximum contaminant level (SMCL) standards by the Environmental Protection Agency (EPA). The SMCL for sulfate in drinking water is 250 milligrams per liter (mg/l), sometimes expressed as 250 parts per million (ppm). Secondary Standards are based on taste, odor, color, corrosivity, foaming and staining properties of water. As shown in Fig. 10, the average sulfate concentration in the Lake Havasu City water exceeds the EPAs SMCL.

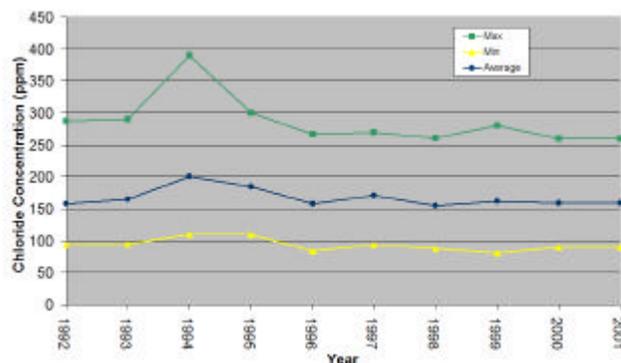
Fig. 11. Chloride content data from the City Water Department.

The SMCL for chloride in drinking water is also 250 ppm. As shown in Fig. 11, the average chloride concentration in the Lake Havasu City water is lower than 250 ppm, however maximum levels exceed the EPAs SMCL.
