Foundation Reinforcement of the Ipanema Beach Offshore Sewage Pipeline

FOUNDATION REINFORCEMENT OF THE IPANEMA BEACH OFFSHORE SEWAGE PIPELINE

The Ipanema Beach offshore sewage pipeline was installed thirty years ago in water depths up to 31m, in Rio de Janeiro, Brazil. It has a unique design, because steel piles were driven every 41 to 50m at joint along its length, in order to support it, keeping a constant gradient flow. These piles maintain the pipeline above mudline. After only a few years a first of these pile supports collapsed, allowing the pipeline to drop on the seabed, because of the occurrence of micro-cracks triggered by corrosion and environmental loads. Similar failures took place again before corrective measures could be taken. The main challenge faced at the end of 1999 was to solve the problem, thus avoiding any major consequence to the environment in the vicinity of the City of Rio de Janeiro, without having to interrupt the sewage pumping. This challenge was met by designing a non-conventional foundation reinforcement. In December 2001 the final support was reinforced. It is estimated that the entire life of the structure was increased by at least 30 years.

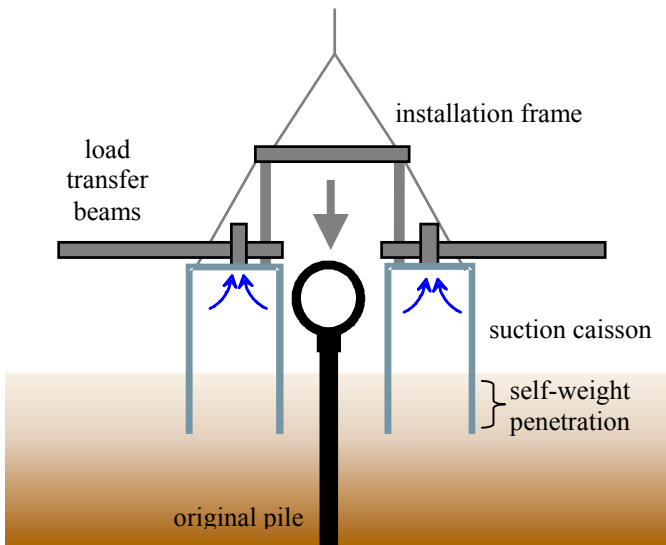
Fig. 3a - Suction Caisson Self-Weight Penetration Phase

Figs. 3a to 3d present, step by step the installation phases. The total installation was estimated to be done in less than four working days per support. The installation sequence included first lifting the installation frame fully loaded with the suction caissons and the load transfer beams (fig. 3a). In order to make the solution possible, in this step the caissons needed to penetrate the superficial soil by self-weight. After the frame was adequately positioned above the pipeline joint, divers would close the caisson valves to start the driving procedure. For the driving of the caissons up to the maximum penetration, two centrifugal pumps were sized in order to discharge all confined water trapped inside the caisson chambers (fig. 3b). When the caissons reached the maximum penetration the pumps would be turned off, the installation frame would be removed and the load transfer beams locked into the support joint, one in front of the original pile and the other behind it (fig. 3c). The brace would then close around the original pile and bolts installed and tightened.

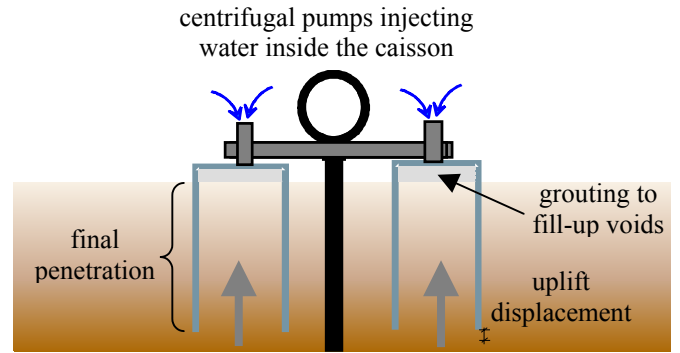
Fig. 3d - Lifting and Grouting Phase

This would cause the caissons to be lifted, thus assuming at least part of the support load (fig. 3d). To prevent any future settlement of the caissons, the gap formed between the caisson top plate and the soil plug will be totally filled with cement grouting.

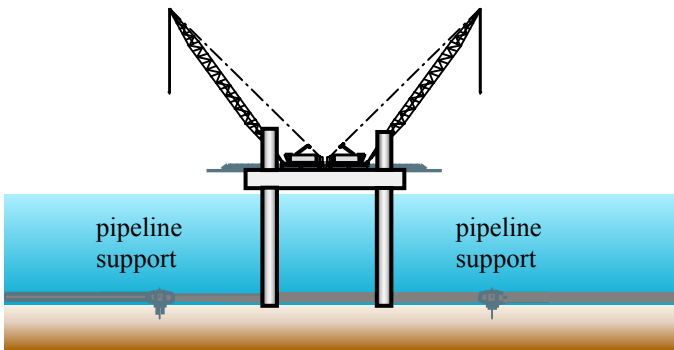
Fig. 6a - General View of the Jack-up Positioning

The contractor used a 2000 ton jack-up platform to install all sixty-seven reinforcements. The planning was prepared to execute two reinforcements per jack-up position. To make this possible the jack-up operated centered above the pipeline. As shown in figs. 6a and 6b, two frameworks were positioned, one on each side of the platform, together with two lattice

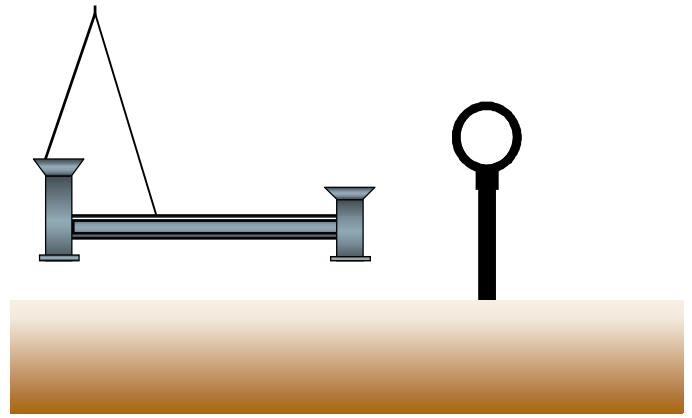
Fig. 7a - Positioning Phase

The installation procedure started with the structure carefully inserted under the pipeline joint until the open brace moved into position against the original pile (fig. 7a). The structure add-on was then lowered, put into position and bolted to the main part. At this time the foundation strengthening was sitting on the seabed. Guided by the fixed template placed on the jack-up steel framework, the piles were inserted into the structure sleeves and driven straight down to final penetration (fig. 7b). Once all piles were at final penetration the reinforcement structure could be lifted until it reached the pipeline bottom of the joint (fig. 7c). Steel wires kept the structure in position for the cement grouting of the annular between the pile and the sleeve, thus fixing the new foundation to the reinforcement structure (fig. 7d).
