International Conference on Case Histories in Geotechnical Engineering (2004) - Fifth International Conference on Case Histories in Geotechnical Engineering

## An Unstable Deep Canal Cut in Fat Clay – A Case History of Slope Failures on the McClusky Canal, North Dakota

Mark C. Gemperline

*U.S. Department of the Interior, Bureau of Reclamation, Denver, Colorado*

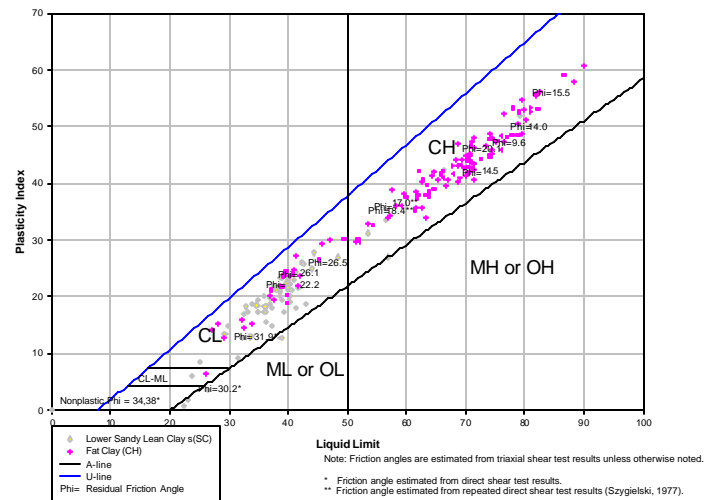
Investigations revealed that a 5- to 60-ft thick surficial deposit, consisting primarily of Sandy Lean Clay, s(CL), overlays a 40- to 50-ft thick layer of Fat Clay (CH). The upper layer supports deep tension cracks along the crest of the canal that have been observed to fill with ice in the winter. Below the Fat Clay lies a thicker glacial deposit composed primarily of Sandy Lean Clay s(CL). Figure 7 demonstrates the difference

in plasticity and residual shear strength between the Fat Clay (CH) and the underlying Sandy Lean Clay s(CL). A layer of Poorly Graded Sand (SP), typically less than 0.5 ft thick, separates the Fat Clay (CH) and the lower Sandy Lean Clay s(CL). This layer is thin and is not shown on Figure 2. A Poorly Graded Sand (SP) is also exposed in the canal cut in the vicinity of canal station 1145+00 and appears to be a buried steam bed.

Fig. 7. Plasticity Chart showing differences between Fat Clay (CH) and Lower Sandy Lean Clay s(CL) layers.

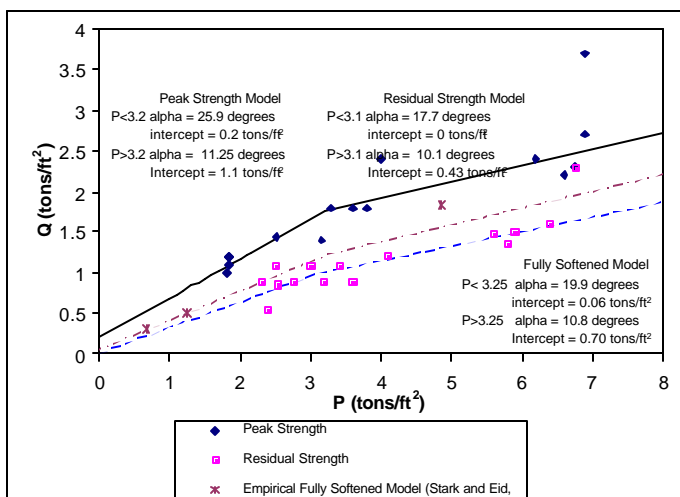
Consolidated drained triaxial shear tests were performed on relatively undisturbed specimens of Fat Clay (CH) and specimens of the overlying and underlying Sandy Lean Clays s(CL). Figure 8 depicts bilinear strength models for the Fat Clay (CH).

The peak shear strength and residual shear strength models represent bilinear models fitted to test results. Also presented on Figure 8 is an empirically derived bilinear model representing estimates of fully softened (FS) strength predicted using liquid limit, plasticity index, and particle size information (Stark *et al.* 1997).

Fig. 8. Soil Bilinear Shear Strength Models.
