## LANDSLIDE STABILIZATION AT MISSOURI ROUTE K BRIDGE OVER BLACKWATER RIVER

### ABSTRACT

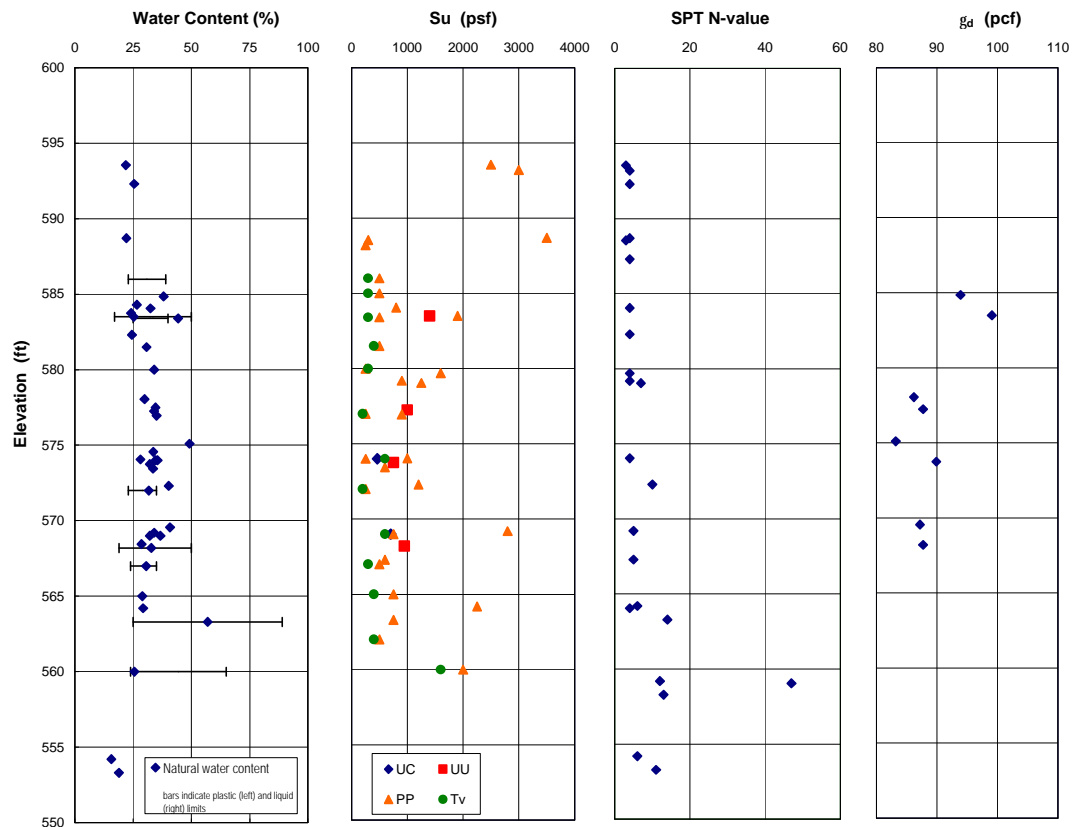
Fig. 7. Index and Engineering Properties of Subsurface Materials.

Four primary subsurface strata are present at the site: (1) interbedded silts and clays; (2) high plasticity clay; (3) gravel and sand; and (4) limestone bedrock. Figure 6 presents the subsurface profile and Fig. 7 summarizes the index and engineering properties of the materials.

indices in this layer ranged from 26 to 57% (3 tests), 65 to 89 (2 tests), and 41 to 64 (2 tests). Measured drained fully-softened friction angle ( $\phi'_{fs}$ ) ranged from 17 to 22°, while published correlations for  $\phi'_{fs}$  ranged from 14 to 18°.

**Gravel and Sand.** Underlying the clayey soils, all recent borings encountered a 10-ft thick layer of gravel and sand. Original bridge borings show that this layer pinches out south of Pier 6. Generally, this layer is loose to medium dense with SPT blowcounts ranging from 6 to 13. Grain size analyses conducted on two split spoon samples indicated average  $D_{50}$ ,  $D_{10}$ ,  $C_c$  (coefficient of curvature), and  $C_u$  (coefficient of uniformity) values of approximately 10 mm, 3.5 mm, 1.3, and 4.0, respectively. Additionally, the possible presence of cobbles in this layer was inferred from the original bridge boring logs, drilling characteristics, and the one high SPT blowcount value ( $N = 47$ ).
