Geotechnical Investigation of the Hollóháza Landslide Case

GEOTECHNICAL INVESTIGATION OF THE HOLLÓHÁZA LANDSLIDE CASE

Hollóháza is a little mountain village in North-East Hungary. Following a long wet period in 1999 the largest mass-wasting event of the 20th century occurred. The total volume of mobilized earth material was over 1.5 million m³. One major concern of problem management was that the value of the damaged infrastructure was less than the total costs of restoration and stabilization, while the natural potential of the settlement is outstanding. After investigating the causes of the landslide the cheapest effective solution had to be found. Hollóháza is surrounded with the residuals of a 4-6 km diameter volcanic caldera. The settlement was established in the natural depression of the caldera where the bottom andesite is covered with varying depth of rhyolite-tuff and clayey marine deposits with the tilt of 10-25 degree toward the valley. The rhyolite-tuff that is originally fallen into seawater has a high bentonite content, montmorillonite content is close to 60%. The covering clay layers has almost 40% illite-montmorillonite content. Water from precipitation moves towa

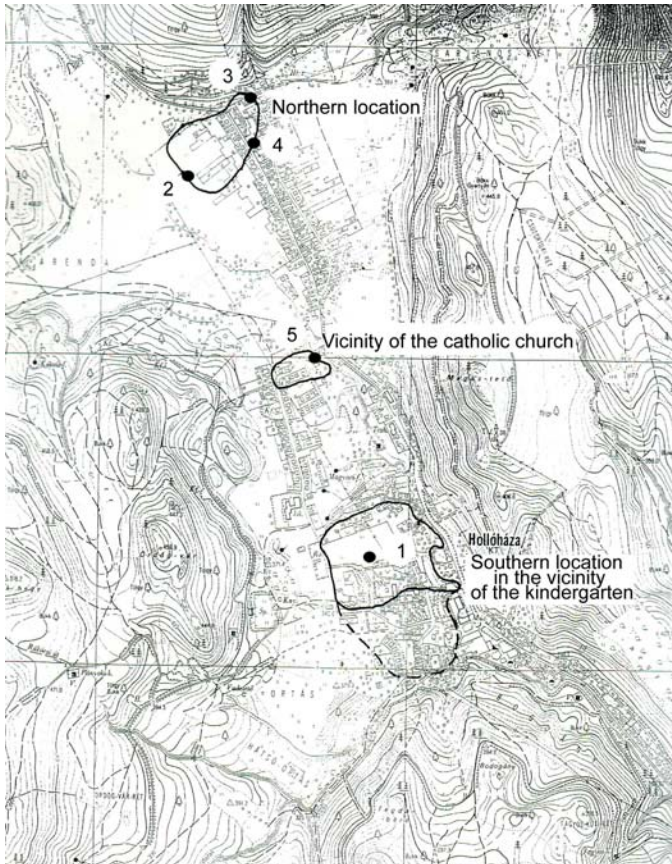
In the spring of 1999 the movements occurred at three locations (Figure 1.):

- a.) Northern location;
- b.) Vicinity of the catholic church;
- c.) Southern location in the vicinity of the kindergarten

Figure 1. Areas effected by mass movements
(The numbers on the map indicate the spot where photographs were shot)

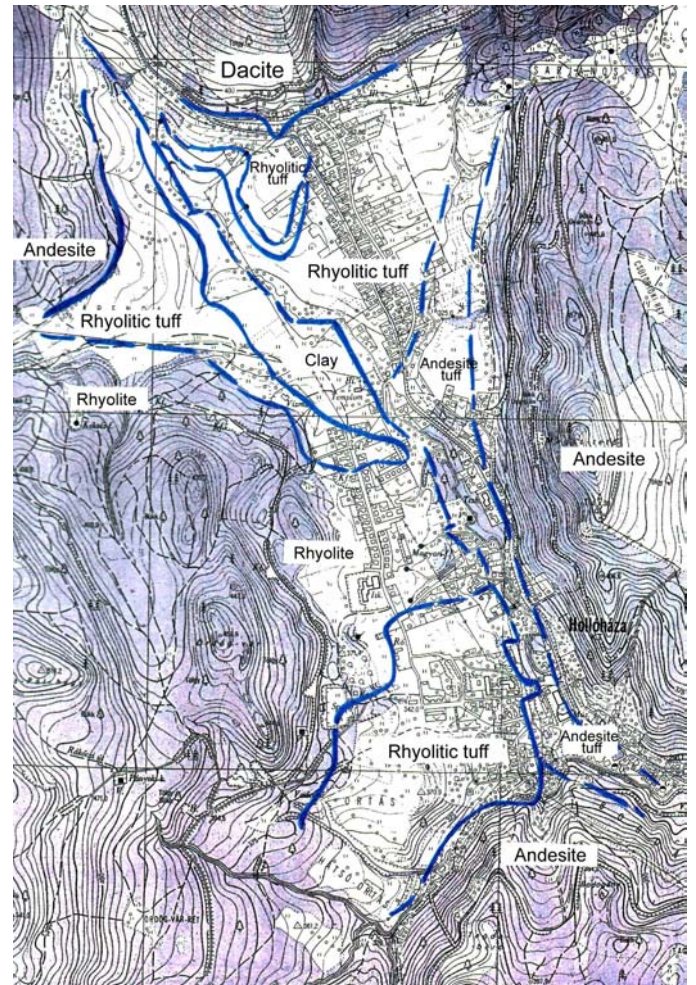
Based on detailed site inspection, investigations and borings the geological map of Hollóháza (Figure 3.) was refined and the clayey and rhyolite tuff layers can be delineated. Considering also the previous mass movements those residential areas threatened the movements are identified.

Figure 3. Uncovered geological map of Hollóháza

Integrated evaluation of geological mapping and aerial photographs prove that only those two areas are exempt from mass movement hazards that are settled on solid lava rocks. All other areas covered by Sarmata clay and rhyolite tuff series are endangered by movements, due to the several series of high angle dip of the layers.

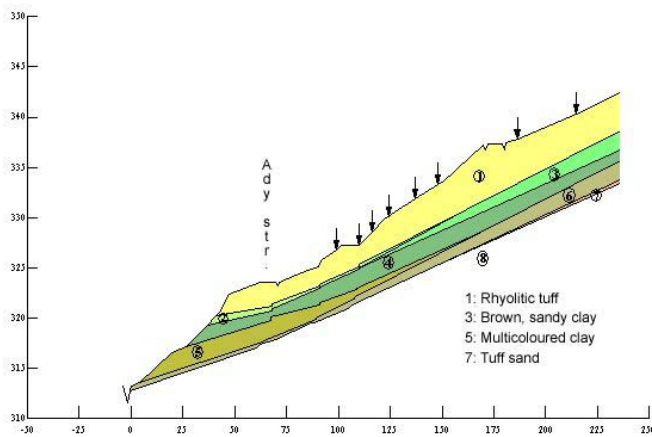
Figure 5. Typical geological cross section of the vicinity of the church

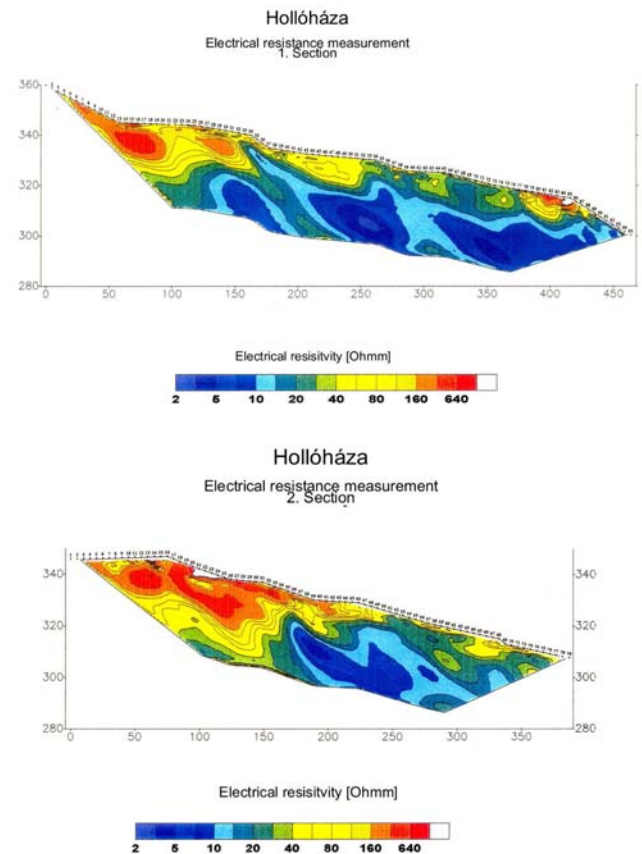
On the two longitudinal sections (Figure 7.) one can clearly differentiate the near surface, high resistance layers and the lower resistance deeper formations. The block structure of these later ones are delineated by the resistance minimum (<5 Ohm). On the perpendicular sections (Figure 8.) the block structure although not so significantly but clearly traceable throughout the whole section.

Figure 7. Geoelectric sections along the gradient (ELGOSCAR Kft)

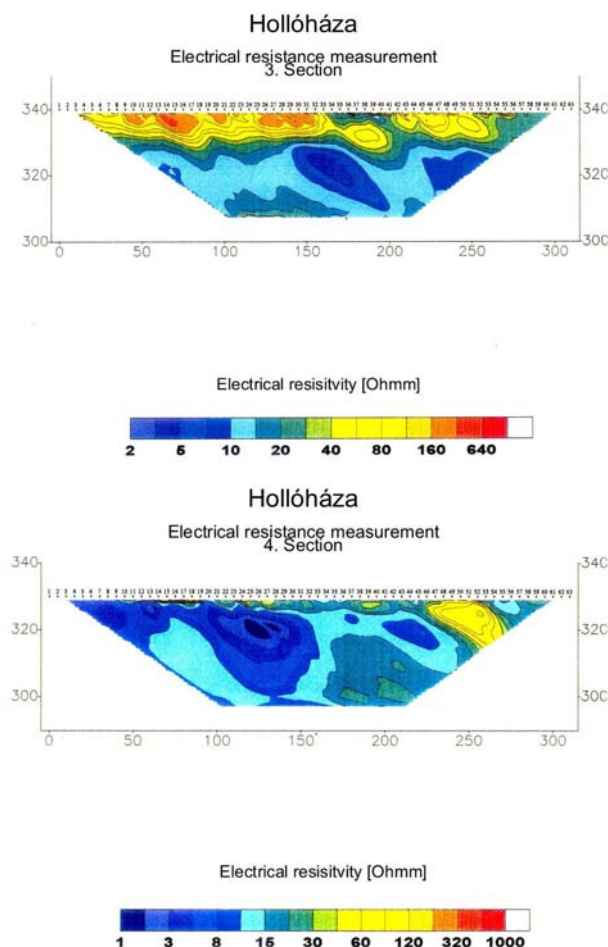
Figure 8. Perpendicular geoelectric cross sections (ELGOSCAR Kft.)

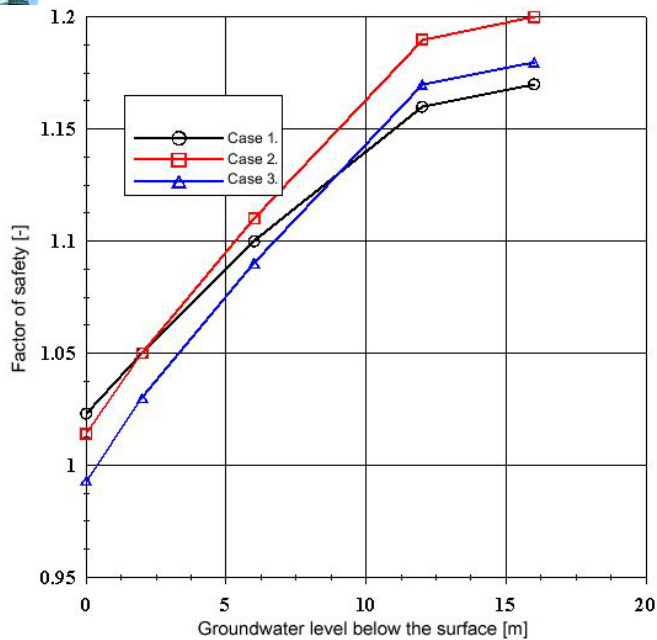
After identifying the shear strength parameters related to unit level of safety, we investigated how the decrease in pore water pressure (lowering groundwater level) would change the value of the safety factor. The results of our calculations are shown in Table 2. and Figure 9.

Figure 9. Probable factor of safety related to different levels of groundwater

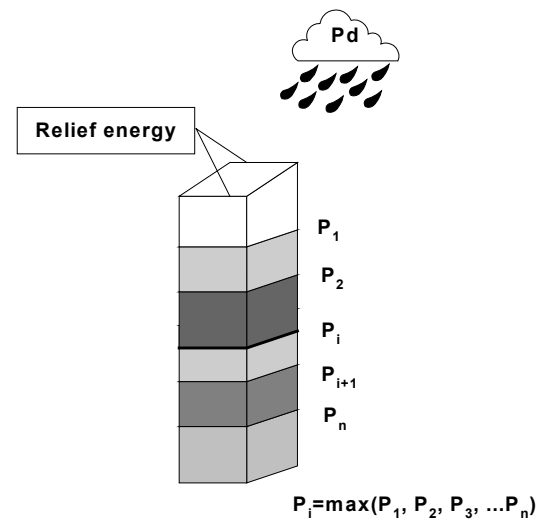
Figure 11. Elements of mass movement hazard.

As earlier discussed the main cause of the geotechnical problems at the Hollóháza case are related to the unfavorable geological setting of clayey sediments and weathered riolite tuff material in a near saturated or saturated condition. Should the pore pressure decrease at these locations the risk of landslides decreases significantly. The high pore pressure is related primarily to precipitation quantity and intensity and secondly to the lack of appropriate surface channeling facilities. The steepness of the slope is also an important factor (See Figure 11.).
