A Study on the Performance of a Reinforced Dike Section With Geogrid During the Tottori-Ken Seibu Earthquake

A STUDY ON THE PERFORMANCE OF A REINFORCED DIKE SECTION WITH GEOGRID DURING THE TOTTORI-KEN SEIBU EARTHQUAKE

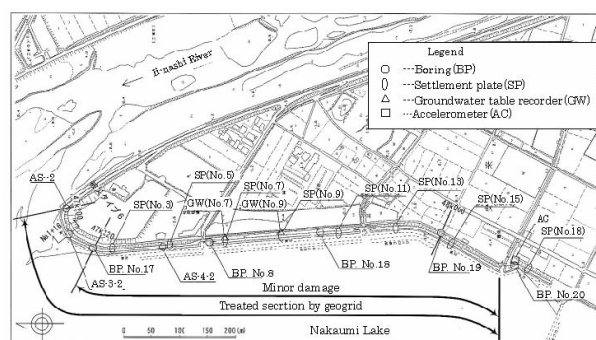
Fig. 3. Plan view of the Arashima dike section

The length of the severely damaged section was about 120 m, located on the curved part of the dike axis continuing to the river dike of the Ii-nashi River as illustrated in Fig. 3. Many transverse cracks as shown in Fig. 12, and the discrepancy at the joint of concrete facing as shown in Fig. 13 were observed at this section, resulting 1 m subsidence of the dike crest. Beside these deformation to embankment, up-heaving of the bottom of the side ditch as shown in Fig. 14 and traces of sand boiling at surrounding ground surface near the toe of the embankment were observed. A fisherman told his fear to one of the authors as he watched the sand and water boiling from the lake bed after he felt the shaking when he was catching corbicula in the lake.

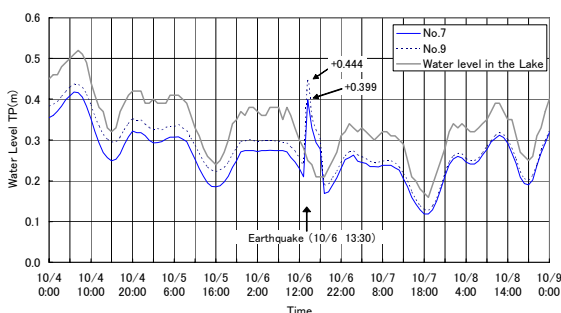
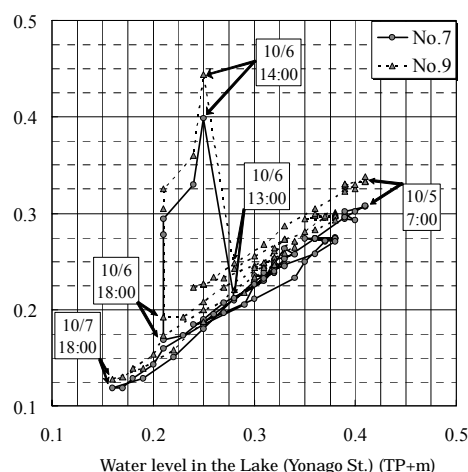
Fig. 11. Recorded groundwater table

Figure 11 shows the records of groundwater table observed at section No. 7 and 9. It was recorded that the groundwater table was raised by 20 cm at 14:00. However, since the groundwater table was hourly recorded only, accurate amount of the groundwater table rise at the time of occurrence of the Earthquake was not known. It is known that the effect of the groundwater table rise seemed to remain until about 18:00, four and half hour later after the earthquake from the comparison of the recorded value to those in the Lake.

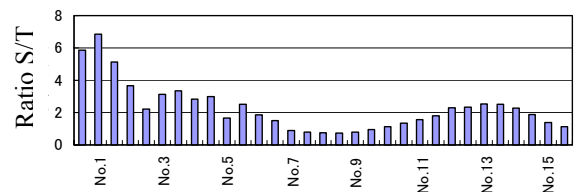
Fig. 18. Settlement/liquefiable layer thickness ratio

The reason why this portion of the Arashima dike section was caused the severe subsidence is not yet clarified, however it could be pointed out that this portion is situated on the ground where liquefiable sand layer is comparatively thicker, and that

this portion is located on the curved part of the dike axis. Curved part of the dike axis may cause comparatively larger cyclic stress to the liquefiable sand layer due to the three dimensional response of the dike. The ratio of the observed settlement to the thickness of liquefiable soil layer is not uniform as shown in Fig. 18. Mean value of this ratio was 2.3%.

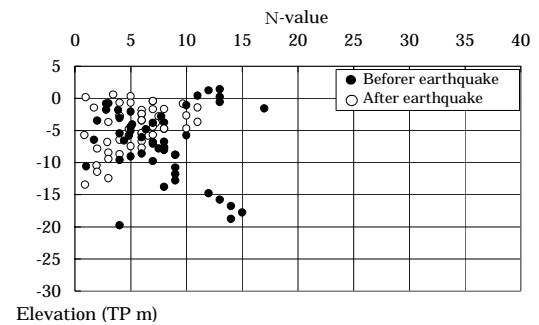
Fig. 21. Comparison of SPT N value

As mentioned before, there were two parts in the treated 850 m long section where the damage was minor and the subsidence was severe. In order to check the soil profile estimated before the construction, additional boring and CPT were conducted after the earthquake. As the results of these investigations, it was found to be short near the river mouth that the length of the section where the uppermost sand layer is thick. It was also found that uppermost sand layer was thinner than that estimated before the construction around the section from Section No.3 to No.5.

that in minor damaged section as shown in Fig. 21, and that the mean particle size of this layer around the river mouth was slightly large. Figure 22 shows the particle size distribution curve of the uppermost sand layer.

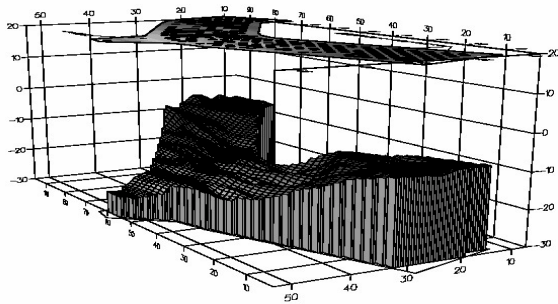
Fig. 23. Trace of Mud Lump estimated from SCP data

The execution data of the Sand Compaction Piles installed near the river mouth as part of the repair works was analyzed to obtain the thickness of the uppermost sand layer. It was found that the section where sand layer is thick existed very locally near the river mouth as shown in Fig.23, and it was thought that this was caused by a trace of Mad Lump phenomena(Izumo, 1994). Soil profile shown in Fig.3 was slightly modified by reflecting these investigation results from that estimated one before the construction.

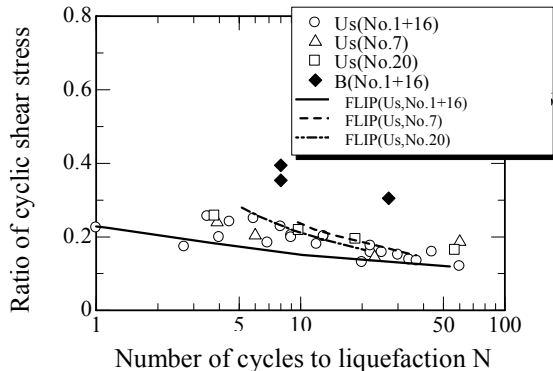
Fig. 24. Cyclic Tri-axial Compression Test

Cyclic tri-axial compression test was also conducted after the earthquake for specimens obtained by triple core tube method at Section Nos. 1+16, 7, and 20 together with disturbed sample of embankment material. Figure 24 shows the test results. It seems that the liquefaction strength near the river mouth is slightly smaller than that at Section No. 7 and 20.

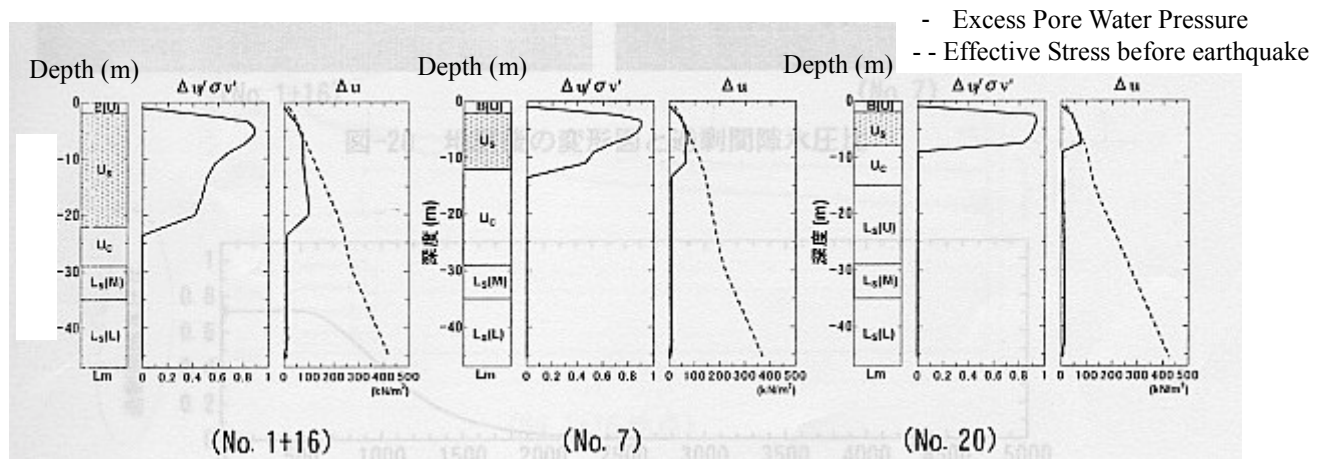
Fig. 25. Comparison of raised pore water pressure

Variation of liquefied thickness in uppermost sand layer were examined by calculation of pore water pressure (PWP) at three cross sections, at Section Nos. 1+16, 7, and 20 where the thickness of uppermost sand layer are different. Figure 25 shows the calculated PWP and the PWP ratio at these sections. It is known from this figure that the thickness of the zone where PWP ratio is larger than 0.6 ($\Delta u/\sigma' > 0.6$) is almost the same among these three sections, reaching to about several meters. This implies that the heavily softened thickness does not differ between Section No. 1+16, and the Section No. 7. However, it is known that at Section No. 1+16, thickness of the layer where PWP (absolute value, not the PWP ratio) was raised up reaches to about 20 m deep, much deeper than other sections as shown in Fig.25. This implies that, at Section No. 1+16, upward seepage flow by the dissipation of raised PWP must have continued longer than other sections causing the

decrease of anti-stretching effect of geogrid due to the lost of friction by immersing water. If this is the case, interval distance between the lowest and middle sheets of geogrid becomes shorter as seen in Fig.20.

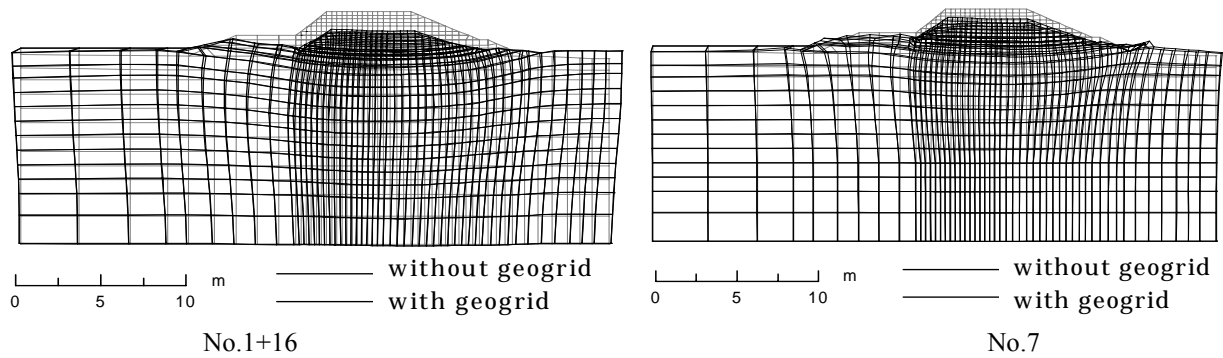
Fig. 26. Calculated deformed shape

Crest settlement of the embankment calculated by an effective stress 2D analysis was 1.3 m at the Section No.1+16 (severe damage), and about 0.6 m at the Section No. 7 (minor damage) as shown in Fig.26. Final shape of the embankment and the foundation ground at both sites are also shown in Fig. 26. These calculated settlements were obtained around the end of ground shaking as shown in Fig. 27. The calculated settlement, under the condition that the groundwater table was set at the same elevation before the earthquake, is very close to the observed one at the Section No.1+16. Contrary to this, the calculated settlement is overestimated at the Section No.7 by this numerical analysis. Stretching amount in the calculation at the Section No.1+16 for both cases with and without geogrid are illustrated in

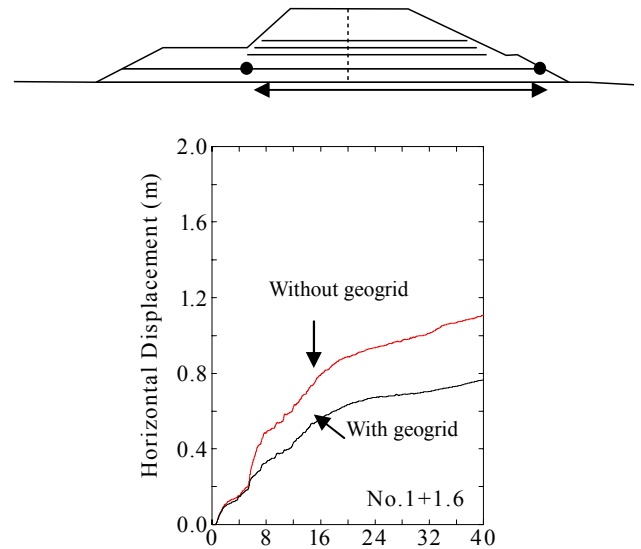
Fig. 28. Time history of calculated stretching

Fig. 28. According to this tentative analysis, it is known that the stretching amount was reduced to about 70% by deploying the geogrid, although calculated amount of this reducing effect against stretching should be further studied.
