Behavior of Reinforced Wall System During the 1999 Kocaeli (Izmit), Turkey, Earthquake

BEHAVIOR OF REINFORCED WALL SYSTEM DURING THE 1999 KOCAELI (IZMIT), TURKEY, EARTHQUAKE

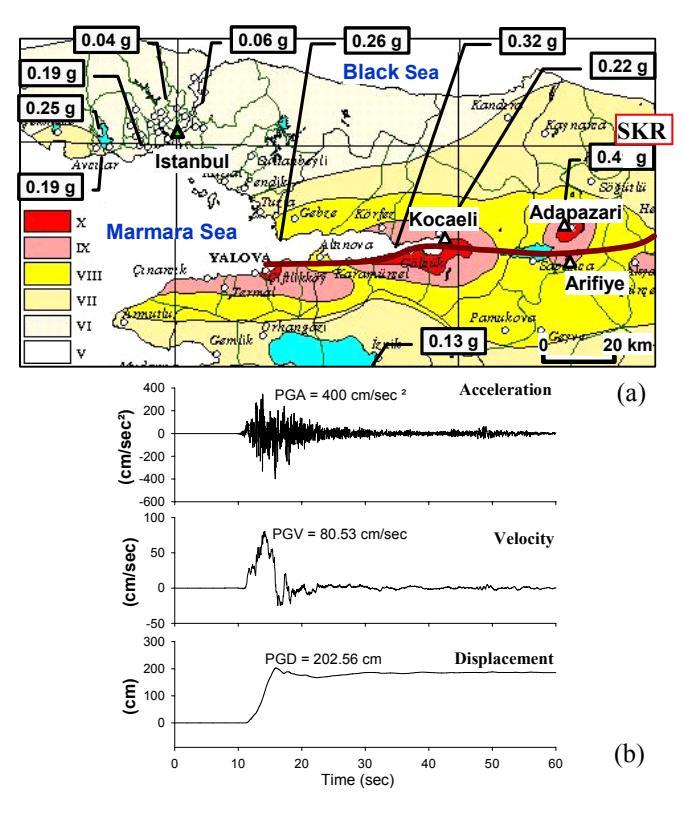
Figure 1a displays the intensity map of the northwestern Turkey combined with recorded peak horizontal ground accelerations (PHGA) in the disaster belt. The earthquake was felt well beyond the epicenter. Serious damage extended even to southwestern suburbs of metropolitan Istanbul. 120 km west of the epicenter. A track of the surface fault is also marked in this figure. Surface faulting started at the eastern end of the Marmara Sea, and then propagated eastward through the Adapazari region,

Fig 1. (a) Modified Mercalli intensities along the fault rupture and recorded PHGA's (ERD, 2000; USGS 2000; KOERI, 2002); (b) accelerograms recordings at Adapazari station (SKR) and calculated velocity and displacement time histories.

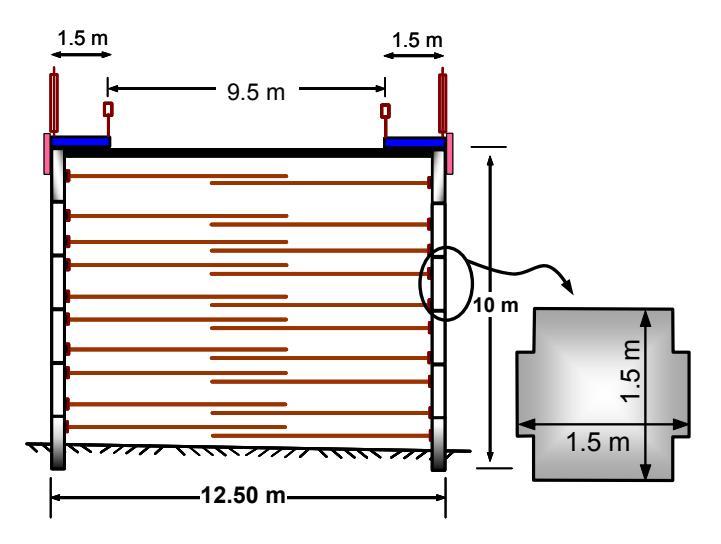
Fig 3. Schematics of double-faced gravity-type MSEW system with reinforced concrete facing panels in Arifiye.

found to be costly as it also required a pile-cap system for each pier. Thereafter, a gravity-type retaining wall system (i.e., Reinforced Earth®) was directly constructed on the ground. This reinforced wall system was selected not only as an economical construction method but also because it could be an effective method for withstanding large consolidation deformations from the compressible poor quality foundation soil (Smith and Unal, 1992). A 100 m-long MSEW system was built as a "doublefaced" or "back-to-back" type wall, having parallel reinforced concrete facings with ripped metallic reinforcing inclusions to accommodate a two-way divided roadway as shown in Fig. 3.

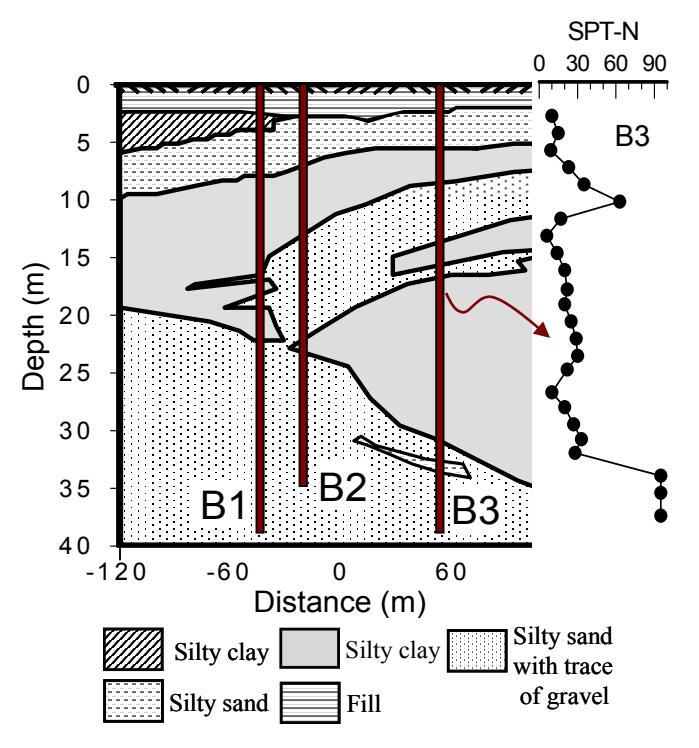
Fig 4. An approximate visualization of subsoil geology along the axis of Arifiye Overpass (modified based on ITU, 1999).

Standard penetration tests (SPT) were conducted by the Turkish General Directorate of Highways (GDH) to gain sufficient subsurface information between both ends of the bridge overpass soon after the earthquake. Three subsurface borings to a depth of 38 m were drilled. Their locations are shown as B1, B2 and B3 in Fig. 2a. A 2-D visualization for the local subsoil conditions along the axis of the bridge overpass is shown in Fig. 4. The ground water table was approximately 5 m below the ground surface.

B1 shows that very soft layers of soil deposits lie under the southern abutment and extend to a depth of 22 m where a dense $(N_{30}=100)$ layer of sedimentary deposit (i.e., Pliocene base rock) of silty sand with some gravel was encountered. The loose layers became thicker to the depth of 34 m below the northern abutment as shown in B3, which was the nearest boring to the MSE walls. The soil profile at B3 consisted of a 2.5m-thick fill followed by varying thicknesses of silty sand and silty clay deposits. Loose silty sand and silty clay layers (with $N_{30} < 20$, Fig. 4) below the reinforced walls might have been prone to liquefaction or seismic-induced densification during the seismic
