International Conference on Case Histories in Geotechnical Engineering (2004) - Fifth International Conference on Case Histories in Geotechnical Engineering

## Behavior of Reinforced Wall System During the 1999 Kocaeli (Izmit), Turkey, Earthquake

## BEHAVIOR OF REINFORCED WALL SYSTEM DURING THE 1999 KOCAELI (IZMIT), TURKEY, EARTHQUAKE

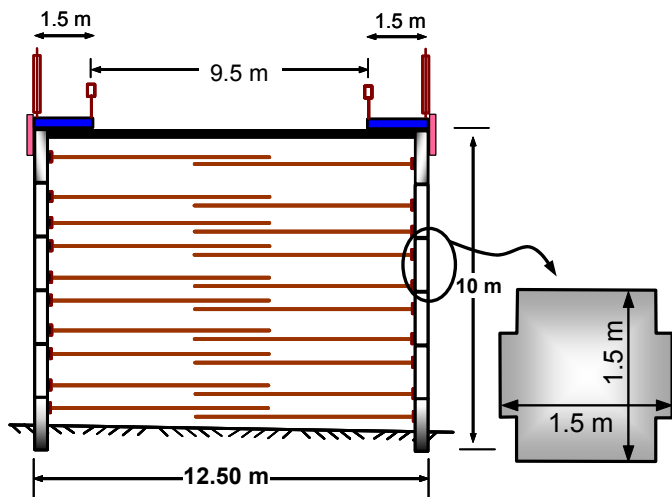
Fig 3. Schematics of double-faced gravity-type MSEW system with reinforced concrete facing panels in Arifiye.

found to be costly as it also required a pile-cap system for each pier. Thereafter, a gravity-type retaining wall system (i.e., Reinforced Earth®) was directly constructed on the ground. This reinforced wall system was selected not only as an economical construction method but also because it could be an effective method for withstanding large consolidation deformations from the compressible poor quality foundation soil (Smith and Unal, 1992). A 100 m-long MSEW system was built as a “double-faced” or “back-to-back” type wall, having parallel reinforced concrete facings with ripped metallic reinforcing inclusions to accommodate a two-way divided roadway as shown in Fig. 3.

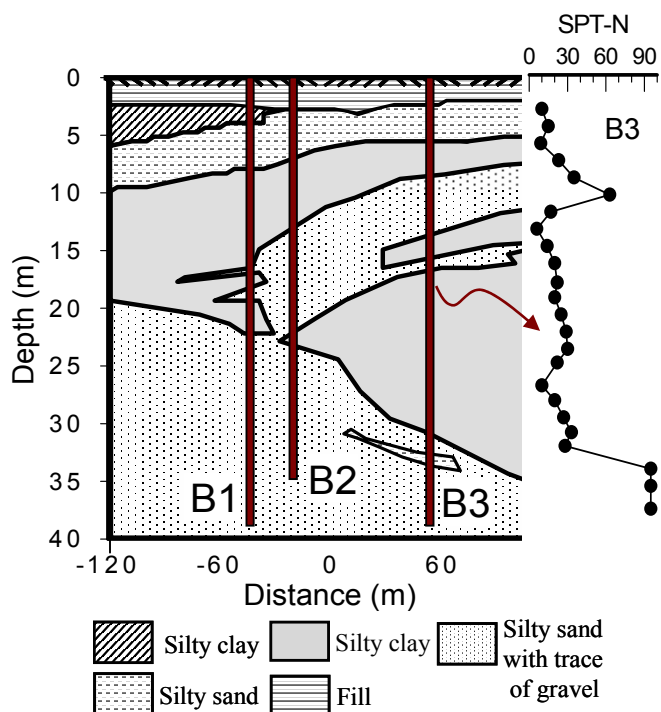
Standard penetration tests (SPT) were conducted by the Turkish General Directorate of Highways (GDH) to gain sufficient subsurface information between both ends of the bridge overpass soon after the earthquake. Three subsurface borings to a depth of 38 m were drilled. Their locations are shown as B1, B2 and B3 in Fig. 2a. A 2-D visualization for the local subsoil conditions along the axis of the bridge overpass is shown in Fig. 4. The ground water table was approximately 5 m below the ground surface.

B1 shows that very soft layers of soil deposits lie under the southern abutment and extend to a depth of 22 m where a dense ( $N_{30}=100$ ) layer of sedimentary deposit (i.e., Pliocene base rock) of silty sand with some gravel was encountered. The loose layers became thicker to the depth of 34 m below the northern abutment as shown in B3, which was the nearest boring to the MSE walls. The soil profile at B3 consisted of a 2.5m-thick fill followed by varying thicknesses of silty sand and silty clay deposits. Loose silty sand and silty clay layers (with  $N_{30}< 20$ , Fig. 4) below the reinforced walls might have been prone to liquefaction or seismic-induced densification during the seismic

Fig 4. An approximate visualization of subsoil geology along the axis of Arifiye Overpass (modified based on ITU, 1999).

event. These SPT measurements obtained after the earthquake might reflect denser states of the soil layers than those prior to the earthquake.
