Excavation Shoring Failure Threatens a Historic Church: Exploration of Causes and Remedial Measures

EXCAVATION SHORING FAILURE THREATENS A HISTORIC CHURCH: EXPLORATION OF CAUSES AND REMEDIAL MEASURES

Recently, excavation works adjacent to the Lady of Annunciation Church resulted in severe cracking and deformations within the walls and floors of the stone and brick structure. The shoring provisions which were executed within the excavated lot consisted of contiguous bored piles with pre-stressed anchors. The failure occurred when the excavation works had progressed to a level of about 12m below original grade. Faced with the imminent catastrophic collapse of the church, the Municipality of Beirut ordered the immediate backfilling of the site in order to limit further movements. The case study presented in this paper includes the details and results of the geotechnical forensic investigation which included an array of measures and efforts, all implemented in an environment of urgency, given the need to find the cause of the failure, and propose and implement remedial measures which would spare the church. The analyses, monitoring measures and actual remedial works adopted and succe

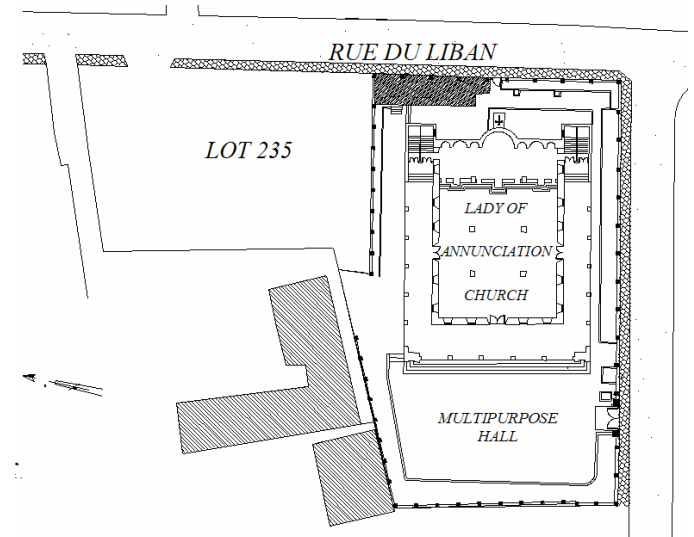
Fig. 1. General plan view of the church and lot 235.

The Lady of the Annunciation church is a sandstone-block structure, built along classical architectural features as shown in Fig. 1. A central hall covered by a dome resting on massive pillars and external bearing walls form the bulk of the space. A peripheral gallery or roofed-walkway runs along the side of the hall with small size circular columns supporting a mezzanine. Two stairwells define both ends of the gallery and lie on either

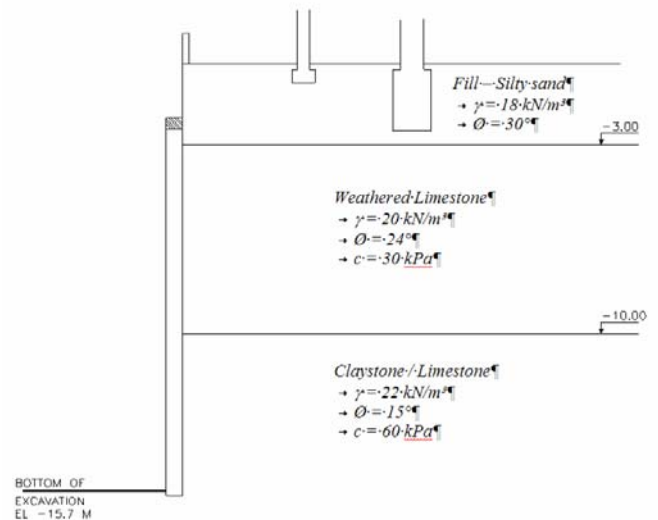
Fig. 2. Typical soil profile and design characteristics

A comprehensive site investigation campaign was initiated and a report prepared by Turba Engineers in May 2000. In total, seven boreholes and a number of test pits were executed within the church premises alone. The deduced stratigraphy at the site is presented in Fig. 2 along with the soil parameters used for the remedial works design. The soil profile consists of:

- A surficial layer of red-brown clayey sand, 2m to 6m thick, in loose to dense state (SPTs between 5 and 27).
- A layer of creamy white weathered marl, moderately firm to firm, 3m to 8 m thick.
- Green-gray claystone and creamy white limestone firm to very firm.

The above formations appeared to have a slight dip parallel to the boundary with Lot 235 which does not appear to affect the stability of the excavation. Water was found in the boreholes at a depth of -12 m to -13 m. However, during the initial excavation works, water influx into the site was reported at much shallower depths, probably seeping from localized sources, likely broken utilities.
