## Failure Investigation of a Fill Slope in Putrajaya, Malaysia

A. N. Hussein  
*Public Works Department, Malaysia*

A. H. Mustapha  
*Public Works Department, Malaysia*

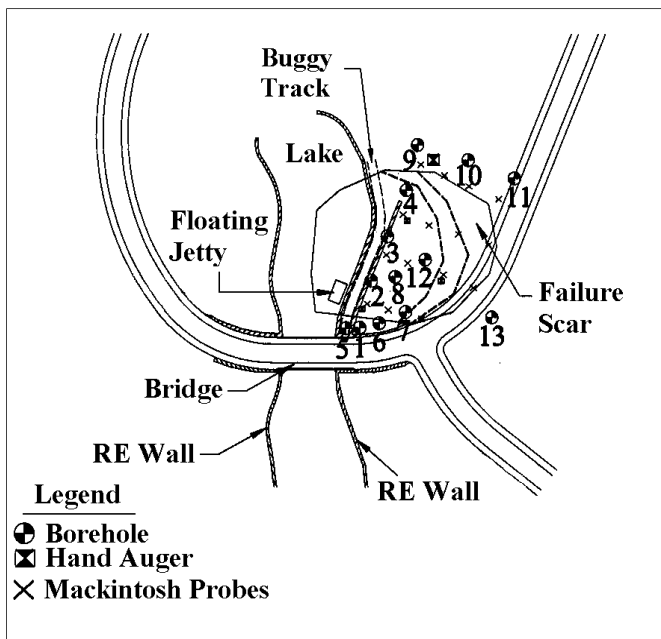
Fig. 6. Location of the site investigation works

After the failure, 13 new boreholes (BH1 to BH13), 15 Mackintosh probes (MP1 to MP15) and 3 hand augers (HA1 to HA3) were carried out by the soil subcontractor to determine the soil profile of the failed area. The generalized soil profile obtained from the boreholes shows that the subsoil consists of medium stiff to stiff silty clay or clayey silt. The locations of the site investigation works are shown in Fig. 6.
