International Conference on Case Histories in Geotechnical Engineering (2004) - Fifth International Conference on Case Histories in Geotechnical Engineering

FORENSIC ENGINEERING IN APPLIED CIVIL ENGINEERING AND GEO-DOMAIN

D.S. “Sax” Saxena, P.E., F.ASCE

ASC geosciences, inc.

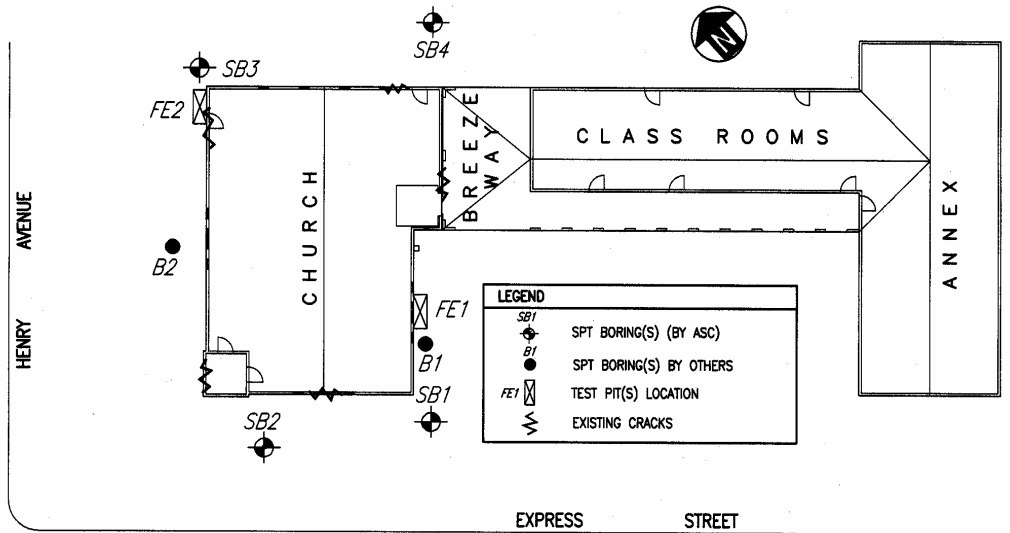
Fig. 1. Project layout and test location plan

Subsoil conditions beneath the site were evaluated by advancing several test borings to a depth of 50 ft (15.2 m). Site layout and test boring locations are illustrated in Fig. 1. Typical subsurface conditions consisted of up to 20 ft (6.1 m) of predominantly non-plastic soils overlaying a thin highly weathered cap of a plastic material, which in turn overlays a recently cemented calcareous limestone formation and variable depth of limestone with water table.

2. the existence of conditions indicative of erosion-type sinkhole activity in a defined area within the exploration area of the building footprint;
3. the anomalous resistivity values recorded by the geophysical resistivity survey suggested the presence of a raveled zone near the base of the sand to silty sand and above the limestone resulting in its connection cavity system in the limestone itself. Evidence of porous zone and/or solution riddled limestone was also detected at about 30 ft (9.1 m) depth; and,

4. remediation was feasible as an acceptable and economical alternate. Development and implementation of a restoration program was, therefore, recommended.

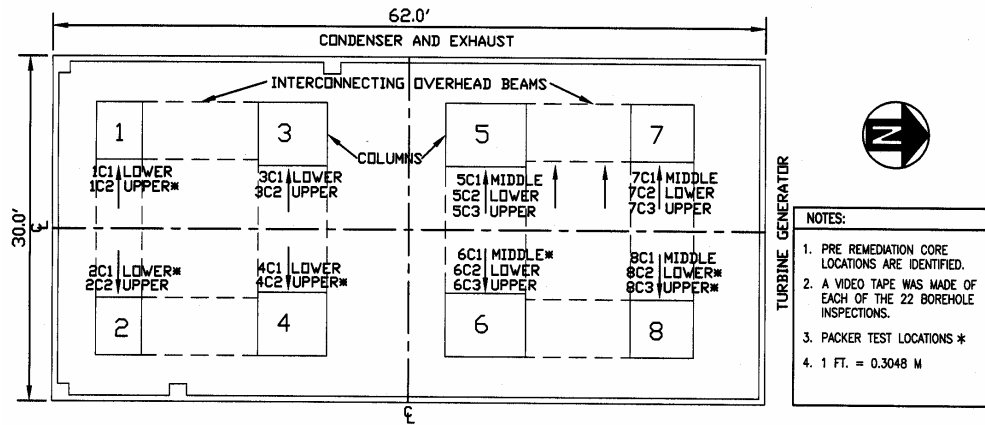
Fig. 7. STG structure layout identifying columns, overhead beams, core locations, and Packer test locations

Improper placement of concrete for a structure resulted in a visual appearance of segregated concrete and honeycombing, as illustrated in Fig. 6. Questions were raised regarding the structural integrity, and removal/replacement of the partially

The pressure testing for this project consisted of forcing water under pressure through the device using the on-site water pressure, allowing the valve to remain open with a constant pressure of 30 to 50 psi (2.1 to 3.5 kg/cm²), and measuring the amount of water, if any, required to maintain the pressure in the cored hole at the maximum pressure achieved. The STG structure layout identifying columns, overhead beams, core TV video, as well as Packer test locations is shown in Fig. 7.
