14 Aug 2008, 4:30pm - 6:00pm

An Investigation on Failure of Embankments in Bangladesh

AN INVESTIGATION ON FAILURE OF EMBANKMENTS IN BANGLADESH

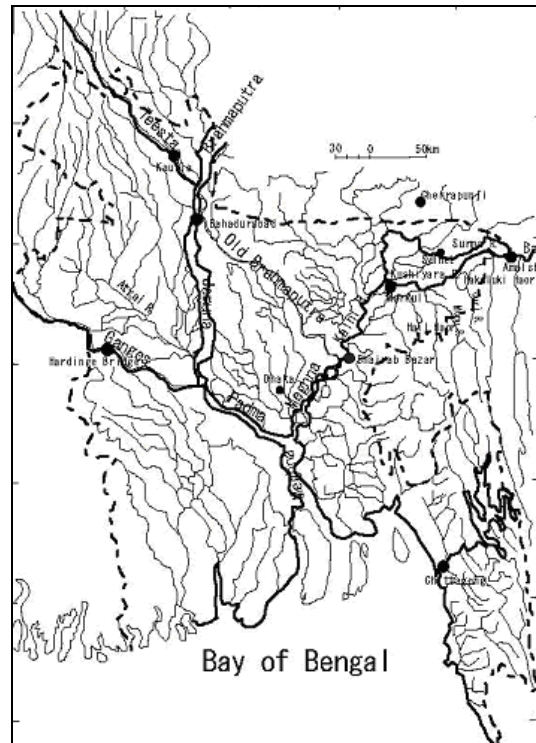
Fig.1. Map of Bangladesh showing the location of failure of embankments

at Talukderpara in Shariakandi upazila, Bogra and 2) Padma river embankment at Rajbari which are breached in the year 2007. The failure locations are being shown in Fig. 1.
