Averted Piping Failure—Earth Dam on Permeable Foundation

Scott Newhouse

Bechtel Power Corporation, Frederick, MD

AVERTED PIPING FAILURE—EARTH DAM ON PERMEABLE FOUNDATION

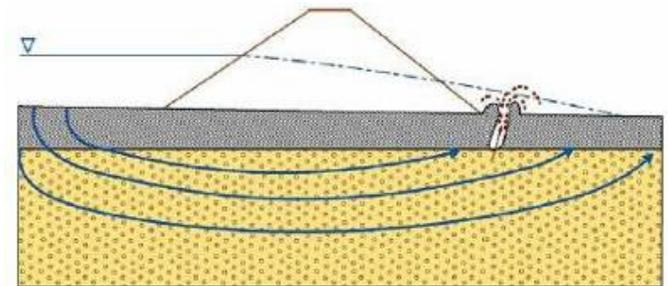
Figure 4 is taken from Danny McCook's *A Comprehensive Discussion of Piping and Internal Erosion Failure Mechanisms* (McCook, 2004). This figure illustrates a potential piping failure mechanism for conditions similar to those at the Lake Mailande Dam (Fig. 1). Figure 4 depicts a homogeneous embankment built on a thin surficial clay layer overlying a sand aquifer. McCook notes that such a

mechanism is a well established one related to failure of flood protection levees, and is more common in levees than in dams. He points out that the mechanism is actually rare in failures of earth dams.

Fig. 4. Potential Foundation Piping Mechanism: Heave caused by excessive seepage pressures under surface clay blanket. Piping of sand aquifer occurs from flow of water through defect in clay blanket, creating sand boil at ground surface. (From McCook, 2004)

The development of the boil indicates that excessive hydraulic gradient developed even with the lake less than 50% full, with a water head near 20 ft of the design 45 ft head. Conditions at this stage clearly showed that continued filling would result in internal erosion of soil from the foundation, and likely a soil pipe, resulting in a breach—the condition illustrated in Fig. 4.
