## Investigation and Repair of a Leaking Earthfill Dam

**Erik J. Nelson, P.E.**  
Geosyntec Consultants  
Tampa, Florida 33637

### **ABSTRACT**

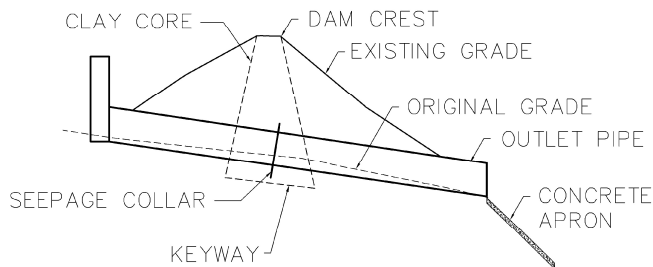
*Figure 1 – Initial Design*

Construction specifications called for the base of the outlet pipe to be overbuilt by 2 feet, at which time the base would be shaped to accept the pipe bottom. The pipe would then be placed in the shaped trench and backfilled. The design plans called for a bolt-on seepage collar to be installed on the outlet pipe at the mid point of the clay core (Figure 1).
