Rapid Recovery of Demolished Young-Dong Highway 205.4km Due to Heavy Rain

KyungSoo Jeon
Korea Expressway Corporation, Whasung, South Korea

RAPID RECOVERY OF DEMOLISHED YOUNG-DONG HIGHWAY 205.4KM DUE TO HEAVY RAIN

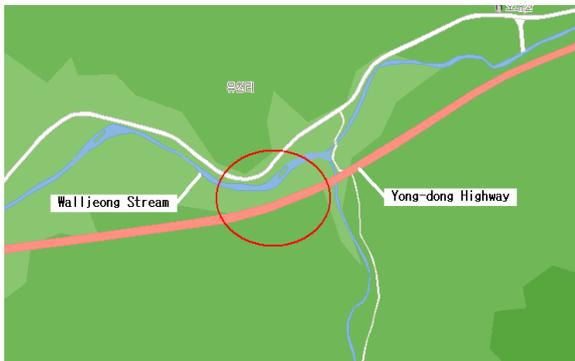
Fig.2 Geometry at 205.4k of Yong-dong highway

The destroyed location of Yong-dong highway that goes through many mountains is the westbound two lanes near 205.4km from the west end. Fig. 2 shows the westbound lane is contact on Walljeong stream, whose bed slope is 4.26% and drainage area is 130.75km². The steep bed slope of the stream makes a rapid flow in a heavy rainfall in spite of S-shape stream channel, and it makes S-shape's head sharpened. Fig. 3 shows a horizontal and vertical geometry. If the highway moved toward the mountain to escape a contact of the stream, excavation of the mountain would be higher and it would have more possibilities for rocks to fall. High mountains and deep valleys gave us a difficulty to choose highway geometry. Fig. 4 shows cross section drawings at 205.4k before the accident. The westbound lane

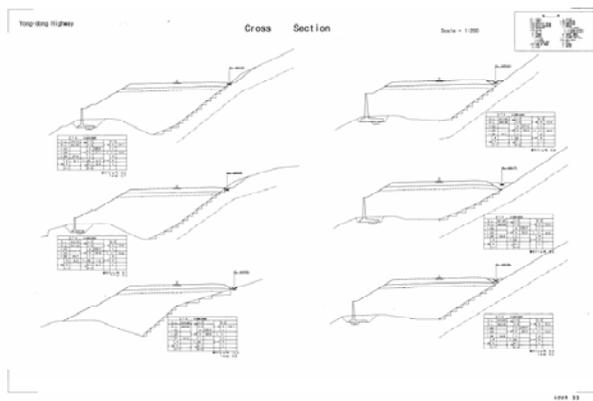
Fig.4 Cross section at 205.4km of Yong-dong highway

of the highway has concrete retaining walls and the eastbound lane is contact on mountains without excavating mountains, which have a steep slope and are very high. Most of this area is consist of granite, and lots of small rocks that are made from small wedge and toppling failure fall frequently.
