# Repair of a Failed Slope Using Geogrid Reinforcement

Pichit Jamnongpipatkul

*Bureau of Road Research and Development, Department of Highways, Thailand*

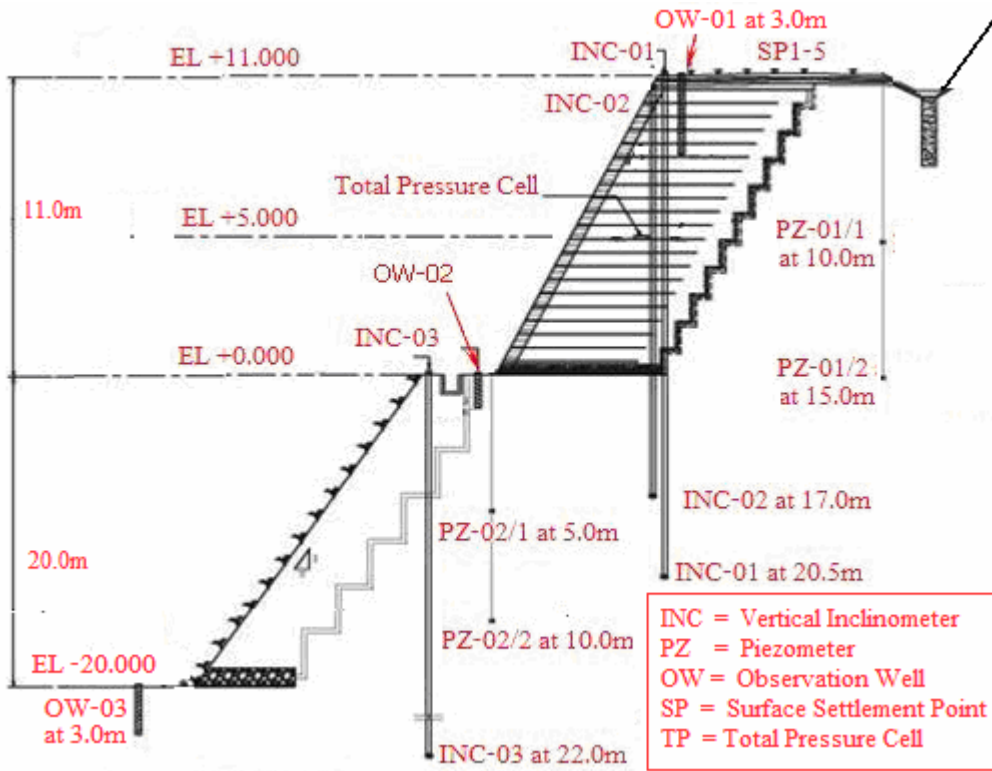
**Figure 3:** Cross Section of Instruments Installed at Test Site

At 9 months after the reconstruction, the maximum horizontal displacement of the top berm was about 470mm, which it was quite similar for the bottom berm. When considering the

vertical settlement at the top of embankment, the reading from SP1-5 showed the maximum of 32cm settlement as shown in Figure 6.

The large horizontal movement and vertical settlement were expected to be due to the underground water, which lessened the soil strength. This was confirmed by the reading of the

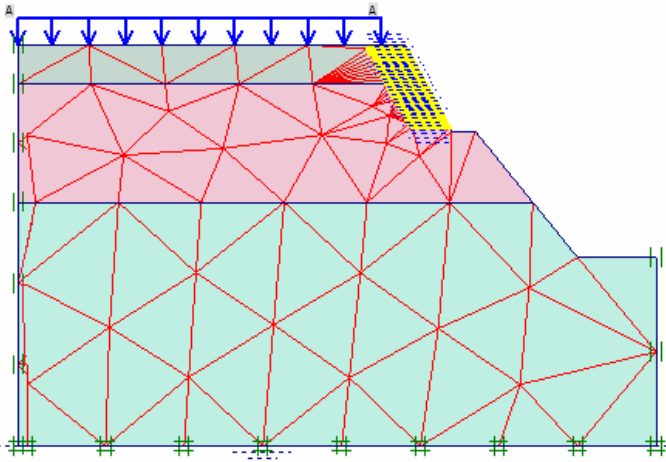
**Figure 9:** Finite Element Model (FEM) of the Sloped Embankment

In order to understand and predict the behavior of the sloped embankment, the finite element model (FEM) was modeled as shown in Figure 9.

The FEM model was calibrated with the measuring data. In the model, two experiments were conducted. The first one was the changing of ground water table, in order to see the effect of underground water on the horizontal movement of the slope. The FEM analysis showed that the higher the water table level, the higher the horizontal movement, especially when water table was higher than elevation -10.000m as shown in Figure 10 and Figure 11.
