REPAIR OF A FAILED SLOPE USING GEOGRID REINFORCEMENT

Pichit Jamnongpipatkul, Ph.D.

Bureau of Road Research and Development
Department of Highways, Thailand

Slope failures often occur in highways located in the mountainous terrain of Northern Thailand. There are several factors which induce those failures. The construction material consists of cohesionless decomposed granite. The highway embankment is steep over 30 m in height. The rainfall is very high during the monsoon season. Due to limitation of right of way, difficulty in the reconstruction and environmental consideration, geogrid reinforced embankment is introduced. The advantages of using the reinforced structure are to use less material because the very steep slope can be maintained and the vegetative cover is feasible. However, the method is expensive, economical design is necessary, i.e., very steep slope, wide spacing of geogrid and the minimum length of geogrid. The research was commenced on a selected failed slope repaired by using geogrid reinforcement. Borings were performed with soil samples taken to our laboratory to determine the engineering properties of the embankment materials as well as the soil profile of

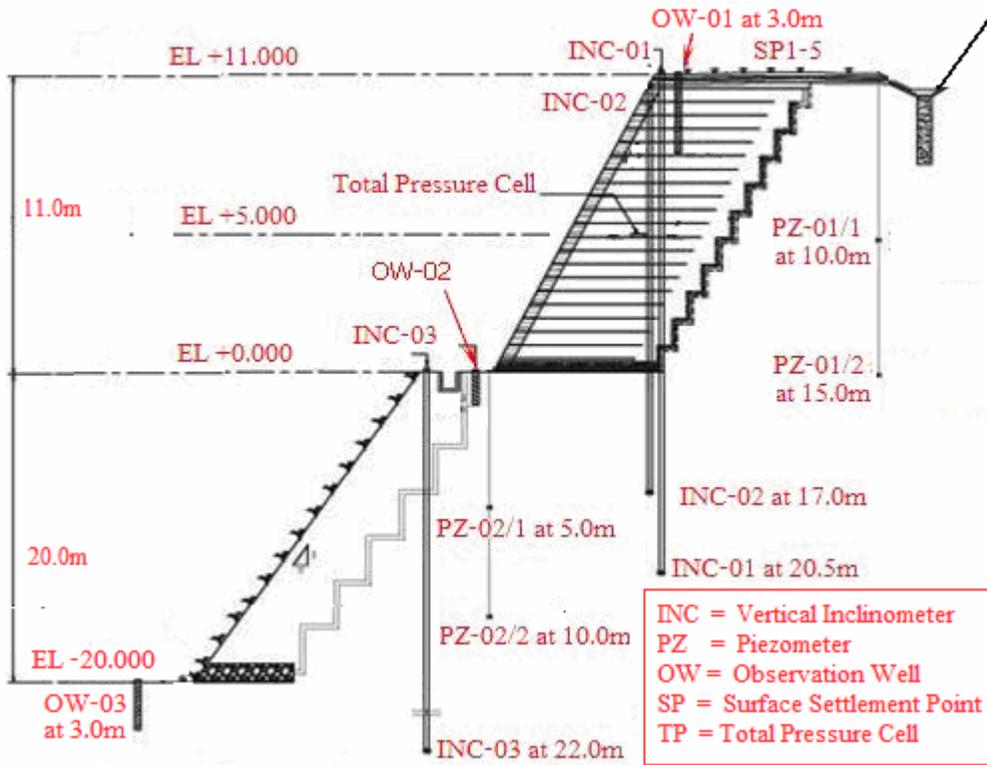
Figure 3: Cross Section of Instruments Installed at Test Site

In order to understand factors causing the failure, the Bureau of Road Research and Development hired a company to install geotechnical instruments at the site. The instruments are inclinometer, pneumatic piezometer, surface settlement plates, total pressure cell and observation well. The number and purpose of each instrument are shown in Table 1 and the layout of instrumentation is shown in Figure 3. In addition, the soil samples were collected and tested in the laboratory to determine some engineering properties

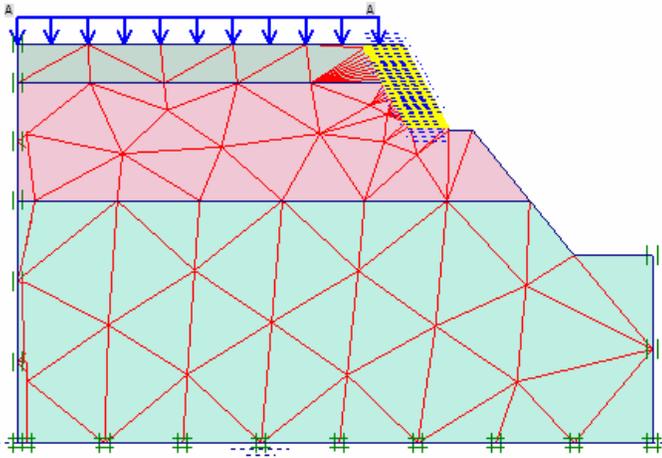
Figure 9: Finite Element Model (FEM) of the Sloped Embankment

In order to understand and predict the behavior of the sloped embankment, the finite element model (FEM) was modeled as shown in Figure 9.

The FEM model was calibrated with the measuring data. In the model, two experiments were conducted. The first one was the changing of ground water table, in order to see the effect of underground water on the horizontal movement of the slope. The FEM analysis showed that the higher the water table level, the higher the horizontal movement, especially when water table was higher than elevation -10.000m as shown in Figure 10 and Figure 11.
