FAILURE OF RETAINING STRUCTURES IN TOWN LEZHA AND THEIR CONSEQUENCE IN NEIGHBOURING BUILDING

Luljeta Bozo

Civil Engineering Faculty Tirana Polytechnics University, Albania

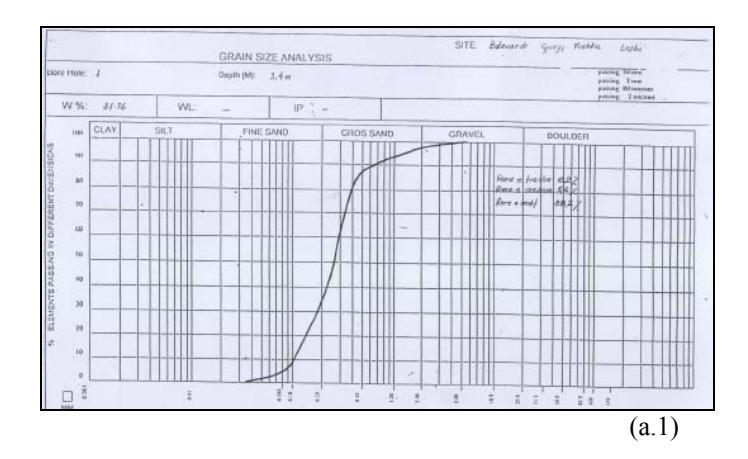
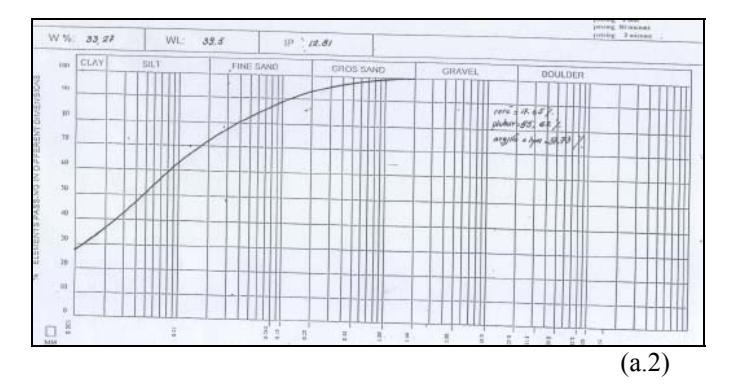
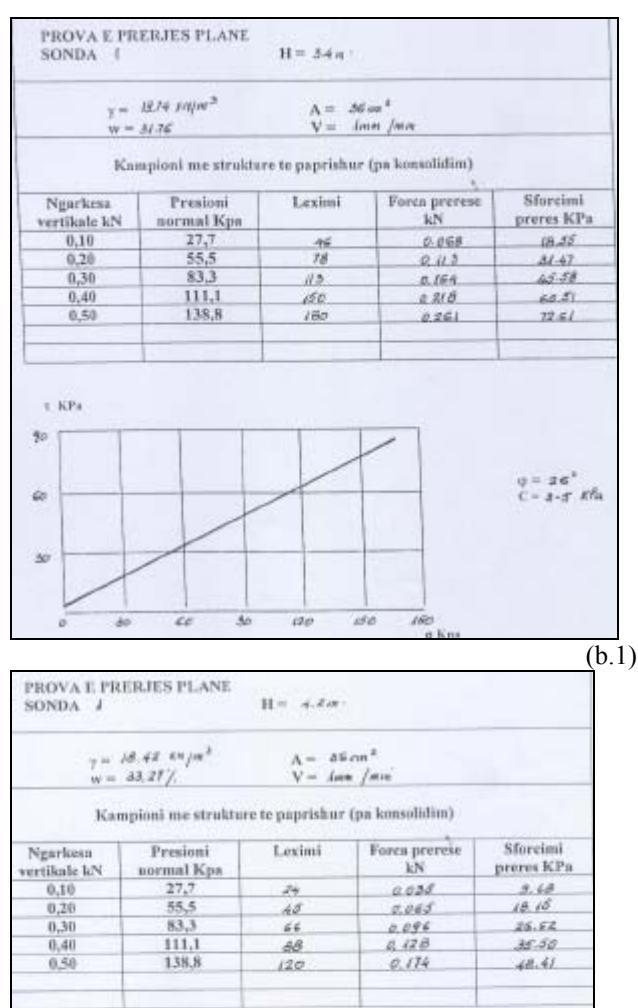
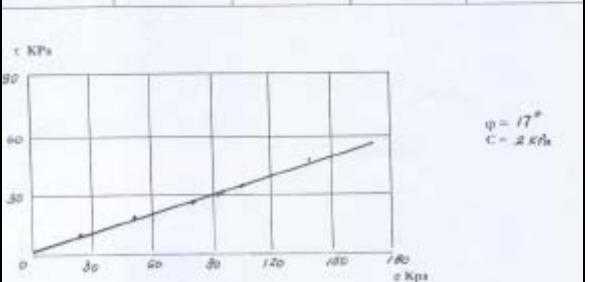
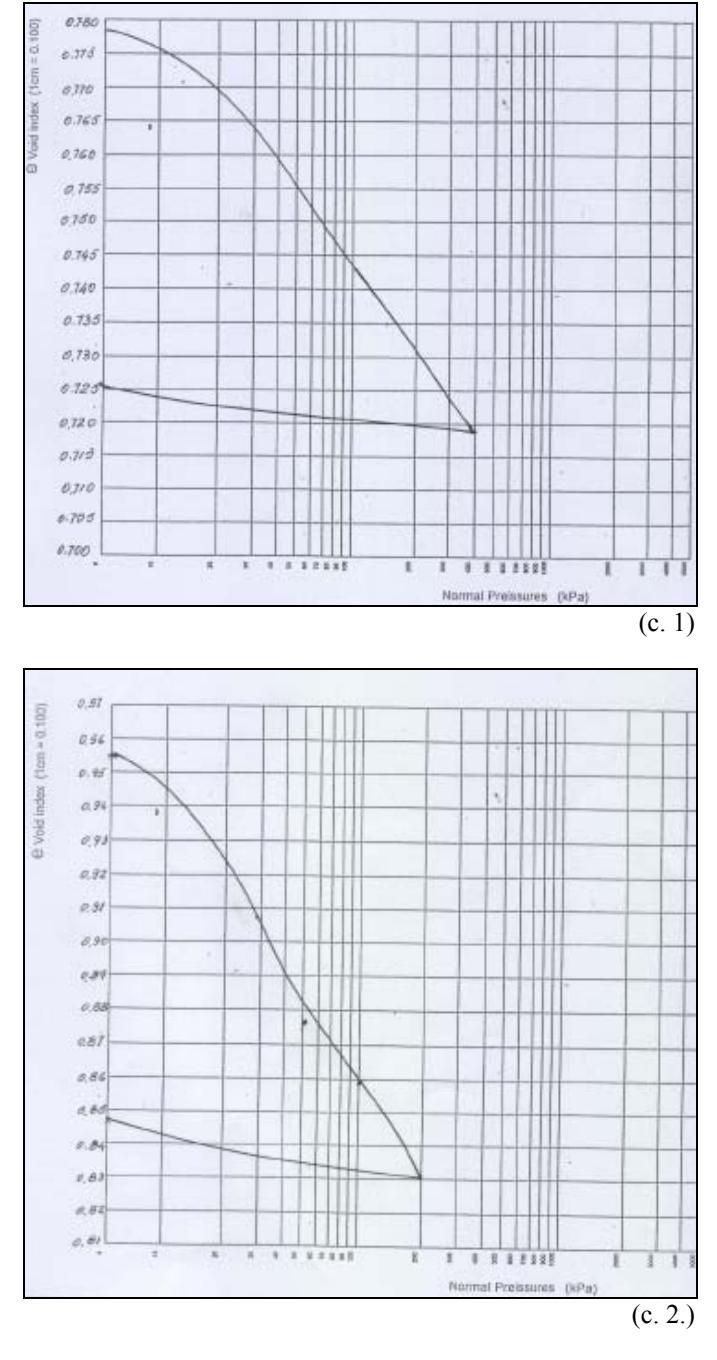
Fig. 4. Sieving and hydrometer tests at borehole nr.1 in depth 3.4m (a1) and 4.2m (a2) and shear box test at borehole nr.1 in depth 3.4m (b1) and 4.2m (b2) and oedometric test at borehole nr.1 in depth 3.4m (c1) and 4.2m (c2).

From the laboratories tests results that:

The bearing capacity of soils is for layer nr.1. R = 120-140 kPa and for layer nr.2. R = 150-170 kPa, that means these soils form a weak basement.

The soils are classified in "C" category by EC-7 and "D" category by EC-08.

This situation isn't regarded well by engineer for good design of retaining structure.
