International Conference on Case Histories in Geotechnical Engineering (2008) - Sixth International Conference on Case Histories in Geotechnical Engineering

## Lessons Learned from Two Investigation Cases of Ground Distresses Due to Deep Excavation in Filled Ground

Liew Shaw-Shong  
*G&P Geotechnics Sdn Bhd, Kuala Lumpur, Malaysia*

Khoo Chee-Min  
*G&P Geotechnics Sdn Bhd, Kuala Lumpur, Malaysia*

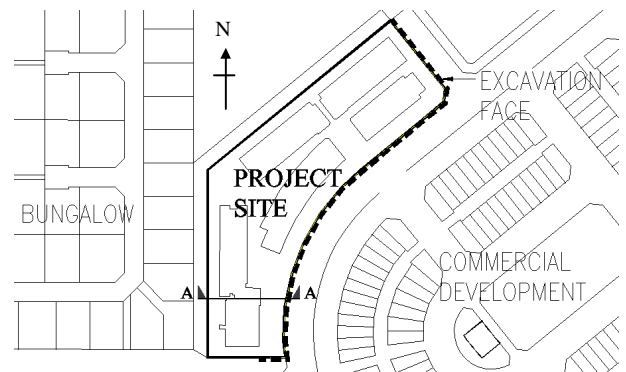
Fig. 1. Development layout.

This case history involves construction of a high-rise mixed development with a five-and-half storey basement car park adjacent to an existing commercial development. Fig. 1 and 2 show the layout and the most severe section (Cross-section A-A) of the development. The entire excavation is about 250m long over an uncontrolled fill to the depths ranging from 7m to maximum of 14.5m.

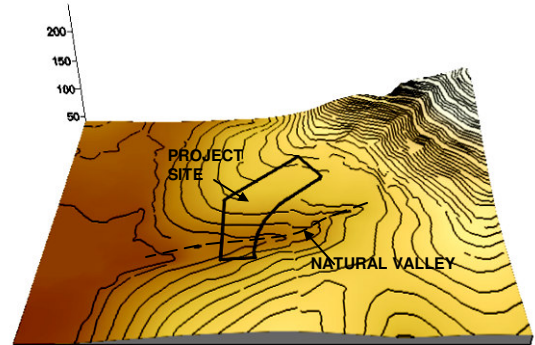
Fig. 5. Three-dimensional original ground contour.

Information obtained from the detailed site investigation revealed that the slope above the lowest proposed basement level mainly comprised of massive uncontrolled fill. At one location where ground distresses were observed in the initial stage of steep open excavation, a previous natural valley with underground stream was later discovered originating from the north-eastern hilly terrain as illustrated in Fig. 5. The adjacent commercial development had subsequently levelled a wide building platform with uncontrolled fill as thick as 15m primarily made up of loose sandy silt overlaying a thin (about 2m thick) deposited soft compressible material at the valley area.

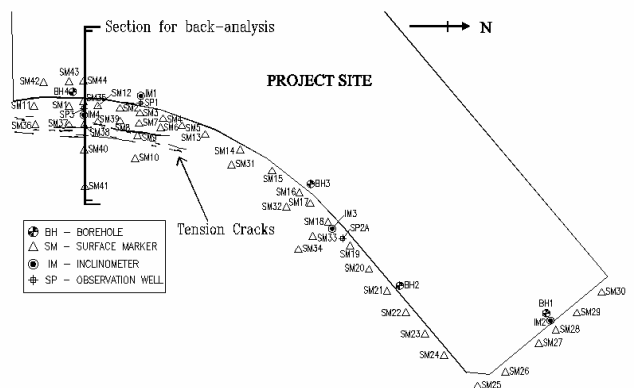
Fig. 6. Subsurface investigation and instrumentation layout.

Subsurface investigation (SI) was carried out to establish the subsurface conditions for the geotechnical investigation and remedial design. The SI layout is presented in Fig. 6 together with the instrumentation layout. Figure 7 shows the interpreted boreholes logging. The fills material mainly consists of sandy silt with SPT-N values generally ranging from 0 to 20. A layer of soft material was detected at the depth of 12m to 15m below the ground surface in two boreholes (BH-IM1 and BH-IM4) within the distressed soil mass, which was overlying the natural valley in the pre-development topographical condition. The existence of this soft compressible material was further confirmed during an additional subsurface investigation when excessive lateral movements were detected in the subsequent staged excavation.

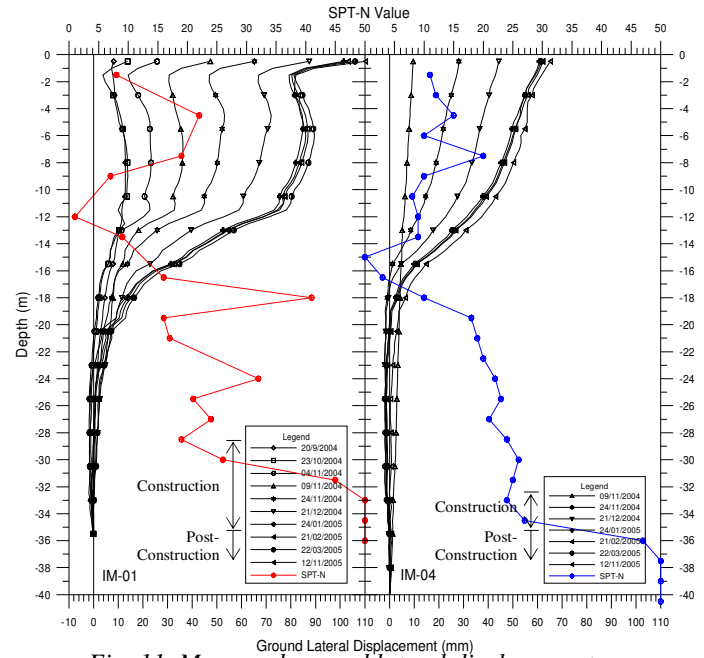
Fig. 11. Measured ground lateral displacements.

Figure 11 shows the monitored soil nailed slope movements during various stages of excavation. While the cumulative ground settlements behind the soil nailed slope are shown in Fig. 12. Groundwater levels had generally been monitored from the installed observation wells throughout the construction period. Figure 13 shows the measured groundwater levels over time.

From the monitoring results, the ground lateral displacement and settlement had stabilised with no appreciable further deformations after the completion of slope stabilisation works. In addition, the groundwater was observed achieving steady state equilibrium even after reaching the the final excavation.

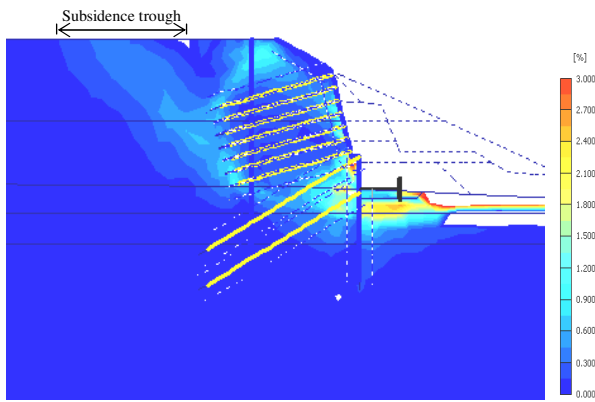
Fig. 14. Shear strain of soil mass within the soil nail reinforcing system.

Subsidence troughs developed on the retained ground surface has been observed from the FE back-analysis results (see Fig. 14). The results show that surface subsidence is generally expected at a distance of 8m from the excavated face, which tallies extremely well with the site conditions as demonstrated in Fig. 15. The location of the trough is just immediately behind the end of the soil nail where a relatively large shear strain is developed along the potential slip surface behind the reinforced soil mass. This is fairly close to the formation of an active wedge in the retaining wall design. Two major tension cracks signify the extent of the developed active wedge behind the reinforced slope mass.

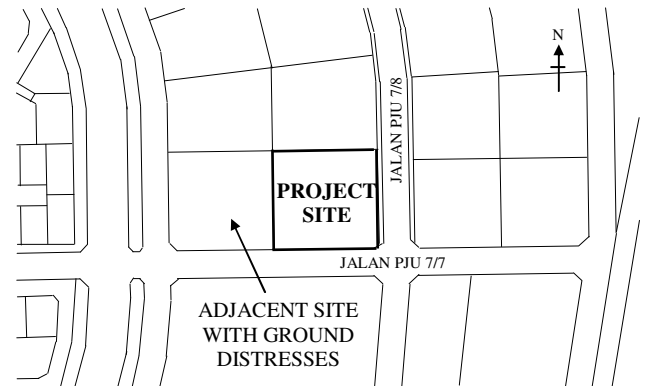
Fig. 16. Site location.

This case history involved construction of a two-storey basement in an urban area. The scope of investigation was to evaluate the conditions of a distressed temporary shoring structure, investigate the probable causes and subsequently to propose remedial options. Figure 16 shows the location of the project site and the adjacent land lot which had been affected due to ground distresses.

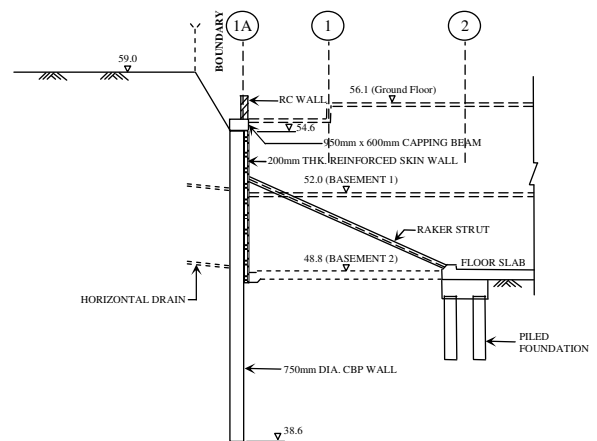
Fig. 17. Cross-section of the proposed alternative retaining walls.

Temporary shoring structure consisting of contiguous bored pile (CBP) wall propped by raking struts against lower basement slab was proposed by the contractor to provide peripheral soil support for the 10.5m deep excavation at western boundary. The designed CBP wall is of 16m long 750mm diameter bored pile with cut off level at RL 54.6m. In order to facilitate the CBP installation, 12m long temporary steel sheet piles (type FSP IIIA) were driven from RL 59.0m at about 0.7m offset away from boundary to provide sufficient working platform and as the temporary shoring support for the exposed 4.4m temporary excavation (from RL 59.0m to RL 54.6m). Figure 17 shows the details and cross-section of the proposed alternative temporary shoring system and permanent retaining wall.

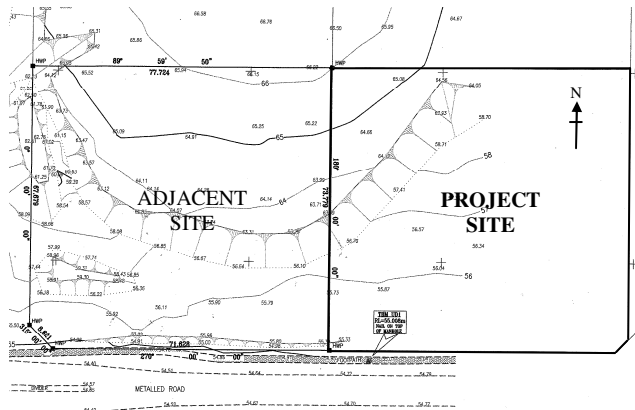
*Fig. 18. Topographical survey plan of adjacent lot (subject to disturbance before the finished level).*

Based on the topographical survey plan of adjacent lot, which was believed to be the condition before the earthworks, part of the proposed site (i.e. at north-western side) is of sloping terrain from approximately RL 65m to RL 56m. There is a 6m high cut slope existed within this sloping ground as indicated in Fig. 18.

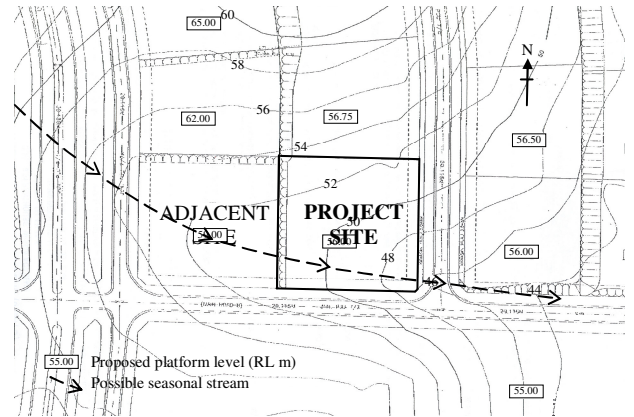
*Fig. 19. Regional major earthworks layout with contour lines.*

Based on the original topographical of the pre-development condition as shown in Fig. 19, the contour lines for both the adjacent lot and the proposed site range from RL 54m to RL 47m. As such, it is evidenced that earthworks had previously been carried out at these areas to raise the building platform level to RL 59.0m and RL 56.0m for the adjacent lot and the proposed site respectively. Both of the sites are on filled platforms. Particularly, the distressed area was located at the valley where thicker fill was placed. High potential of saturation of fill due to perched groundwater seepage after filling in the previous valley terrain can be expected if subsurface drainage is not provided.

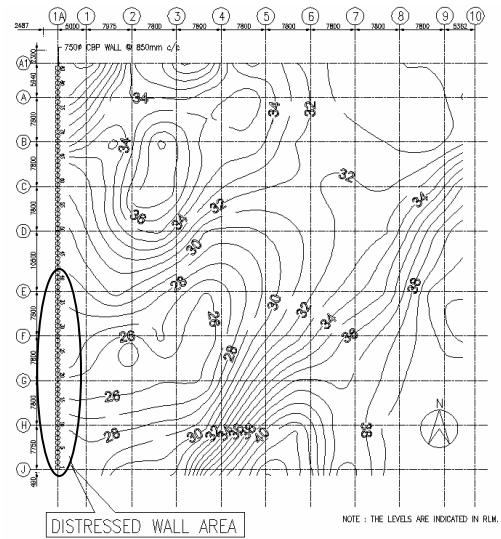
*Fig. 20. Interpreted contour of hard stratum from piling information.*

In addition to the topographical map, assessment on the piling information was carried out to reveal the soil consistency profile within the site as shown in Fig. 20. It was found that the distressed ground and retaining wall areas correspond well with the expected thicker fill and deeper weathering profile at the valley area as discussed.

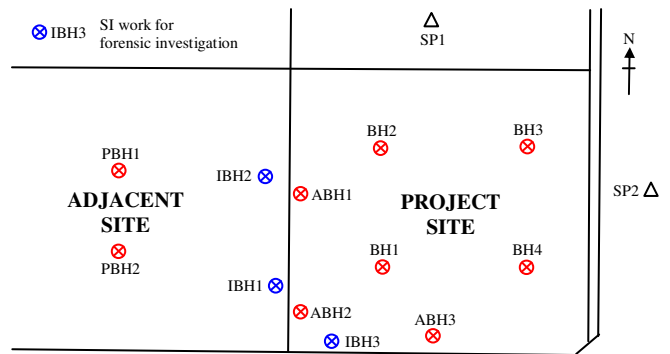
Fig. 24. Subsurface investigation layout.

Before the wall and ground distresses, two stages of subsurface investigation (SI) works were carried out at the proposed site. The second stage SI works is the additional SI conducted at the perimeter western boundary for the alternative basement wall design by the contractor. At that time, no much attention was given in identifying the weak deposits between the original ground and the platform backfill. The SI layout is shown in Fig. 24.

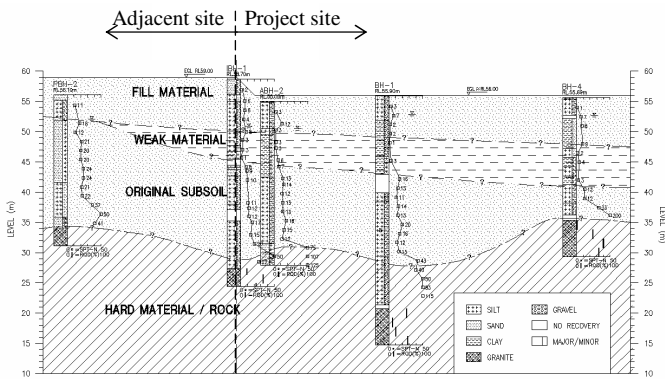
Fig. 25. Typical cross-section of subsurface profiles at the distressed wall area.

After the incidence, additional three boreholes were sunk within the distressed wall area to investigate the subsurface profile and to install instruments for construction monitoring. In particular, a layer of 6-9m thick of very soft to soft sandy/silty clay (SPT-N <= 4) was encountered from RL 52m to RL 43m as detected in the few boreholes near to the distressed wall area. Generally, SPT-N values of the subsoil range from 3 to 6 at the top 13m of the subsoil and gradually increase with depth thereafter. This implies that the top layer of subsoil is most probably of fill material underlain by the

soft deposits in the valley. A typical cross-section of subsurface profiles at the distressed wall area is shown in Fig. 25.

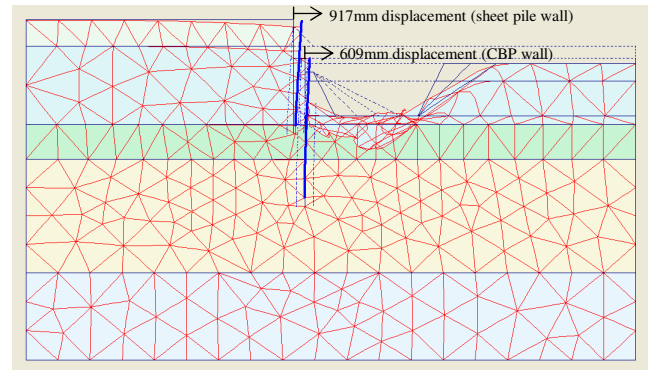
Fig. 26. Results of finite element analysis.

In order to confirm the probable causes of ground distresses and wall movement, Finite Element (FE) analysis using computer software “Plaxis” was performed independently based on the subsurface profile as shown in Fig. 26. The construction sequences of excavation were simulated in the FE analysis.

At one analysis stage where over-excavation in front of the wall was carried out, the analysis results revealed that the retained earth platform displaced excessively in the horizontal and vertical (settlement) directions with the temporary sheet pile retaining wall moving forward. As part of the lateral resistance to the temporary retaining walls by the passive berm was removed before installation of raking strut, over-excavation of this berm had reduced the lateral resistance to the sheet pile wall and subsequently mobilises the resulting strength of the retaining walls from serviceability state condition towards the ultimate limit state condition. The excessively displaced temporary sheet pile wall had induced additional lateral force to the installed contiguous bored piles (CBP) walls. The high induced flexural stress unavoidably damaged the CBP pile and led to excessive ground distresses. The results of FE analyses (see Fig. 26) reasonably well agreed with the measured wall movements and ground deformations (e.g. tension cracks, settlement and depression).
