A Case Study on Rectification of Damaged Structures on Expansive Soil Deposits

A CASE STUDY ON RECTIFICATION OF DAMAGED STRUCTURES ON EXPANSIVE SOIL DEPOSITS

J.M. Kate

Indian Institute of Technology, Delhi
New Delhi – 110016, India.

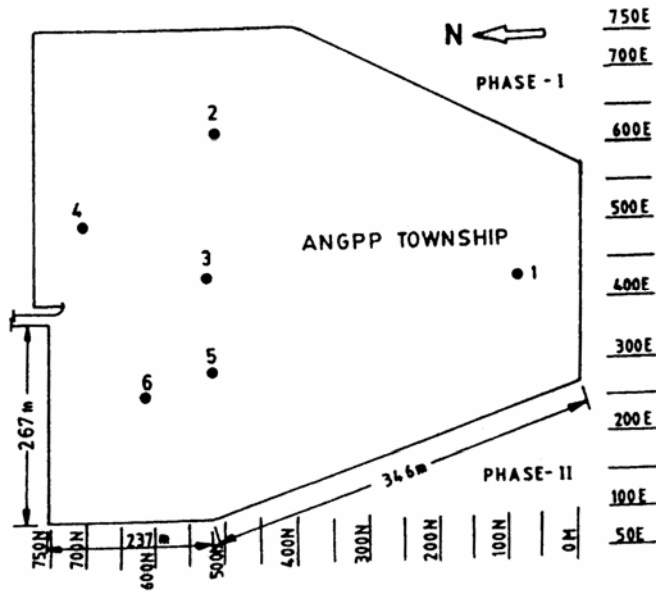
Fig. 1. Locations of boreholes for soil sampling.

At these locations, during September 1995 boreholes of 15 cm diameter were drilled to a maximum depth of 2.50 metre using auger. The exploratory depths of these bore holes were decided on the basis of generalised subsurface profile of the area, which is discussed in the subsequent section. Undisturbed soil samples were obtained from the depths of 0.75, 1.50, 2.25 and 2.50 metres below ground level (GL) in sampling tubes (around 10.5 cm internal diameter and 30 cm length). Representative soil samples in substantial quantity from various depths were also collected during augering operations.
