International Conference on Case Histories in Geotechnical Engineering (2008) - Sixth International Conference on Case Histories in Geotechnical Engineering

Evaluation of Damage to a Road and Sports Complex on Expansive Clays

EVALUATION OF DAMAGE TO A ROAD AND SPORTS COMPLEX ON EXPANSIVE CLAYS

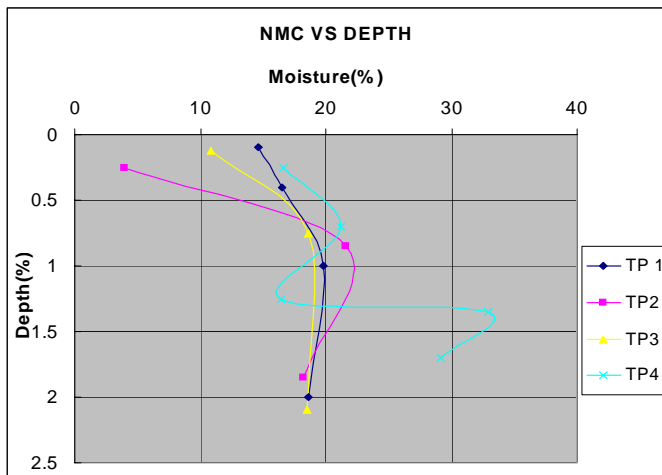
Fig. 10. In situ moisture content versus depth

In general the moisture contents tend to increase with depth as would be expected from soils sampled during the early stages of the dry season. The wettest soil was recorded at TP4 which was excavated one meter away from the foundation of the Administration building. The pit was located on the south side of the structure in an area that received little direct sunlight during the day. Fig. 10 illustrates the relationship between the moisture content and depth.

The “equilibrium” moisture content (into the dry season) appears to be about 18 to 20 per cent. The wet material from TP4 had a moisture content of about 30 per cent, which is probably close to the equilibrium moisture content during the wet season but is somewhat lower than the data determined for the road in Ethiopia (Case I) where the average moisture content at a depth below one meter was closer to 50%. This is in line with the generally higher Liquid Limits and Plasticity Indices determined on the Ethiopian materials. The moisture content of the oedometer samples after full saturation varied between 30 and 44 % with a mean of 38 %, indicating that volumetric changes would typically occur on site as the moisture fluctuated between about 18 and 30 %, unless full saturation at depth occurred and was constant, which is unlikely.

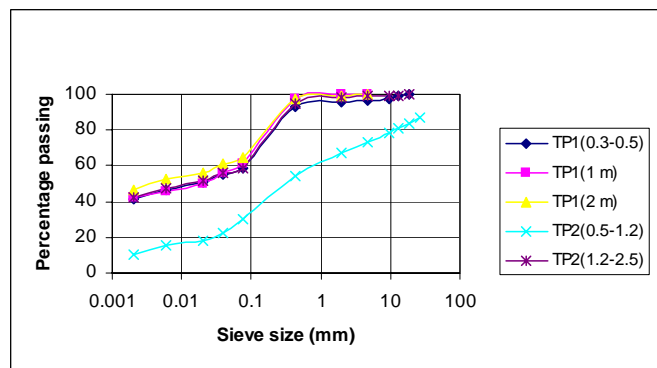
Fig. 11: Particle size distribution of test pit samples

The particle size distribution curves are given in Figs. 11 (TP1&TP2) and 12 (TP2, TP3 & TP4).

The results show that except for the imported materials from TP2 and TP4; which were classified as silty or clayey gravel and sand; the rest of the materials tested were classified as clayey soils with greater than 35 per cent passing the 75 micron (No. 200) sieve. The materials are classified as A-7-6 using the PRA Soil Classification System.
