Forensic on Construction Induced Failure of Pipe Pile Foundations

Xiong Bill Yu

Yuewen Huang

FORENSIC ON CONSTRUCTION INDUCED FAILURE OF PIPE PILE FOUNDATIONS

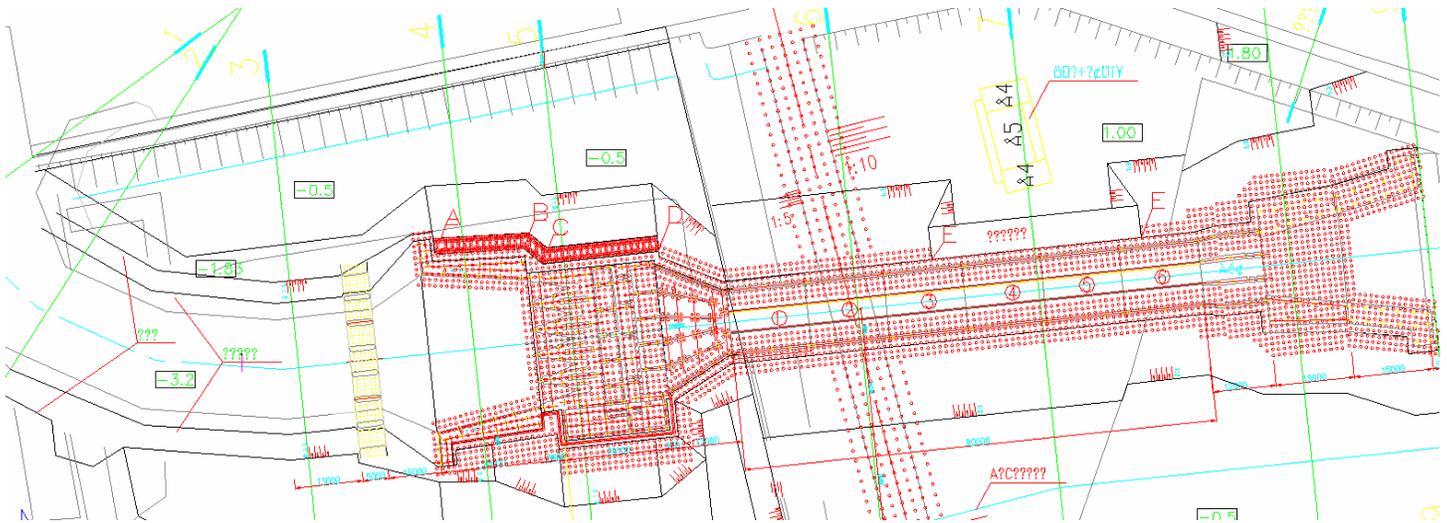
Fig. 1 Schematic design of Jiaoxi pump station

Jiaoxi pumping station is located in the Nansha District of Guangzhou city in the southern province of Guangdong, China. It belongs to part of a comprehensive hydraulic project for JiaoMen Canal. A schematic of the pumping station design is shown in Fig. 1. It includes wing-wall, house of pump station, and transition inducts, and sluice etc. Deep foundation was selected due to the thick soft soil layer, which involved the use of pre-stressed concrete pipe piles to reduce structure settlement. Prior to installing the pipe piles, the ground under pumping station was treated by cement deep mixing. The diameter of these cement deep mixing columns
