International Conference on Case Histories in Geotechnical Engineering (2008) - Sixth International Conference on Case Histories in Geotechnical Engineering

Need for Prior Geotechnical Engineering Studies for Foundation Design: Cases of Collapsed Buildings in Port Harcourt and Environs, Nigeria

NEED FOR PRIOR GEOTECHNICAL ENGINEERING STUDIES FOR FOUNDATION DESIGN: CASES OF COLLAPSED BUILDINGS IN PORT HARCOURT AND ENVIRONS, NIGERIA

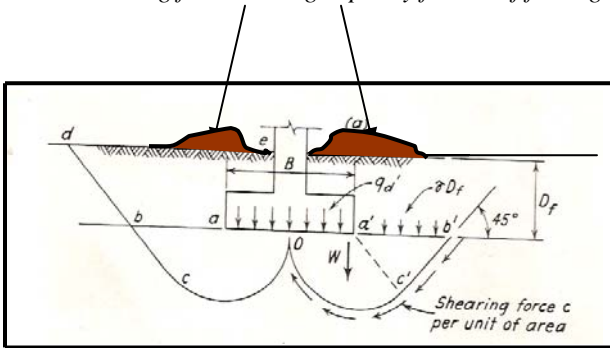
Bearing Capacity (heave) Failures. Bearing capacity failures occur usually when the bearing capacity of the soils at the foundation level is less than the imposed load on the soil. Such failures are usually followed by “heave” outside the buildings signifying the extrusion of soils from under the foundation levels.

Figure 1: Bearing Capacity failure arising from “heave”
(adapted and modified from Peck, Hanson and Thornburn, 1974)

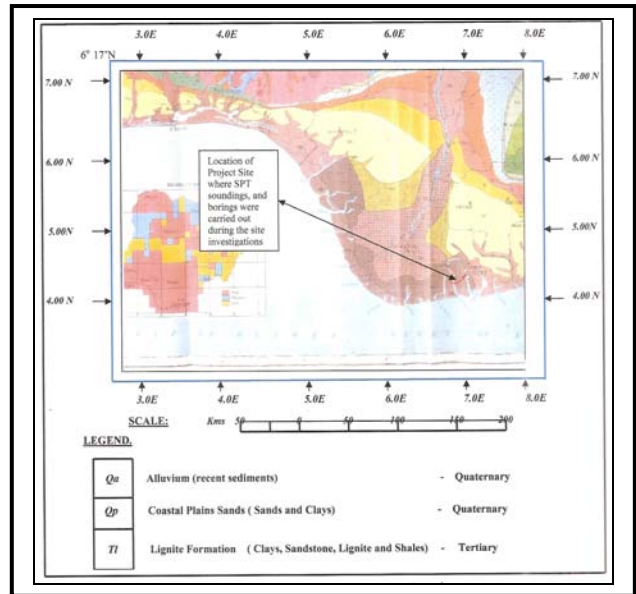
Local Geology. The local geology of the project areas is basically that of the Coastal Plains Sands (Qp) of the lower Quaternary (Pliocene-Pleistocene) and Alluvium of upper Quaternary (Recent sediments). (Geological Map of Nigeria

Fig. 4. The geological sequence at the project sites
