International Conference on Case Histories in Geotechnical Engineering (2008) - Sixth International Conference on Case Histories in Geotechnical Engineering

UNEXPECTED CAISSON PROBLEMS, SOIL STRUCTURE INTERACTION PREDICTIONS AND REQUIRED GROUND MODIFICATION

ABSTRACT

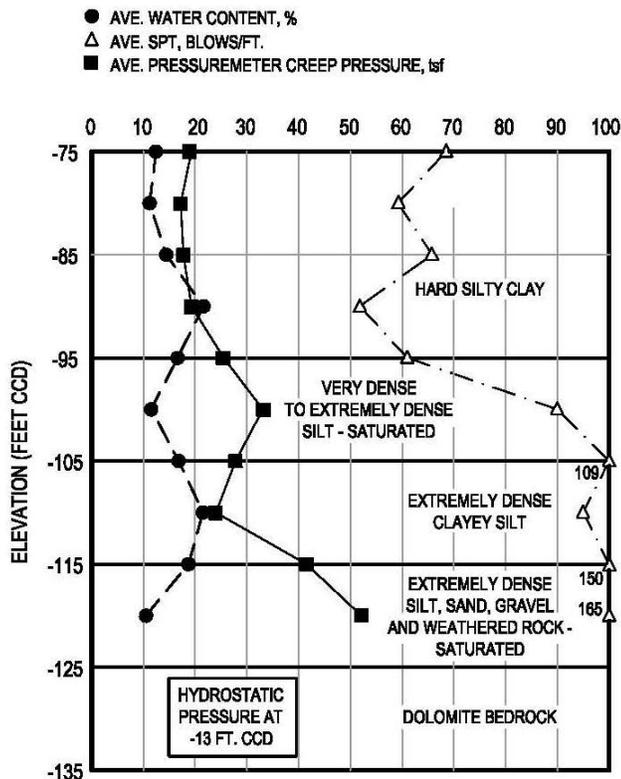
Fig. 1. Soil Profile based on Initial Subsurface Exploration

The building site had previously been occupied by a 3-story building on footings and a 4-story building on small diameter belled caissons. A previous investigation was performed at the site for a proposed 9-story building. Information from a number of projects within one block of the site included a total of 45 soil borings that were extended at least to the hardpan layer with some extending to the deeper underlying dolomite. An additional 5 borings were performed at the site (1 before building demolition and 4 after). The anticipated soil profile based on all of the available boring information is shown in Fig. 1.

The soil property information below -75 feet CCD at the time of design is summarized on Fig. 1.

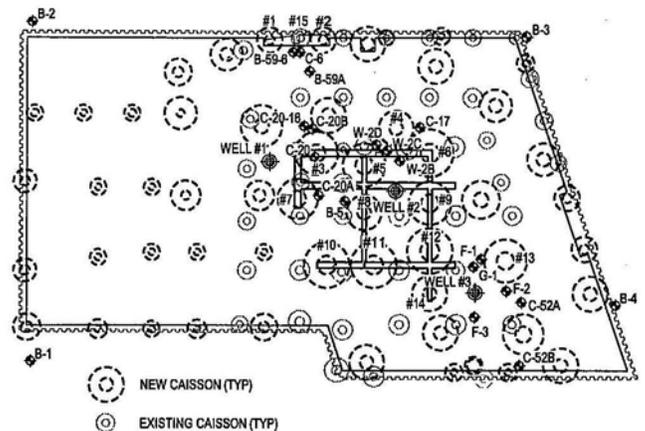
Fig. 4. Site Plan and Soil Boring Locations

The locations of the caissons, wells and soil borings are shown on Fig. 4. The compaction grout injection points and grout take summary are shown on Fig. 5. The grout take volumes indicate that the cave-in was not necessarily uniform around the shaft.
