GEOTECHNICAL FAILURES CAUSED BY HUMAN ERRORS

Marek Tarnawski

West Pomeranian Technical University
Szczecin, POLAND 70-311

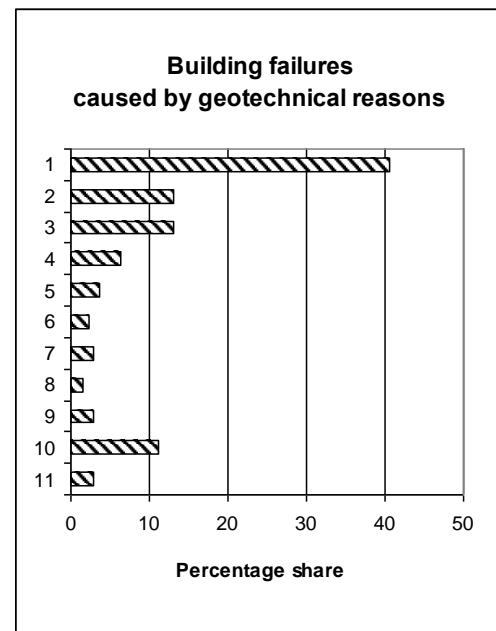
Fig. 2. Geotechnical reasons of the building failures according to ITB data.

1. Errors in design
2. Errors in construction works
3. Excavations made nearby
4. Leaks in water-sewage system
5. Drop of ground water level
6. Washing by river or sea water
7. Mining damages, vibrations, earthquakes
8. Landslide processes
9. Shrinkage and swelling of expansive soil
10. Karst and other geological threats
11. Quasi-geotechnical failures.

Errors in designing are definitely at the first place (> 40%). Adding (inappropriately secured) excavations carried out nearby to the mistakes in „our own” construction works (both are contractor errors, in fact) as well as leaks in water-sewage system and dewatering works we will obtain more than 36 % altogether and the second place among the reasons of building disasters and failures of geotechnical base.

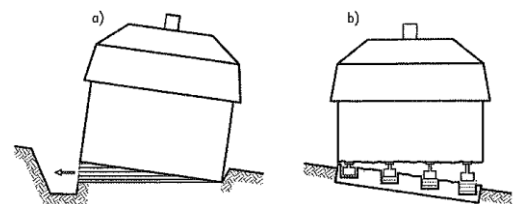
Tilt of building structures is obviously an often phenomenon in the areas of mining exploitation. Strong structures may not be damaged then, but when inclination exceeds 25 mm/m their further use is impossible both due to reduction of their serviceability and overall safety. However, tilt can be eliminated. Rectification can be carried out by removing soil from under higher positioned part of the structure (Fig. 8a) or by lifting the lower part by lifts (Fig. 8b).

Fig. 8. Schemes of basic methods of inclined structures rectification (Gromysz, Niemiec 2007).
