## Analysis of Piled-Raft Foundation for CAI MEP Container Port, Vietnam

## ANALYSIS OF PILED-RAFT FOUNDATION FOR CAI MEP CONTAINER PORT, VIETNAM

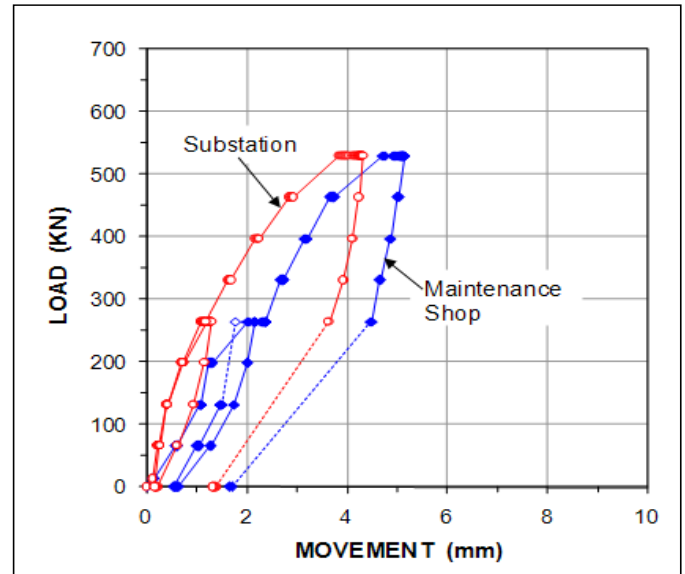
Fig. 3. Pile-head load-movement curves from static loading tests performed 17 days after driving

The total number of piles supporting the Maintenance Shop and Substation buildings was 256 and 52, respectively. The average pile spacing center-to-center was about 2.7 m and the pile to building footprint ratios were 2.4 % and 2.0 %, respectively. On September 17, 2010, about three months after the surcharge had been removed, two 400 mm diameter piles were driven at each building location to an embedment of 18.4 m and 18.8 m embedment depth, respectively. Seventeen days later, a static loading test was performed on each test pile to twice the intended working load of 265 kN. Figure 3 shows the pile-head load-movement curves of the tests. The tests indicated that the piles showed no sign of having exceeded or even reached capacity. Therefore, all piles for the buildings were chosen to be 18 m long. The production piles were driven during November 16 through December 01, 2010.
