GROUND HEAVE DUE TO JET GROUTING NEAR AN EXISTING STRUCTURE

Renovations of the MBTA Copley Station in Boston included construction of a new elevator shaft to improve disabled access to the existing Green Line station. The site is immediately adjacent to the Eastern façade of the historic Old South Church. The construction work required excavation support including a perimeter secant pile wall and a jet-grouted base plug. Significant ground and structural movements were observed during jet grouting, mainly associated with soil displacements during grout injection. A three dimensional numerical model was developed, using the Plaxis 3D Foundation™ program, in order to test the hypothesis that the observed movements of the structure could be associated with the installation of the jet grout piles. The amount of volume expansion associated with installation of jet grout piles is estimated based by calibrating the model to measured ground movements. The finite element model results give a consistent explanation for the observed pattern of movements, including the heave of the church wall and lateral displacements at inclinometers located within the vicinity of the structure, measured at

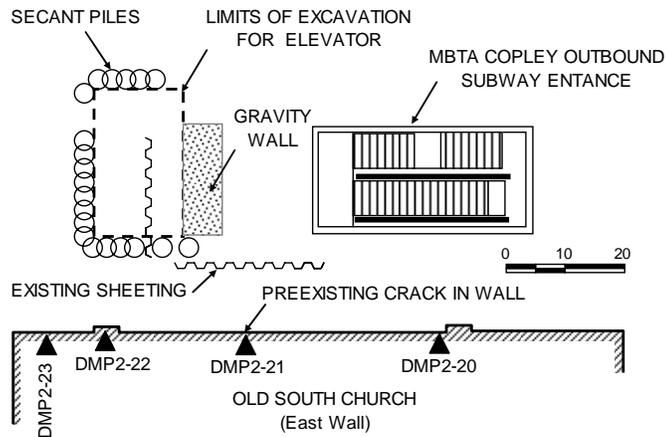
Fig. 1. Site plan

The Copley Station of the MBTA Green Line abuts the Old South Church (OSC); a historic structure built in 1874. Renovations to the Station included an elevator for handicapped access to the outbound platform (Fig. 1). This project involved excavations for a vertical shaft to the existing underground station. The Contractor’s system for Support of Excavation (SOE) included a perimeter secant pile wall along the Northern, Eastern, and Western limits of the excavation, with jet grout columns at perimeter locations. The Southern limit includes a flow-fill gravity wall cast above the existing station. The base of the shaft is also stabilized using a series of jet grout columns that cutoff groundwater seepage and provide foundation support. There was no provision for relocation of utility lines associated with the contract.

measured at several displacement measuring points (DMP, Fig. 1). The ground and structural movements were attributed to jet grouting activities for the new elevator shaft that were on-going at the time. Subsequent investigations focused on possible mechanisms causing the movements including detailed inspections of the OSC foundations (involving load testing of several timber piles), an extensive geotechnical site investigation, and implementation of a sophisticated instrumentation program to monitor for any further ground or structural movements. After establishing that movements had stabilized, the below grade works resumed in November 2009 using a revised construction sequence. With careful planning and execution, the elevator shaft was completed in April 2010, with no further movement or damage to the Old South Church. This paper summarizes the development and validation of a 3-D model of the soil-structure interactions that was carried out to test the hypothesis that the observed movements of the OSC could be associated with the installation of the jet grout piles.

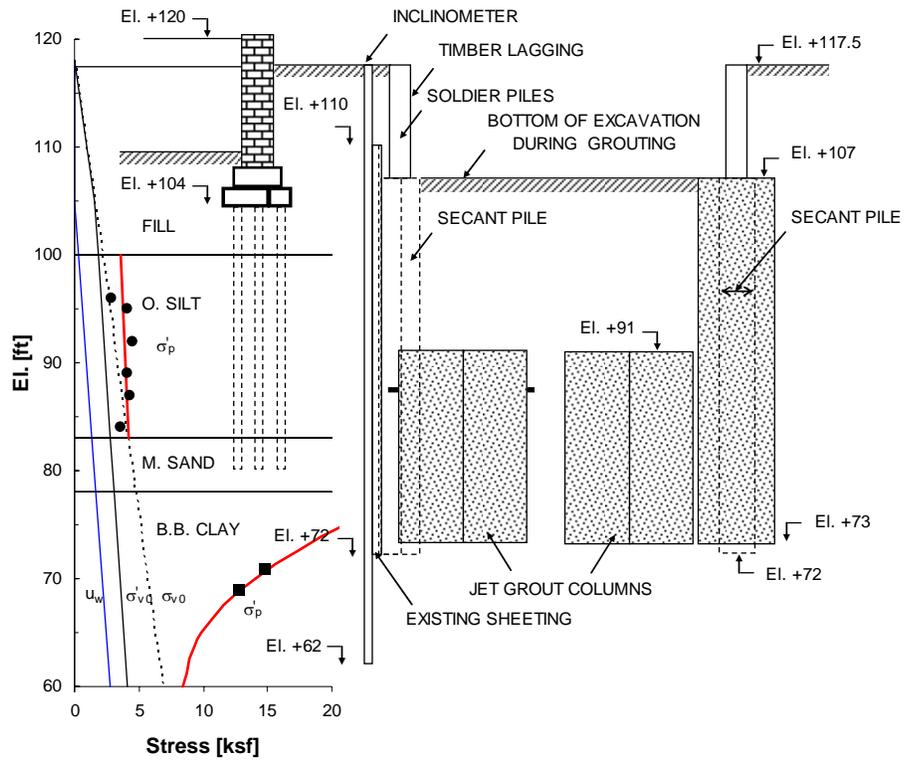
Fig. 3. Typical soil profile, OSC foundations and excavation support for elevator shaft

Figure 3 shows the typical soil profile, together with a vertical section showing the excavation support system for the elevator shaft and pile foundations of the Old South Church.

The ground surface is level at El. +117.5 ft. The average soil profile at the site is comprised of an 18-ft thick layer of dense sand and gravel fills (average $N = 44$ bpf), an organic silt unit of similar thickness ($N = 6$ bpf), and a 5-ft thick layer of very dense marine sand ($N = 72$ bpf), underlain by Boston Blue Clay (BBC). Groundwater conditions are assumed to be hydrostatic with a seasonally-averaged groundwater level located in the fill at El. +105ft. Laboratory tests conducted on samples from the forensic site investigation (September 2009) shows that the organic silts are lightly overconsolidated with an average $OCR = 1.70$, while the upper BBC is desiccated and more highly overconsolidated ($OCR \geq 5$).

The timber piles are assumed to extend 2ft into the very dense marine sand layer. Assumed pile properties are summarized in Table 2. The pile tops are modeled fully in contact with the overlying pile cap, this was confirmed by test pits performed during the forensic site investigations. These investigations also revealed a remnant sheet pile wall located around the existing subway entrance structure, Figs.1 and 7. This sheeting (section PZ-27) is assumed to extend to El. +72 ft, with an upper cutoff at El. +110 ft. The sheet pile wall is assumed to have elastic properties.

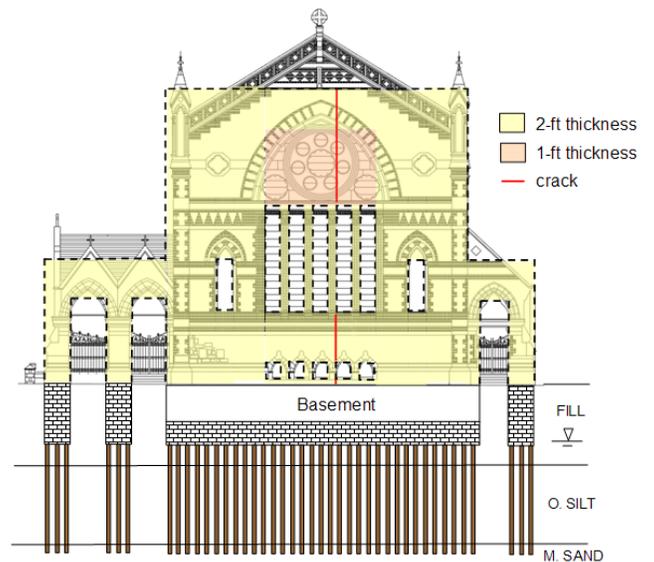
Fig. 5. FE representation of East Wall

Due to limitations in the capabilities of the FE program used in the current analyses (Plaxis 3D Foundation™, v2; Brinkgreve & Swolfs, 2007), only horizontal planes and lines are allowed in the model. Figure 5 shows a representative model of the East Wall, where a vertical crack is introduced at the observed location. The model approximates the crack pattern with a continuous vertical through-crack. This approximation captures the lack of continuity between the two wall “blocks”, as well as the intersection of the discontinuity line at the ground corresponding to a point of rotation when deformations take place.

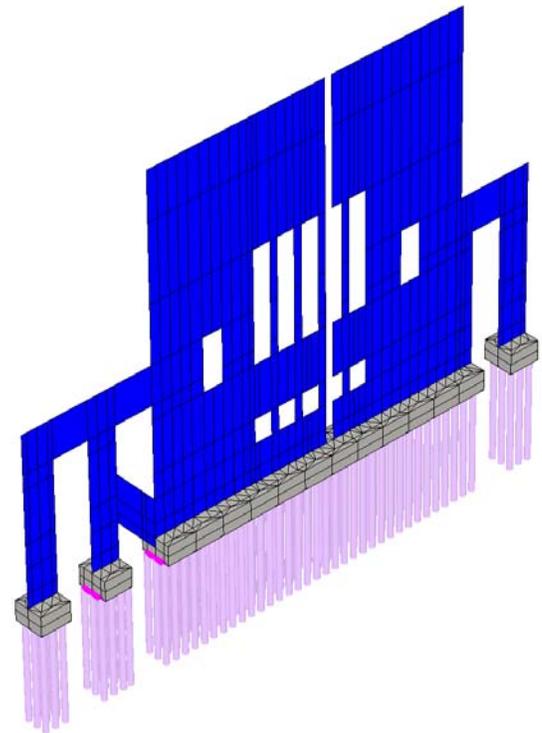
Fig. 6. East wall and foundations – FE Model

Figure 6 shows a 3D view of the FE model of the East wall and foundations, where the vertical crack is shown as a vertical discontinuity. Piles are modeled by means of embedded beam elements, connected to a granite pile cap that supports the church wall. Additional connection elements are included in order to provide a smooth transition of forces between these elements, without significantly altering the overall behavior of the foundation-wall system.

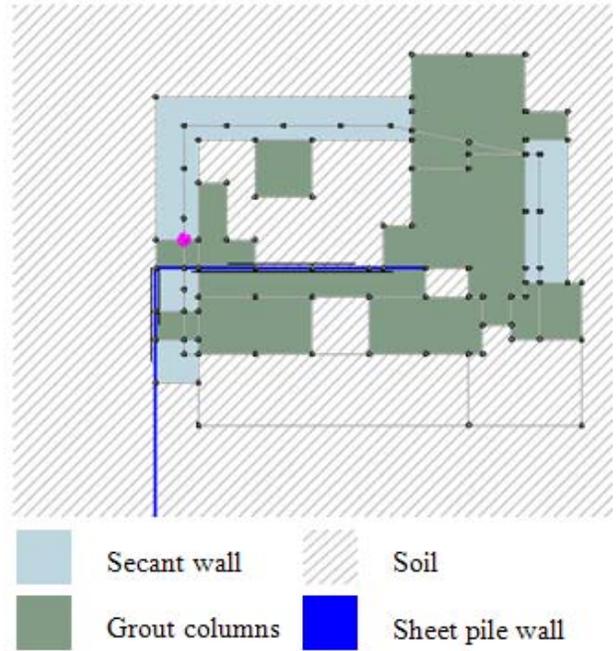
Fig. 9. Plan view of FE representation of jet grout piles installed through Dec. 2008

Figure 9 shows a plan view of the FE model of support elements for the elevator access shaft.

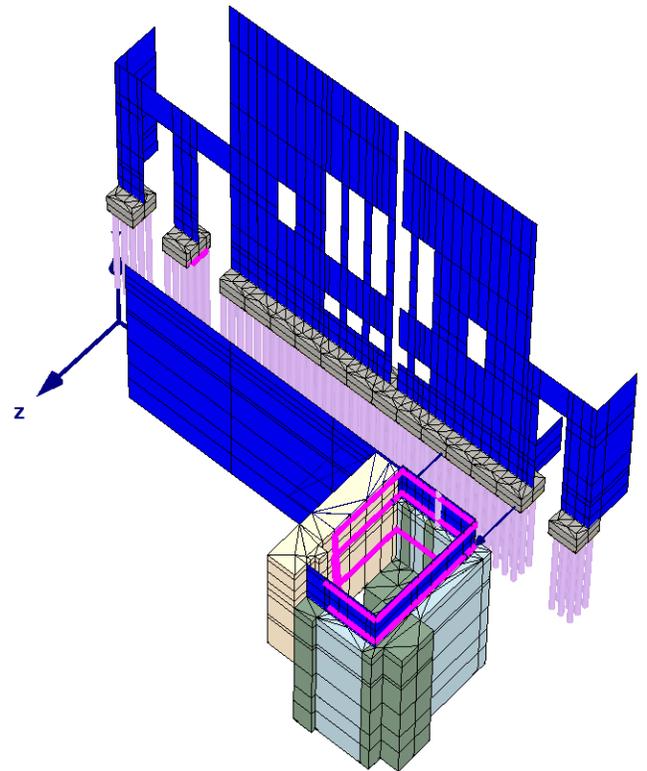
Fig. 10. FE model showing all structural elements for support of the elevator access shaft and Old South Church façade

Figure 10 shows an isometric view of the complete structural model, highlighting the relative positions of the elevator access shaft, the pile foundations and eastern façade of the Old South Church.
