(2013) - Seventh International Conference on Case Histories in Geotechnical Engineering

Accumulation of Rainfall in the Permeable Fill Behind a Soil Nail Wall

ACCUMULATION OF RAINFALL IN THE PERMEABLE FILL BEHIND A SOIL NAIL WALL

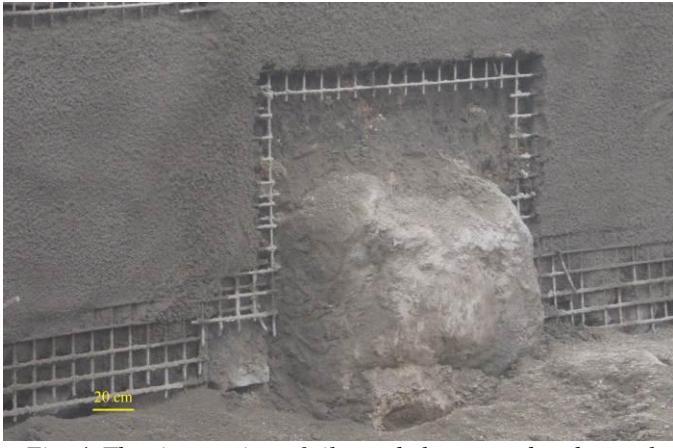
Fig. 4. The site consists of silty and clayey sand and gravel along with boulders up to few meters in diameter

Geotechnical explorations indicate that the site consists of altering layers of silty and clayey sand and gravel (SC, SM, SW, GC, GM, and GP) along with boulders and cementation. Soil to the East of the site is generally sandy, whereas the west of the site tends to contain more gravel. Soil is generally brown or light brown and rarely light green or grey. Fig. 4 shows an example of the sizable boulders encountered in the site.

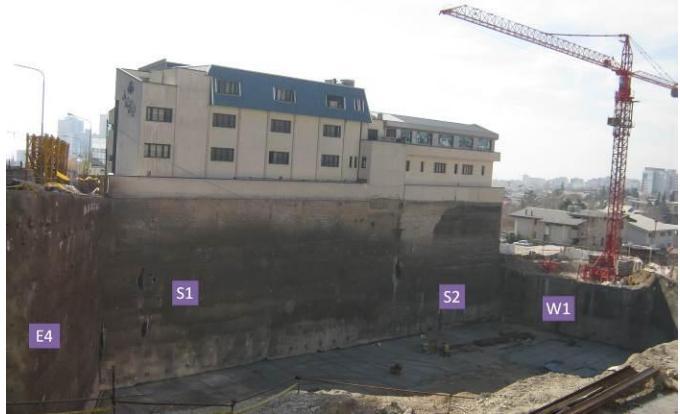
Fig. 17. S1, S2, E4, and W1 soil nail walls after excavation to the full depth

The site is excavated to a constant level throughout the excavation site. Fig. 16 shows W3, W4 and N1 soil nail walls before excavation reaches its final grade. On the other hand, S1, S2, E4 and W1 soil nail walls and W1, W2 and W3 soil nail walls are shown in Fig. 17 and Fig. 18 respectively. The

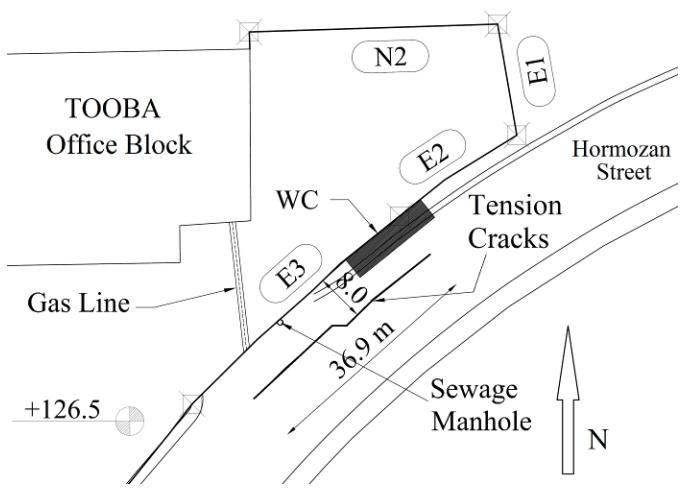
Fig. 30. Positions of the subsurface infrastructures near the excavation pit

indicated that there is a high pressure gas pipe to the south east of the TOOBA tower which supplies the tower. Fig. 30 shows the position of the gas pipe the crack and their relative positions to the E3 soil nail wall and the TOOBA tower. The gas pipe has held in place using a strut system since the beginning of the excavation as shown in Fig. 30. In this picture, water marks are also evident on the shotcrete surface of the E3 soil nail wall.

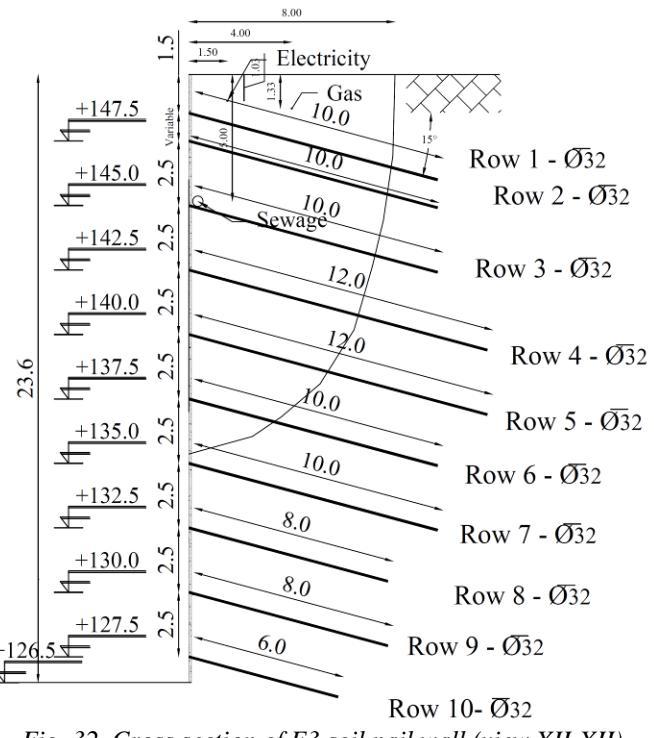
Fig. 32. Cross section of E3 soil nail wall (view XII-XII)

Fig. 32 and Fig. 33 show schematic cross section and front view of the E3 soil nail wall and depict the location of the underground infrastructures.

All the cracks on the surface of the road were closed with proper combination of tarmac to avoid further intrusion of water into the tension crack. The scratching of the shotcrete at the location of watermarks alone allowed that some of the accumulated water behind the wall to dissipate quickly. However, 6 meter long handmade drains which consisted of a grooved PVC pipe wrapped inside a geotextile cover were installed to help dissipate the rest of the water possibly trapped inside permeable deposits behind the wall. Fig. 34 shows the strut from a different angle while workers are installing the drains on the locations were water marks have appeared on the surface of the shotcrete.

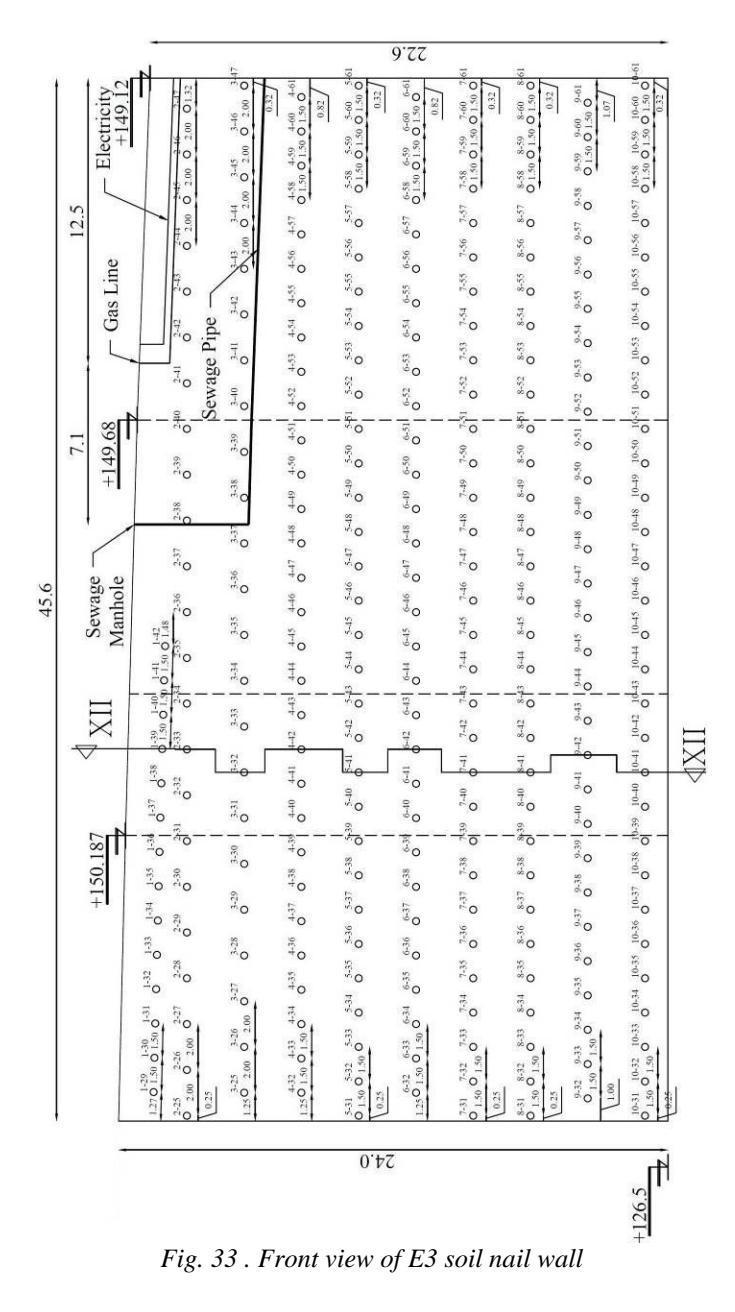
The temporary shotcrete facing of the soil nail wall was carefully investigated for any signs that could indicate that a moving block of soil has been formed. Based on the fact that the crack occurred 8 meters from the excavation boundary, it was expected that the toe of the block be located at 14 to 15 meters below the top of the wall. Since no manifestations of the crack was observed on the wall surface, the premise that soil block is moving was abandoned. Further monitoring of the E3 soil nail wall did not indicate progressive deformations.
