Failure Investigation and Restoration of Two Cellular Sheetpile Structures

FAILURE INVESTIGATION AND RESTORATION OF TWO CELLULAR SHEETPILE STRUCTURES

Frank M. Clemente, Jr., Ph.D., P.E.

AECOM

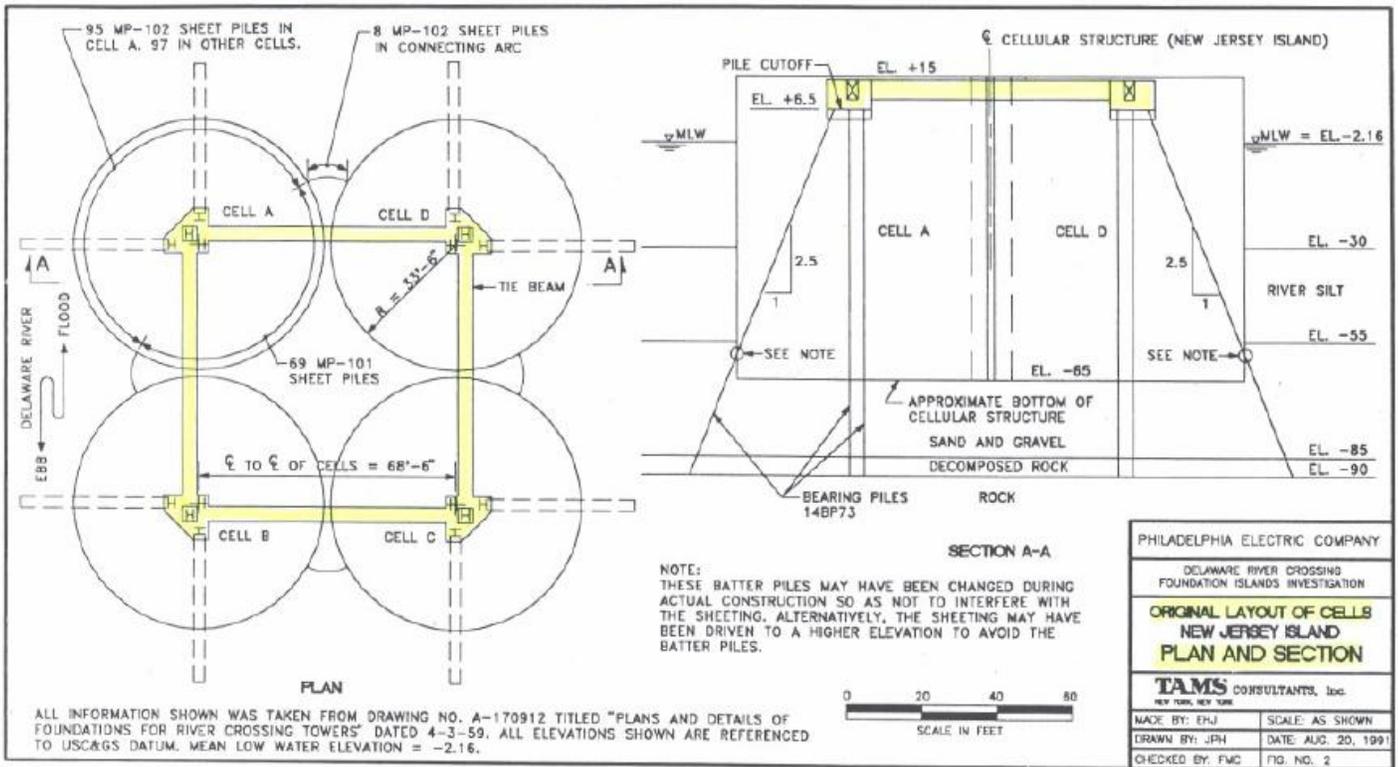
Fig. 2: Plan and Elevation of New Jersey Island

Existing drawings were obtained from PECO and US government agencies. The drawings were used to prepare a geologic profile of the New Jersey Island (Fig. 4) and to define the original configuration of the cells (Fig. 2).

Corrosion Probe, Inc. performed ultrasonic thickness testing of the sheetpiles and evaluated the condition of the cathodic protection system. The cathodic protection system on the New Jersey Island was not operational. An overload trip feature probably deactivated the system when the cables from the H-pile groups to the anodes in the two failed cells were ruptured due to the large displacements of the cell fill. Potential measurements indicate that all structures on the New Jersey Island, including the sheetpiles, H-piles, pile caps and electrical grounds were electrically continuous. This appears to corroborate calculations and oral recollections which indicated that the batter H-piles on that island intersected the sheetpile cells, as shown on Fig. 2. The cathodic protection system on the Pennsylvania Island was operational and in service.

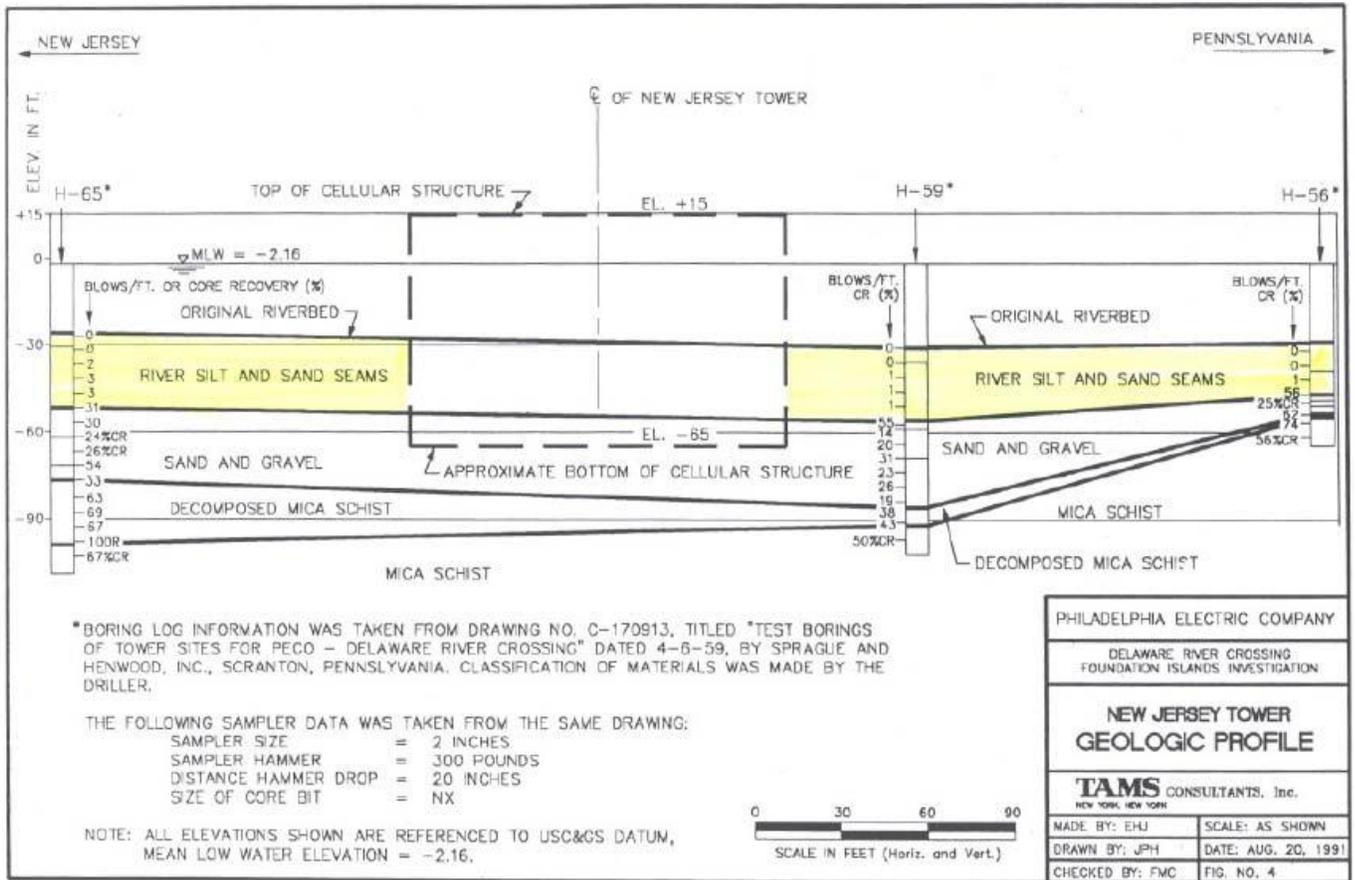
Fig. 4: Idealized Soil and Rock Profile

The soil profile in Fig. 4 shows that the sheetpiles were driven through the soft riverbed silt into an underlying sand and gravel layer. This layer is medium dense to dense and could have caused substantial resistance to penetration of the driven sheetpiles. In overcoming this resistance the sheetpiles, being long flexible members, were vulnerable to damage by tearing of the webs or deformation of the interlocks.
