(2013) - Seventh International Conference on Case Histories in Geotechnical Engineering

# Lessons from Revisiting Three Cases of Slope Failure

# LESSONS FROM REVISITING THREE CASES OF SLOPE FAILURE

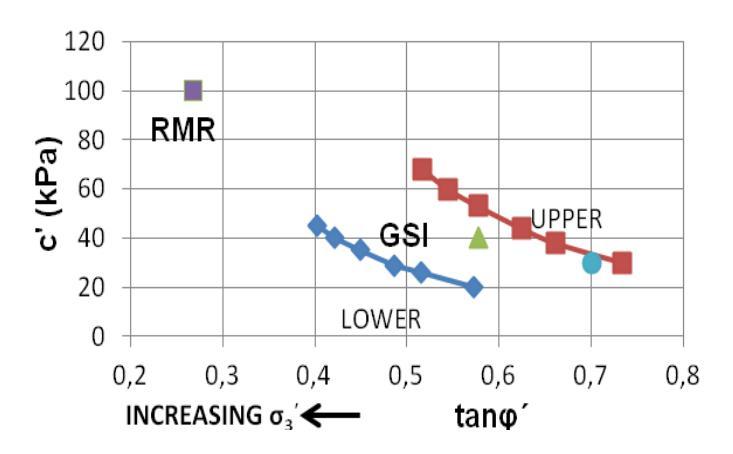
However, a classification rockmass system could be marginally used on the condition that during the final choice of  $\varphi'$ , c' parameters, the nature of the soils and the influence of the in situ stresses would be taken into account. In Fig. 3 a diagram of correlation of equivalent shear strength parameters is given for different values of lateral stresses  $\sigma_3$ ', according to Hoek-Brown (1997) criterion. The parameters c', tan $\varphi'$  were computed for two limited mean values of Geological Strength Index (Marinos and Hoek, 2000) GSI=12 and GSI=17 (for intensely weathered rockmass) with corresponding values of the parameters of the criteria  $m_i=7$  or 8 and  $\sigma_{ci}=5$  or 7MPa. In Fig. 3 two combinations of parameters are also shown for limited equilibrium of the slope from the back analyses. The

corresponding points are included in the range of variation of the combinations c' and tan $\phi$ ' and near the upper curve (GSI=17). In Fig. 4 the deformed finite element mesh is presented for a representative analysis. From the picture of the deformation of the anchored shotcrete its extensive damages could be justified. Finally, in Fig. 5 the plastic zones, and the shape of failure are presented, which seem compatible with the in situ observations.

Fig. 3: Shear strength parameters according to Hoek-Brown criterion.

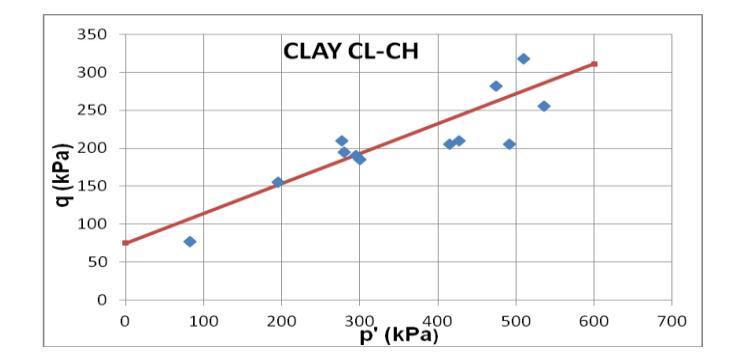
The new analyses were carried out after taking into account the variation of shear strength parameters and also the probable boundaries of piezometric line during the time of slope failure. The shear strength parameters of lignite usually range as  $\varphi'=24^{\circ}-28^{\circ}$  and c'=70-150 kPa. However, at the failure site, clay CL, CH, or OH prevails with lower shear strength as a rule. The range of shear strength parameters  $\varphi',c'$ variation is obviously important. From triaxal compression tests on samples of boreholes, which were made at the failure site the following values were taken:  $\varphi'=21^{\circ}-28^{\circ}$  and c'=25-80 kPa. In Fig.7 indicative results are shown from triaxal tests CIU on specimens, which were prepared from an undisturbed block sample.

*Fig.7: Representative diagram, p'-q from CIU tests.*

The appreciable variation of results from only one sample is evident. The back analyses revealed important differences in the safety factor. Taking into account the mean design parameters mainly for the clay and the unfavorable possibility for the development of temporary groundwater level, the slope failure is successfully justified, as demonstrated in Fig. 8. Considering the low safety factors, which are applied at the open pit mines (MSF=1-1,3 in most cases), the importance of uncertainty in design parameters becomes obvious. Consequently, it seems that the experience of the staff and the capability of estimation of forerunner slope failure phenomena is a matter of particular interest.
