## Lessons Learned from the Disaster at Lippe Canal Bridge

Markus Herten

### ABSTRACT

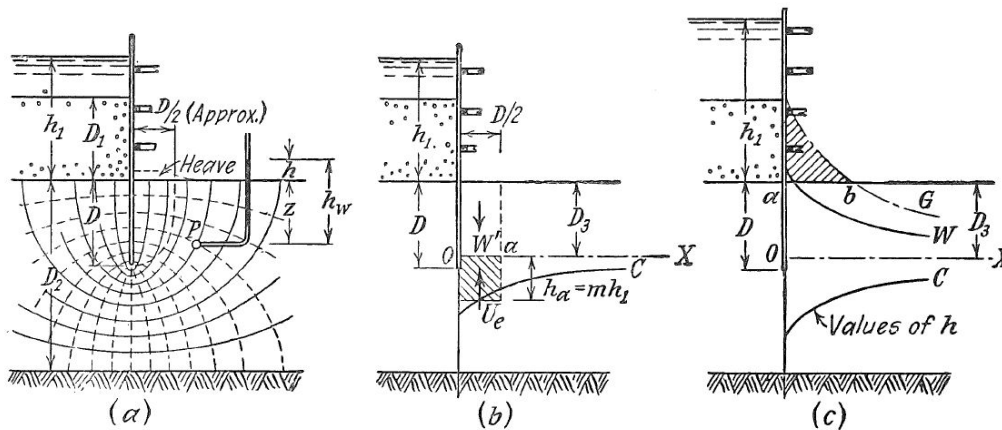
Fig. 9: Graphical determination of safety (from: Terzaghi K.(1947), Fig. 79)

Terzaghi further mentions in regard to failure by heave: “With sufficient accuracy we can assume that the body of sand which is lifted by the water has the shape of a prism with a width  $D/2$  and a horizontal base at some depth  $D_3$  below the surface. [...] For the simple row of sheet piles represented in Figure 79b an investigation has shown that the critical section passes almost exactly through the lower edge of the sheet piles, or  $D_3 = D$ .” In Germany, this is defined as the failure body after Terzaghi. Instead of using a potential net, another way of simplification is used in Germany for such a case; the potential at this wall base is calculated based on the formula by Brinch Hansen (1953), which is also mentioned in EAU (2004). According to this approach, instead of a prism with a width  $D/2$ , only a flow channel needs to be examined. The result for the simple row of sheet piles represented in Figure 9b would be on the safe side.

A more realistic result is obtained if, as described in Terzaghi (1947), the balance is considered not only at the wall base but also at other depths  $D_3 \neq D$  (Fig. 9c). Terzaghi writes: "The investigation can be repeated for different horizontal sections through the sand, which are located at different depths  $D_3$  below the bottom of the pit. The critical head is determined by the condition  $h_p = \text{minimum}$ , and the horizontal section to which this minimum refers is the critical section. It represents the lower boundary of the mass of sand subject to lifting in the initial state of the piping phenomenon." However, this was not considered when planning the excavation pit at the canal bridge Lippe and hence a false safety was calculated.
