HIGH-RISK FLOOD CONTROL DAMS ON DIFFICULT SOIL FOUNDATIONS

Gary S. Chow, P.E.
 U.S. Army Corps of Engineers
 Galveston, Texas, U.S.A.

Addicks and Barker Dams are two flood risk management structures owned and operated by the U.S. Army Corps of Engineers (USACE) and recently classified as extremely high risk. These dams were built in the 1940's in west Houston, Texas, upstream of a densely populated metropolitan area. The dams consist of 11 and 13 miles of rolled earth embankments, outlet structures with five barrel conduits, and uncontrolled spillways at both ends of both dams. The original design of both dams provided for four of the five outlet conduit barrels to be ungated, permitting a combined uncontrolled discharge from both dams of 15,700 cubic feet per second into Buffalo Bayou. Due to urban development throughout the 1940s and 50s, all conduit barrels of both dams were gated by 1963 to allow restricted discharge flows into Buffalo Bayou during normal operating conditions.

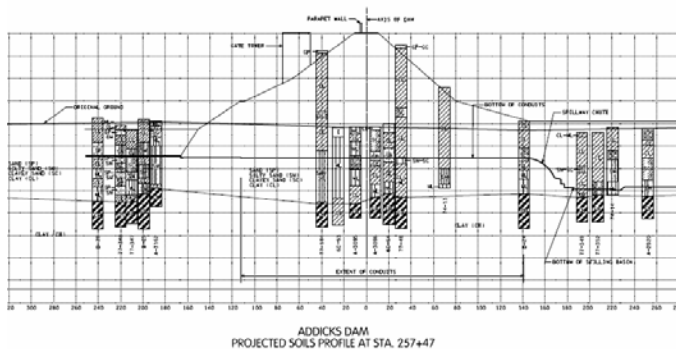
Figure 6 - Addicks Dam Soils Profile

Outlet Works Geology, Addicks Dam. At the outlet works for Addicks Dam, the upper stratum of sandy, silty, low plasticity clay extends to the depth, as indicated above, of about 10 to 15 feet, or to about the depth of the original excavation for construction of the outlet works. This upper stratum is underlain by interbedded low plasticity clay (i.e., CL – including silty clay and sandy clay), silt (i.e., ML – including rock flour, and silty and clayey very fine sand with slight plasticity), and sand (i.e., SP, SM, & SC – including silty and clayey sand, and poorly graded sand). This interbedded stratum is highly variable horizontally as well as vertically. The erodible fine sand, silty fine sand, sandy silt, and silt occurs in interbedded layers and pockets throughout the stratum. This interbedded stratum extends to a depth of about 30 feet and overlies high plasticity clay. The lowest stratum consists of high plasticity clay with little silt or sand. A composite presentation of the soils profile and phreatic surface with key boring logs at the outlet works for Addicks Dam is shown as Figure 6.

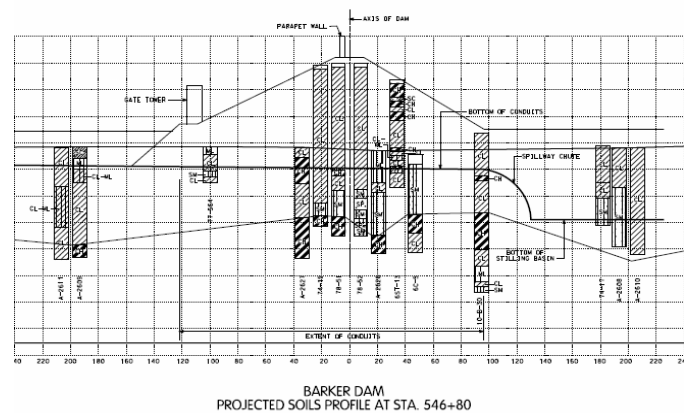
Figure 7 - Barker Dam Soils Profile

construction of the outlet works. This upper stratum is underlain by interbedded low plasticity clay, silty clay, sandy clay, silt, clayey silt, sandy silty, clayey sand, silty sand, and fine sand. This interbedded stratum is highly variable horizontally as well as vertically. The erodible fine sand, silty fine sand, sandy silt, and silt occurs in interbedded layers and pockets throughout the stratum. The sand below the outlet works at Barker Dam was encountered deeper in this interbedded layer than encountered at Addicks Dam. This interbedded stratum extends to a depth of about 30 feet and overlies high plasticity clay. The lowest stratum consists of high plasticity clay with little silt or sand. At the outlet works for Barker Dam, silt and sandy was encountered below the high plasticity clay. A composite presentation of the soils profile and phreatic surface with key boring logs at the outlet works for Barker Dam is shown as Figure 7.

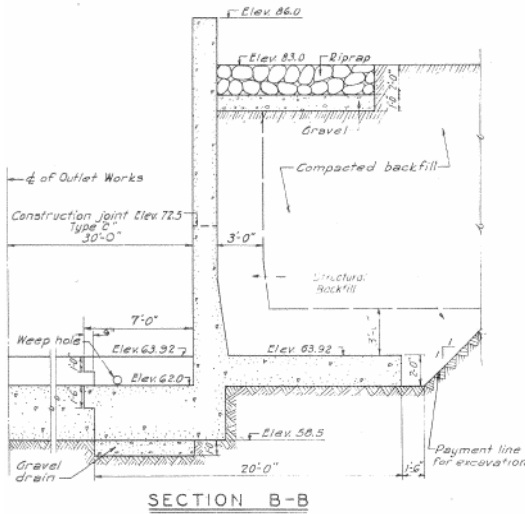
Figure 11 - Spillway Wall and Slab Cross-Section

Spillway Cavity Repair, Addicks Dam. In 1968 a large cavity was discovered under the southeast cantilever wall base and the parabolic spillway slab. The cavity was assumed to have

been caused by flow into upper weep holes, expansion joints, and cracks. The foundation material was apparently washed out through weep holes at the base of the spillway slab due to the lack of a properly installed filter preventing the foundation materials from exiting the structure. Investigations revealed that the cavity was extended under about two-thirds of the spillway slab and had a maximum depth of about 10 feet. Samples obtained from the bottom of the cavity through the weep holes revealed that the soils under the spillway slab range from sandy clay to silty sand with some sandy silt and clayey silt. Observations during these investigations revealed that the silty and sandy silt were readily transported by the flowing water and that the clay was being eroded by the flow of water. Figure 10 shows the spillway and stilling basin slabs of the original installation for Addicks dam. Expansion joint material between the spillway slab and cantilevered walls was replaced and the small crack in the toe of the east cantilevered wall was repaired. Figure 11 presents the typical arrangement of the expansion joints between the spillway slab and wall. Well screens were placed in the lower weep holes, and filter sand was flushed through the upper weep holes and some intermediate holes that had been drilled for the repair. After placement of the filter sand, the intermediate holes were plugged and relief valves were inserted into the upper weep holes.

Additional Repairs to the Cantilever Wall, Addicks Dam. In 1973, the measures taken in 1968 to repair the crack in the toe of the east spillway wall were discovered to be ineffective. Foundation material beneath the spillway wall and the spillway slab was still being lost through the crack. Approximately 10 cubic feet of spalled concrete was removed from the cracked area. The existing reinforcing steel was cleaned, then Dow Earthfoam (joint filler) and sealant were used at the vertical and horizontal expansion joints. An epoxy binder was applied to the cleaned concrete surface prior to placing the replacement concrete. The eroded filter sand was replaced.

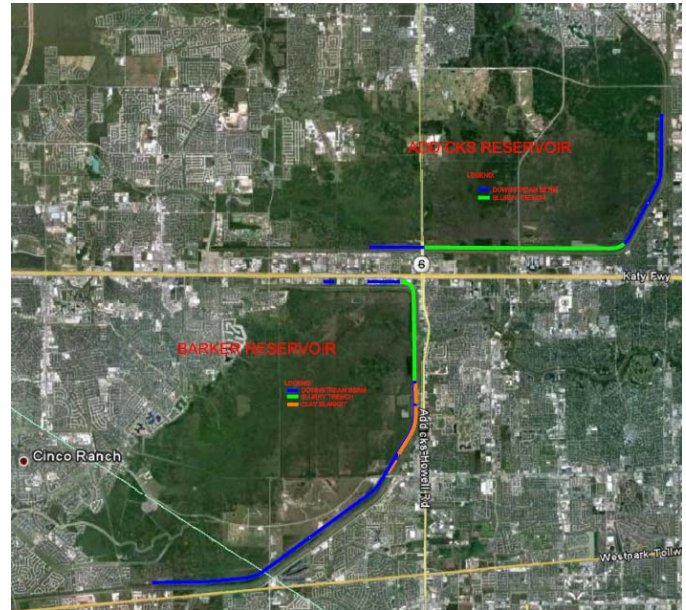
Figure 12 – Addicks and Barker Dams Seepage Control Measure Installations

Remedial Seepage Control Measures, Addicks and Barker. In February 1977, seepage boils were discovered along the channel slope of the newly excavated Turkey Creek drainage ditch located below and parallel to Addicks Dam. Subsequent analyses and evaluations of the seepage potential at both Addicks and Barker Dam resulted in four contracts awarded to construct remedial seepage control measures at Addicks Dam and three contracts at Barker Dam. These works included construction of slurry cutoff wall and downstream stability berms along portions of the embankment, installation of clay blankets in upstream borrow areas, and other repair work at the outlet spillway area at both dams. As shown in the aerial map (Figure 12) that the slurry seepage control cutoff wall was installed across the outlet work conduit locations at both dams. However, the cutoff walls only penetrated the embankment to near the top of conduits and therefore leaving a window of seepage area around and beneath the conduits as shown in Figures 13 & 14. The works were performed during the periods of 1977 through 1979 and 1978 through 1982 for Addicks and Barker Dams, respectively.

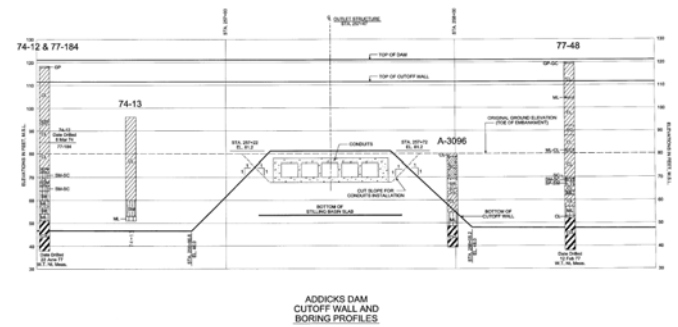
Figure 13 - Seepage Window Profile Around Conduits at Addicks Dam

PFM 6 – Foundation seepage and piping beneath conduit or within the window where there is no cutoff wall as the cutoff wall rises and goes over the conduit leading to backward piping and erosion.
