Landslide Stabilization Along The Ohio River Using Cantilevered Stub Piers

LANDSLIDE STABILIZATION ALONG THE OHIO RIVER USING CANTILEVERED STUB PIERS

Paper No. 3.34a

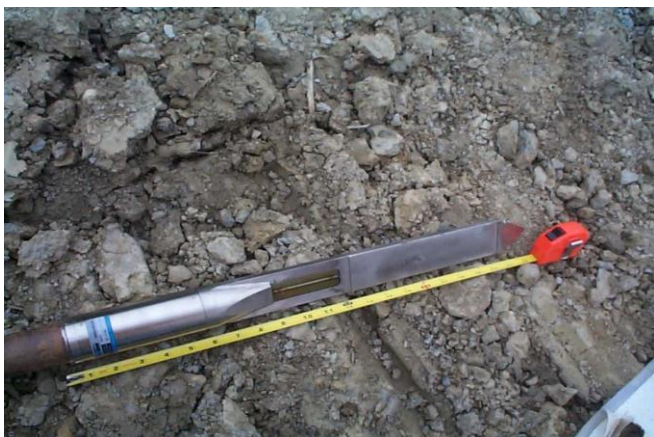
4. Three Push-In Earth Pressure Cells (Geokon Model 4830; see Figure 6) were installed within boreholes located about 8 to 10 feet upslope of selected Stub Piers. These devices were located about 40 to 45 ft. below grade and were installed with the intent of being just above the bedrock surface (close to the interpreted shear plane). These devices measure total horizontal pressure in the soil.

Fig. 6: Push-in earth pressure cell.

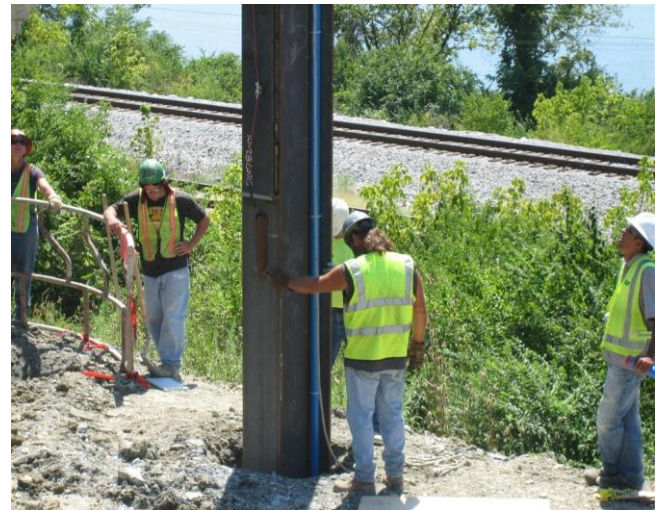
Fig. 10: Setting instrumented steel beam into shaft excavation.
