RECONSTRUCTION OF ROAD EMBANKMENT FAILURE USING REINFORCED GEOGRID: REVISITING THE SITE AFTER 15 YEARS

A case history of repair works of road embankment failure at KM39, Route 68, Kuala Lumpur – Bentong Road in the state of Selangor, Malaysia and an observation on the condition of the site after 15 years and some tensile strength testing carried out on buried and exposed geogrid was presented in this paper. Due to heavy rainfall in 1995, about half of the road embankment which was located at the alluvial fan of an upslope stream valley was washout. For the reconstruction of the alignment, the existing half of the alignment was converted into a buffer zone with a row of gabion as a barrier to trap any fallen debris from the upslope stream valley. A geogrid reinforced embankment was constructed to provide an additional area for the new alignment of the road.

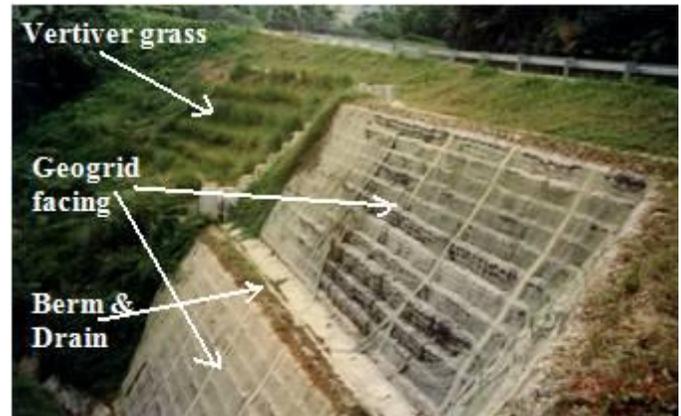
Fig. 13. Photo taken on May 25, 1998

Figure 13, 14 and 15 is a series of photo taken on various times shows progress of vegetation growth on the slope surface. Within four years construction completed, fast growing vegetation covers transformed the constructed slope surface into thick bushes as shown in Fig. 15.

There is no evidence of any crack or settlement on the road surface or at the top of the geogrid embankment on the last visit to the site in 2001.

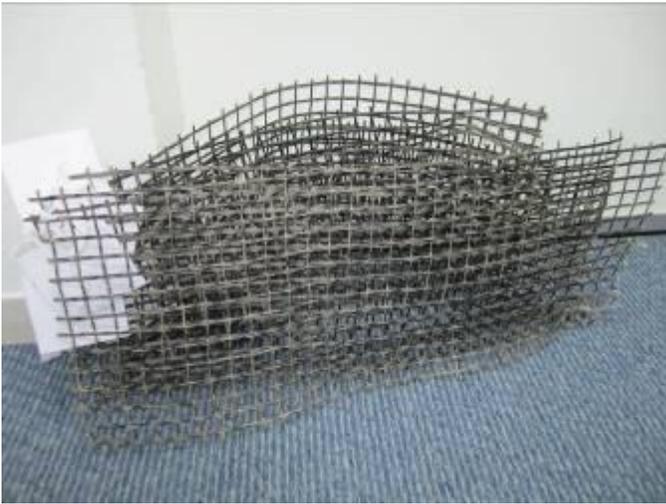
Figure 21 shows sampling of buried geogrid from top layer of geogrid embankment where the soil covering the geogrid was removed before a piece of 600mm (Wrap) by 200mm (Weft) was cut. Figure 22 shows sampling of exposed geogrid from the facing was in the process. The samples were then washed because it should be freed from soil, sand and algae before sending it to the laboratory. Figure 23 shows the cleaned samples of geogrid with minimum size of 600mm (Wrap) by 200mm (Weft) ready to be sending to an accredited laboratory for tensile testing.

Fig.23. Samples of geogrid with minimum size of 600mm (Wrap) by 200mm (Weft) ready to send to an accredited laboratory

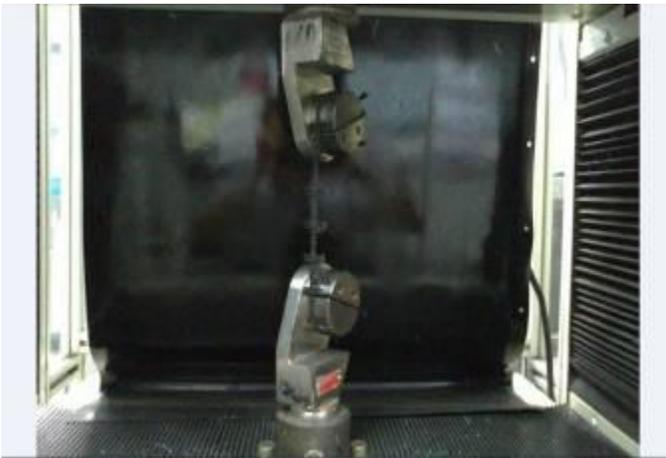
Due to the Fortract 80/30-20 and 110/30-20 geogrid was high strength geogrid, the Wide Width Tensile Test was carried out using split roller grips on the single strand of geogrid as shown in Fig. 24. This test procedure is based on ISO 10319-2008. A strain rate of 20% per minute was applied. The results were then multiply by 40 to get kN/M unit.

Fig. 24. Wide Width Tensile Test using split roller grips based on ISO 10319-2008

was observed. For exposed Fortrac 110/30-20, the percentages reduction of strength is between 2.3% and 17.7% with an average of 10.2% and standard deviation of 7.68%. Glaring in difference of strength reductions is difficult to explain. Is it the contractor tries to cut cost by using lower grade of geogrid? Noted that the only available grades of Fortrac geogrid attached in the Design Report (RAS, 1996) are 110/30, 80/30, 55/30, 35/20 and 20/13.

If we ignore the last two samples (BR6 and BR7), an average percentage reduction of strength for both condition is not much difference. This means that Malaysian tropical environment effect of ultraviolet, temperature and humidity) didn't much effect on the strength of geogrid.

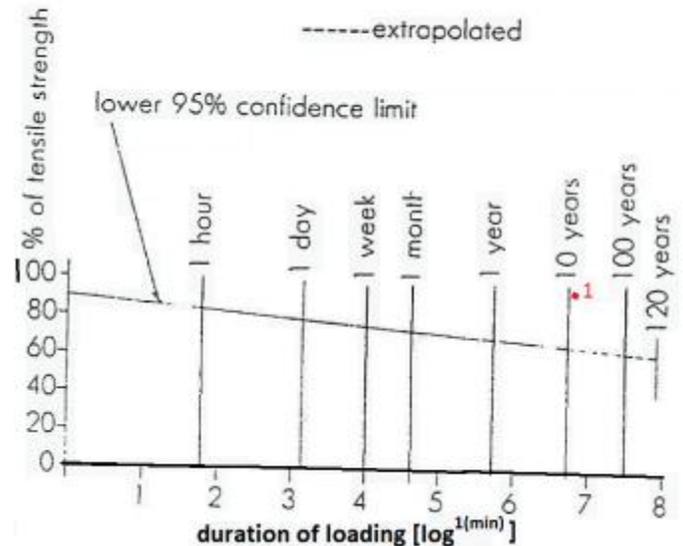
Fig.25. Time to rupture (BBA, 1992)

Figure 25 shows a graph of time to rupture, under varying load, for Diolen yarn, as suggested in the Roads and Bridges Agreement Certificate No 92/69 (BBA, 1992). From this graph the characteristic strength (P_{char}) above which the material will fail in tension, can be determined for a given design life. If we put the average percentage of strength for both condition in this study into the graph, it was much higher than the suggested strength after 15 years it was installed. This high percentage of geogrid strength is may be due to the geogrid are not exposed to constant loading based on the location of sample taken: at the top most geogrid layer (thin overburden) and at the facing of slope.

behaviour of Diolen yarn under constant load till rupture temperature range 0° C to 30° C.
