BANK INSTABILITY PROBLEMS ASSOCIATED WITH THE RIVERSIDE CONSTRUCTION

Gennaro G. Marino, Ph.D., P.E.
Marino Engineering Associates, Inc.
Urbana, IL-USA 61801

Abdolreza Osouli, Ph.D.
Southern Illinois University Edwardsville
Edwardsville, IL-USA 62026

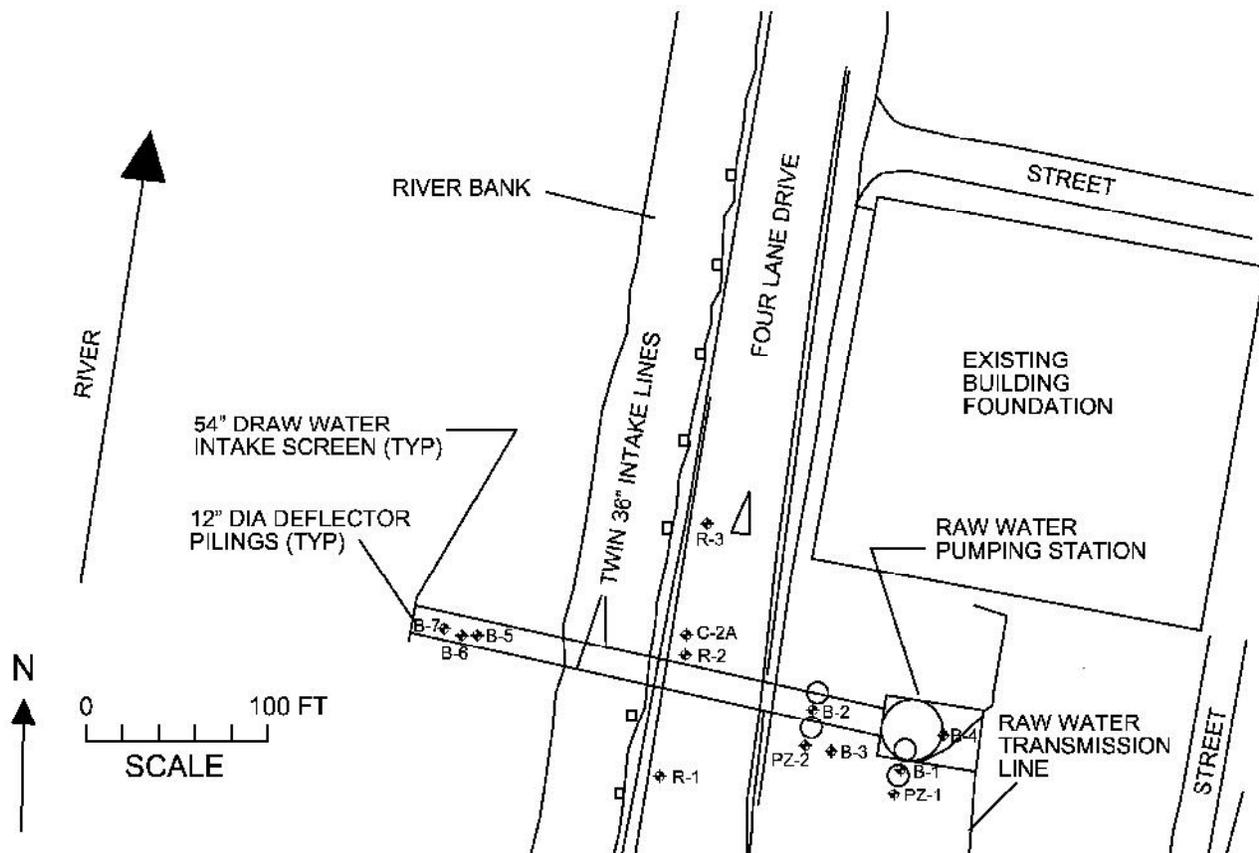
Fig. 1. Site plan of river intake area

This study is a geotechnical investigation of the bank instabilities associated with the riverside construction of the Water Intake Structure in Tennessee. A general plan of the water intake facilities along the river is shown in Fig. 1. This water is transported by pipeline to be treated and then distributed to neighboring communities. As can be seen from Fig. 1, the intake structure basically consisted of the wet well on the east side of a four lane roadway which is connected to two 36 in. diameter intake pipes that are at an approximate depth of 70 ft (i.e. planned invert elevation at 320 ft). The intake pipes are installed inside 5 ft diameter drilled-in steel casings from the shore well and below the road and a portion of the riverside embankment for the four-lane roadway.

As part of the geotechnical design investigation, a total of 8 borings were drilled: 3 around the Pump Station Building (B-1, B-4, and PZ-1), 3 immediately west of the wet well shaft and east of the highway (B-2, B-3, and PZ-2), and 3 in the river near the intake structure (B-5, B-6, and B-7) (see Fig. 1). No design borings were drilled in or immediately above the riverbank slope.

Between November 19 and 20, 2004, three additional auger borings (R-1, R-2, and R-3) were drilled in the roadway on the west side (see Fig. 1). The borings were located within about 20 ft of the crest of the slope on the north and south sides of the alignment. The holes were drilled approximately 9 months after the February 2003 landslide. The borings were advanced using a hollow stem auger and were drilled to refusal. Split spoon soil samples were taken every 2.5 ft in the upper 20 ft of the hole and then at 5 ft intervals to refusal. No rock cores were taken in the post-construction boreholes.
