# Damage to Agricultural Facilities Caused by the 1993 Kushiro-oki and Hokkaido Nansei-Oki Earthquakes

Paper No. 9.15

S. Tani

**SYNOPSIS** Two large earthquakes struck Japan during only a 6 month period in 1993: Kushiro-oki on January 15 and Hokkaido Nansei-oki on July 12. Both caused a lot of damage to facilities, including installations such as farm roads, reclaimed farmland, channels, head works, drainage pump stations, pipelines and fill dams. In this paper, we present an outline of the damage to agricultural facilities and its features.

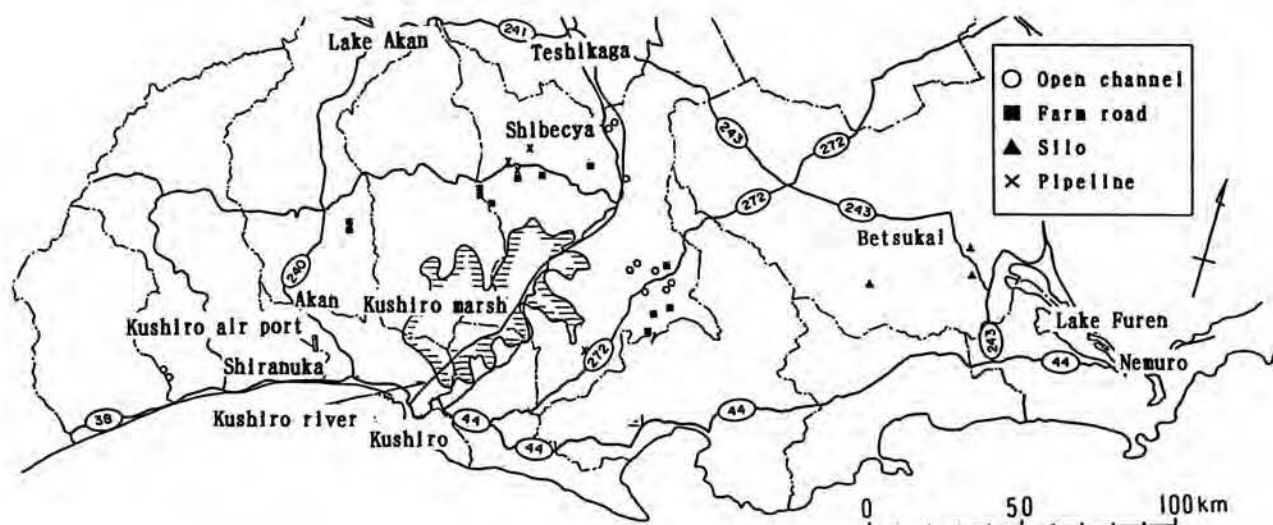
Fig.2. Map of Damaged Agricultural Facilities caused by the 1993 Kushiro-Oki Earthquake.

The damaged sites of agricultural facilities are shown in Fig.2

(1) Farm roads: The main farm roads were damaged at 7 places, 5 of which were relatively lightly damaged including faulting resulting in 3-5 cm differences in surface level and pavement cracks. The remaining 2 places in Isobunnai (town of Shibecha) were greatly damaged. The total length of damaged road was 180 m, faulting emerged, and the ground caved in 2 m at the maximum. Most of the damage on farm roads occurred in the boundary area between the cut and the bank over a ravine. Judging from the surrounding topography, the thicker the layer of soft ground, the greater the damage was.

(2) Miscellaneous water facilities (small caliber pipelines): Air valves were broken, water leakage occurred because joints dropped off, and holes appeared in the pipes. Both cast iron pipes (250 - 350 mm) and asbestos pipes were damaged. The damage was observed in crossings of the ravine and where there is a sudden topographical change, but a general distinct tendency of the damaged areas is not recognized.

(3) Silos: Three silos in the town of Bekkai were damaged. One was completely destroyed (Fig.3) and in the case of other two, panels on the side walls were damaged and anchor bolts fixing the silos were broken. It is presumed that acid silage had corroded the bolts.

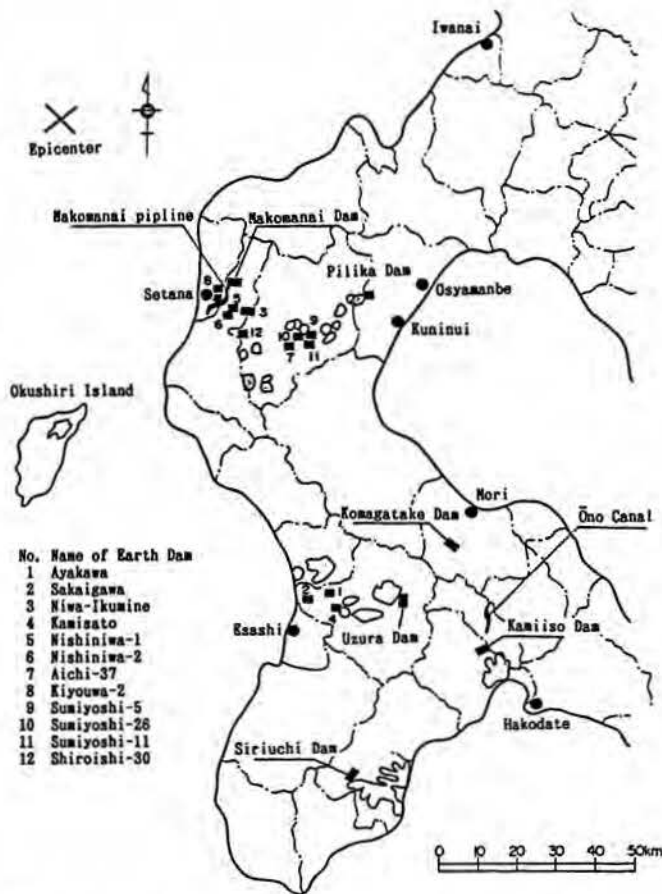
Fig. 4. Map of The North Hokkaido Showing Dam Sites.

The major damaged places and dam sites are shown in Fig. 4

- (1) Reclaimed farmland: Slope collapse occurred in 6 districts. The bank of the reclaimed farmland in these districts was as high as 20 - 30 m in most cases and thus collapsed very intensively. The collapse of the slope caused cracks in the cultivated land, which extended several hundred meters from the top of the slope.

- (2) Open channels (irrigation and drainage canals): In the western district of Mt. Komagatake, the base of the channel which is made of blocks on the three faces suffered upheaval extending up to 120 m. In the Ono district, damage was concentrated in a 1.7 km section of the 7.2 km channel. A past soil survey revealed that damage occurred in places where there was sandy ground and where L-shaped blocks were placed. The area with cast-in-place concrete was not affected. Judging from the fact that Kushiro-oki earthquake caused damage to precast inlet in the open channels but not to inlet made of cast-in-place concrete, it is presumed that cast-in-place concrete structures are resistant to earthquakes.

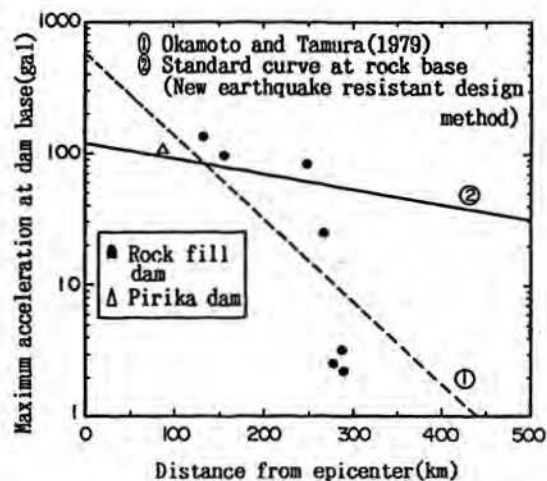
Fig. 6. Maximum Acceleration Records at Dam Base.

occurred on the natural slope around the reservoir. Fig. 6 shows the relationship between the distance from the epicenter and the maximum input acceleration, based upon the data obtained at the fill dams in the vicinity. The result in Fig. 6 adheres closely to the relationship suggested by Okamoto and Tamura. Judging from the data, the maximum acceleration at Makomanai Dam is estimated at about 180~250 gal.

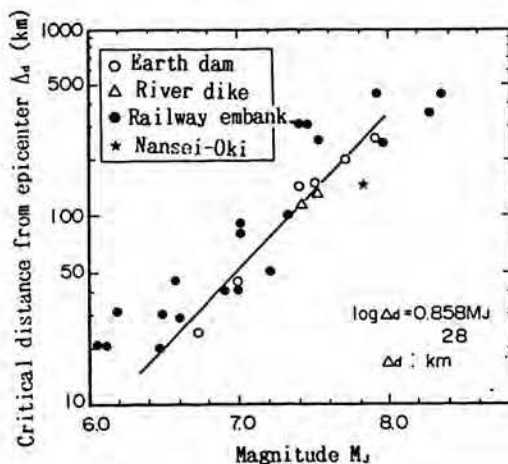
Fig. 9. Relationship between Magnitude and Critical Distance from Epicenter.

Fig. 9 shows the relationship between magnitude and critical distance, the greatest distance from the epicenter when any earth dams are damaged by the earthquake. The line in the figure was drawn based upon the data of earthquakes in the past and the area below the straight line shows affected areas. ★ indicates the data of Hokkaido Nannsei-Oki earthquake, which appears to relate closely with tendencies of past earthquake result data.
